“The rebuilding of Norman’s 75 Eleganza II-X, 01-09-75”, Rev.2

Norman Wheatley, Houston, TX 77054-4160 metrolog@hal-pc.org

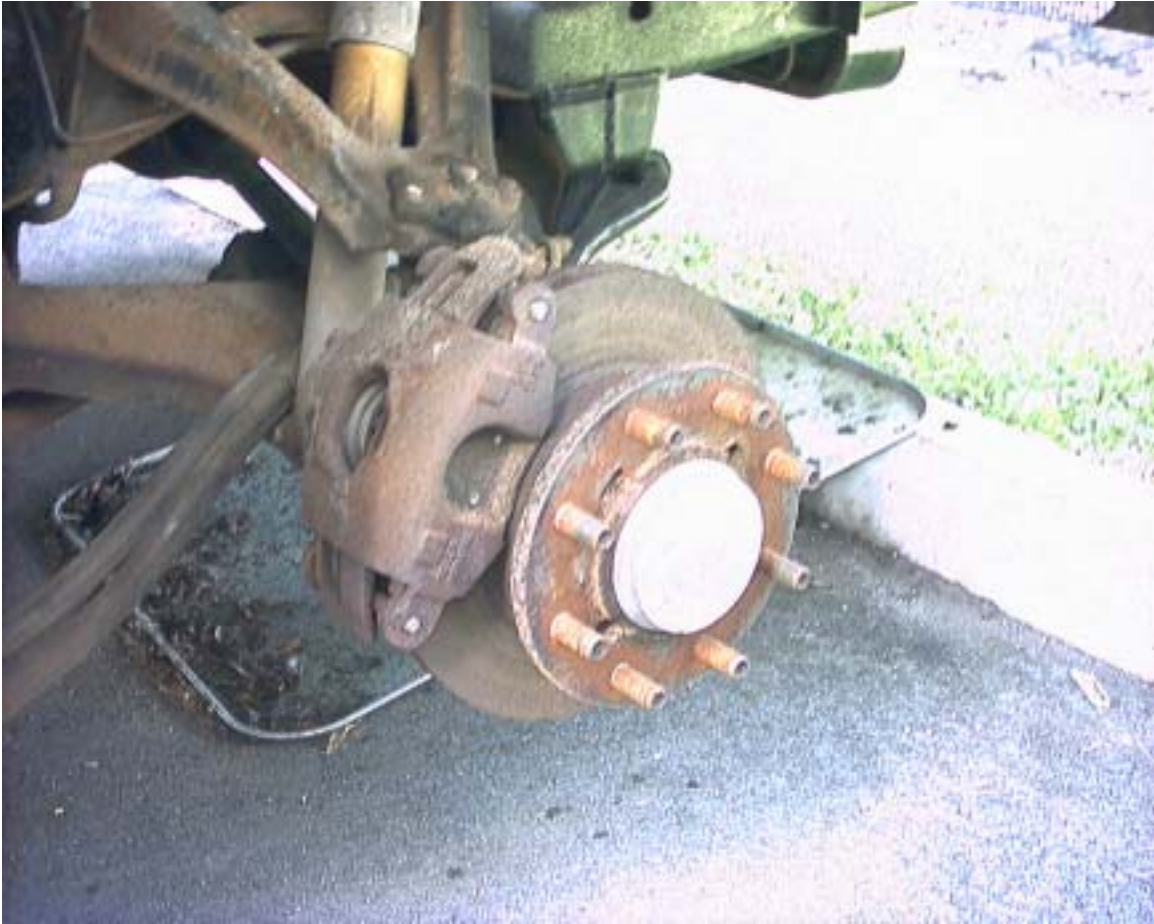
Shock Absorbers -

KG5436 rear). I also found that a P.O. had installed Bilstein shocks on the front and put KYB shocks on the rear in my case. Both were rusted extensively and were in very bad shape. I guess I made my final choice based on the fact that I couldn't come up with a good reason to use two different brands and I had received many positive comments on the service life of the KYB's. We shall see how they work out and I will let you know the results some day. The shocks were also obtained from Gateway.

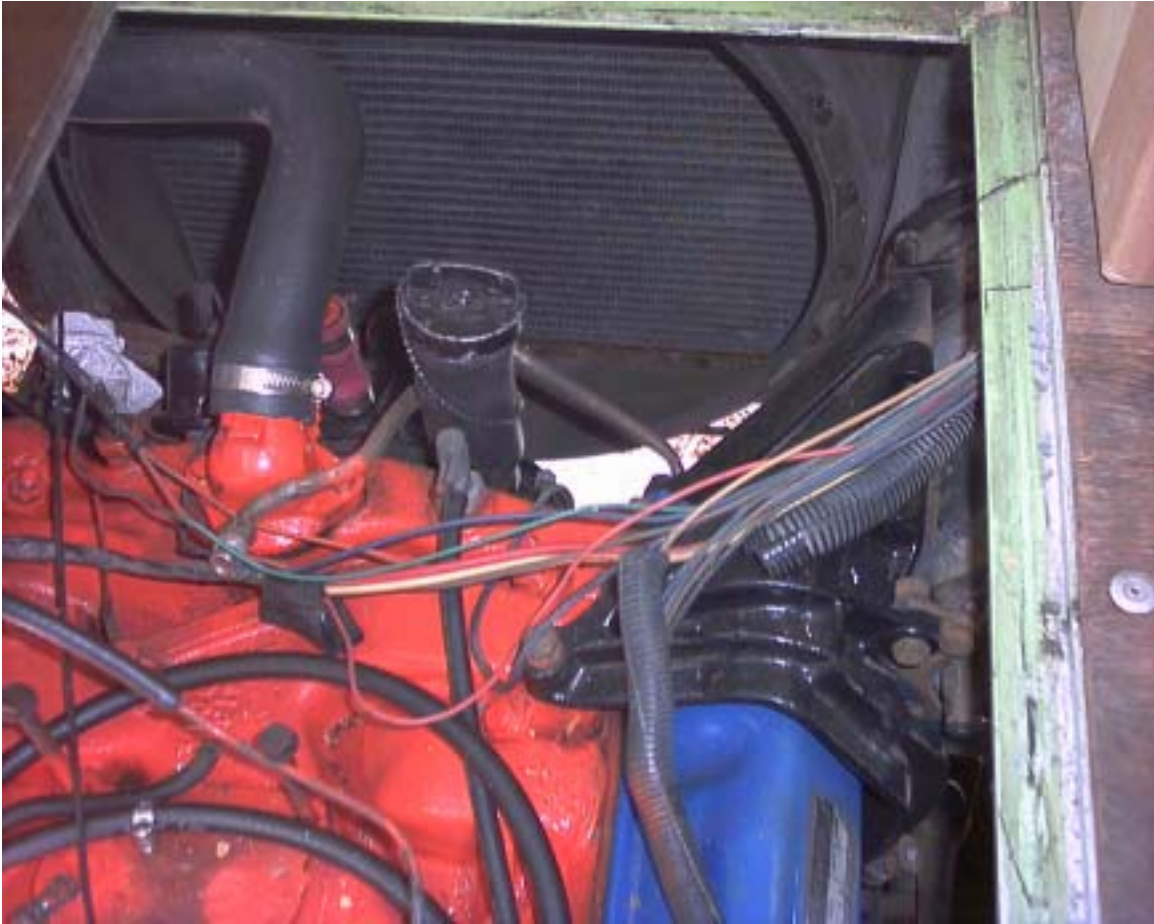
I noticed that the rubber elbows on the oil fill tubes were cracked and needed replacement. But after thinking about it for a while, I saw this contraption as little more than something else to break. Besides, who would rather stand out in the weather adding a quart of oil, when they could do it from within the comfort of their living room? Having removed the original fill tube hardware back to the stack pipe on the front of the old 455, I took a pipe cutter and shortened the piece with the cap on it by an inch or so. Then, after removing the small flange that used to attach it to the front frame and using a six inch strait piece of leftover radiator hose, the two pieces were wedged together, where I felt they should have been in the first place. Just for appearances, I decided to give both pieces a coat of high temp, gloss black engine enamel paint prior to final assembly. The

fit was so good, that hose clamps were unnecessary. This arrangement left at least an inch or more clearance for the engine hatch cover and no more leaky rubber elbows to worry about 8-).

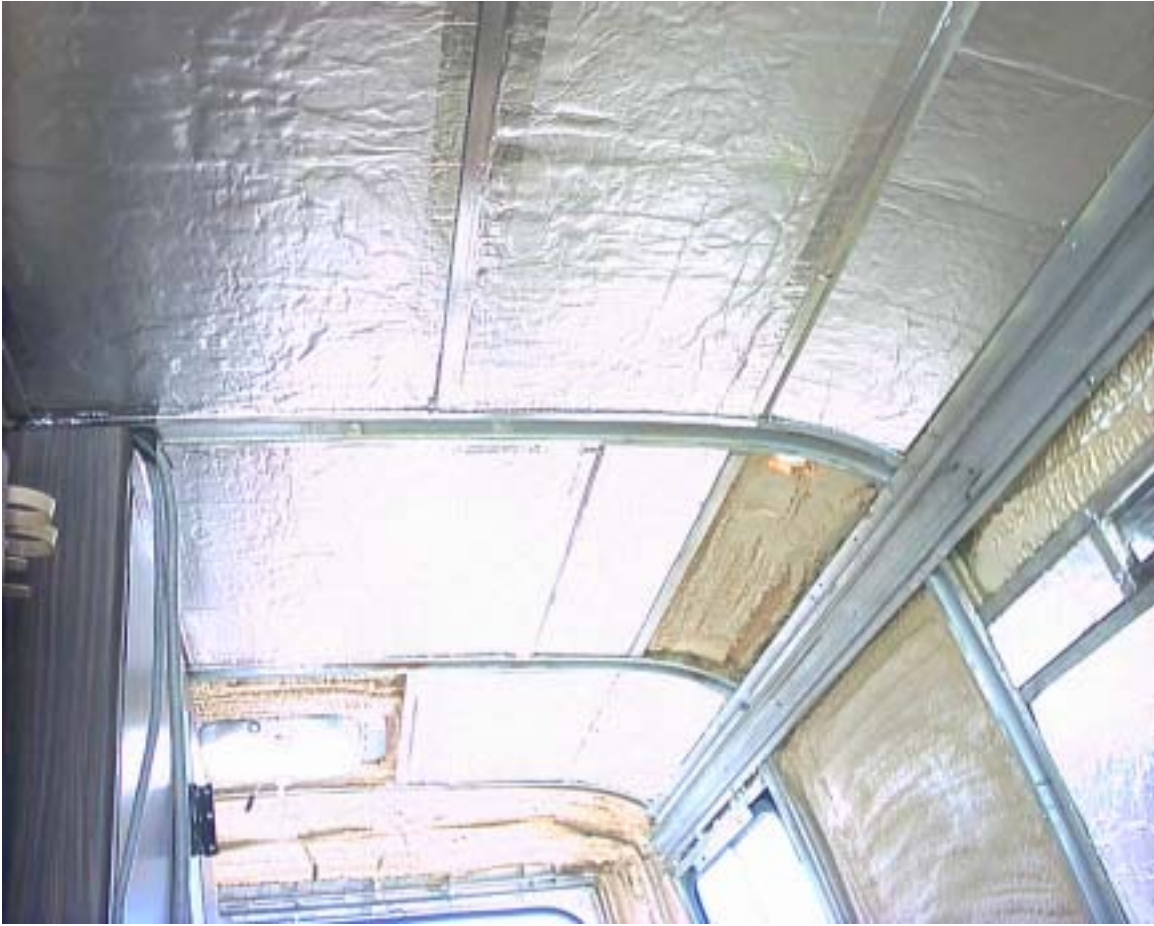
It was obvious that the particleboard furnishings were shot and would have to go, so they went... It took several days and several trips to the dumpster but it was certainly educational. At least they used screws instead of the staples and glue found in the junk they make today. I take that back about the glue. Everywhere I read on the web, folks were commenting about the poor insulation used in the original GMC MH design, so I set out to tackle that situation. Using a hacksaw blade to trim the original sparse application of urethane insulating material, I trimmed it to a depth of ½ inch where it wasn't already missing (which was usually the case) from the inner frame surface. I then began cutting panels from the six 4'x 8'x 1/2 "sheets of rigid foil backed urethane insulation board (R rated @ 3.6) I had purchased from the local Home Depot and then sprayed expanding urethane foam to fill any and all of the remaining voids prior to positioning the new insulation panels. Finally, I used 2-inch aluminum foil tape to completely seal each panel in place. This also served to restrict the expanding foam from escaping through the cracks, leaving a clean, and airtight foil surface. I estimate that the relative 1-inch

urethane layer topped with foil and new headliner or wall panels should yield an R-value in the neighborhood of R-8+. Not bad considering what it was to start with (my guess would be around R-3+ maybe...). I should offer a cautionary note here. Application of the correct amount of expanding urethane foam can be a bit of an art form. Apply too little and you may have poor adhesion with excessively large voids. Apply too much and it may result in a bulging distorted surface that can be a minor pain to correct once it sets up. Anticipate that it will expand by 100% volume. Tape only along three of the panel edges initially and wait an hour or so to tape the fourth edge. This will permit excess gases to escape and not form a bubble that could distort the surface. Any excess foam can be trimmed flush with the surface when it hardens and can then be taped over. There are several benefits to this approach. First of course, the overall energy savings and comfort factors improve substantially, then there is the reduced likelihood of any condensation problems in humid environments such as we have here in Houston or along other coastal regions. It is also relatively impervious to water, so leaks of any kind should not result in any serious consequence. But best of all it provides a sealed metal barrier, eliminating access to those little nooks and crannies where any and all of the creepy crawly critters can hide or make mischief. The aluminum foil does the same thing to their teeth when they try to chew on it! 8-) But, just like the original insulation, urethane panels will **BURN AND PRODUCE TOXIC GASSES** if they catch fire.

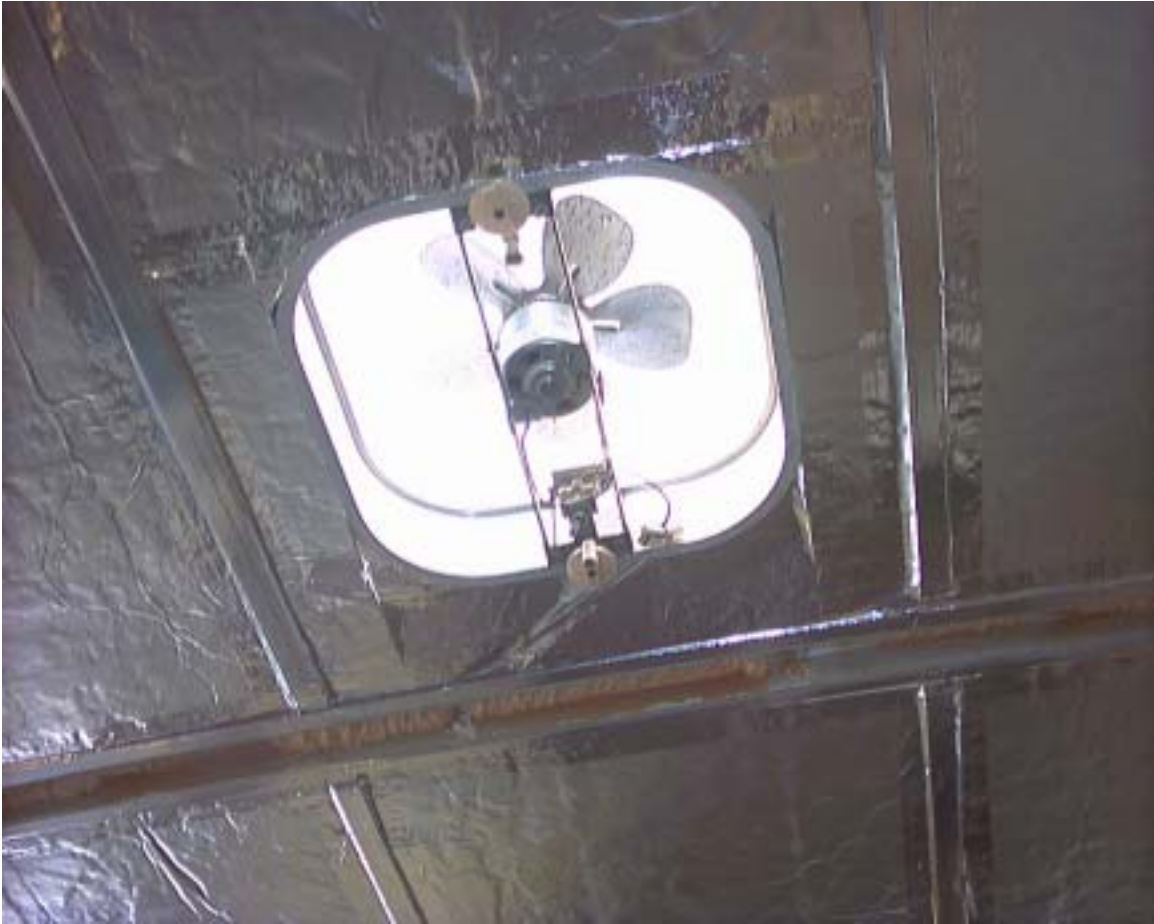
daunting task, nice, but perhaps overwhelming. The fact of the matter is, it doesn't have to be. This is not rocket science. I choose to completely revamp my insulation because the interior had suffered such damage through 21 years of neglect, that it made more sense, in my case, to do the whole thing at once. However, it is quite practical to obtain the same benefits one piece at a time. I would suggest starting with the entrance door as a way to practice the technique and begin to enjoy the additional benefits and comfort of having a well-insulated GMC. All that is required to begin, is a single 4' x 8' x 1/2" sheet of the reflective urethane insulation panel, (my choice, others flavors may be used) a single can of expanding urethane foam, a 2" roll of foil tape, a box cutter knife, a screwdriver, a putty knife, a tape measure, a 4' sheet rock square (this acts as a straight edge for making longer cuts), a hacksaw blade (this is used to trim lumps and irregularities from the original insulation), and an hour or two to complete some portion of the task. Removal of the door latch mechanism will also require a pair of long needle-nose pliers to extract and re-install the retainer clips. After the interior panels are removed, use the hacksaw blade to trim the original insulation back to a depth of 1/2" over the entire surface to allow clearance for the new insulation. The urethane board is cut as close to the dimensions of the frame segment as possible such that the least amount of expanding foam is required to fill in around it. Measuring from the inside recessed edge of the frame to the outer lip edge of the opposite side will permit the panel to be slipped

within the wall segment and actually be held in place by friction with the frame as it is centered. Carefully cut each panel and test it for proper fit, trim the edges as may be necessary. Then carefully remove the panel with the aid of the putty knife. The foam may be applied to either the frame or the panel just prior to final insertion. This is where the guess-timate comes in. Observe the overall surface of the remaining original insulation, in particular the void areas, which do not make direct contact with the new panel. Spray the expanding foam around the edges in a zig-zag pattern over the surface so that it will fill about 50% of the existing voids. Hold the can upside down when applying the foam or you will reach a point where you run out of gas before the can is empty. Wearing old clothes, rubber gloves and safety glasses when you work with the foam is advisable. It can take days for the foam to wear off the skin. Soap and water will not remove it, nor will most solvents! Have plenty of paper towels handy for any accidental over-spray or drip. Depress the valve slowly when applying the foam. On hot days, it can blast out of the can with quite a force and end up in places you would rather not have it. Be careful where you set the can when you have finished applying the foam. It will continue to slowly drip from the nozzle for several minutes and could make a mess before you realize it. I always have a plastic pan handy to rest the can in and catch any drips. The foam will begin to expand as soon as it hits the air, so apply it fairly quickly and then reinsert the panel into the wall segment and position it as you had done

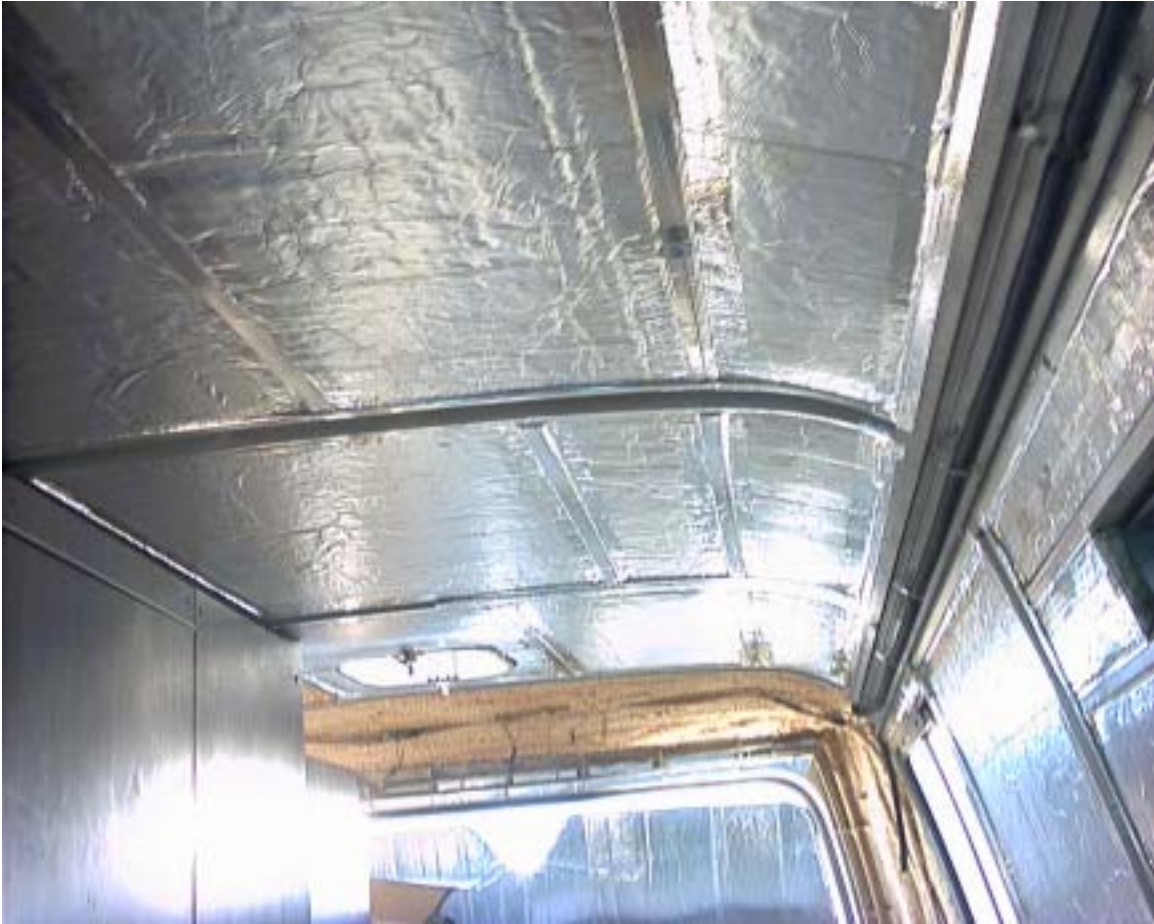
previously. Once the panel is in place, tear or cut lengths of the 2" aluminum foil tape and seal the edges to the structural members. Align the tape with the frame and press it along the seam working out the air to seal the surface. Do this on three sides. Leave the fourth and final edge open for a little while (20-30 minutes) so that the excess gas can escape as the foam expands to fill the voids and bond the new insulating panel in place. This will prevent the foam from forming any large bubbles under the panel and causing it to bulge or dome out in the middle, leaving a nice flat surface. If the foam happens to ooze out along the edges a bit, don't worry about it. The foam will set up and can be trimmed away with your knife or hacksaw blade after a couple of hours. If there is a bunch of it, grab a couple of paper towels and catch the blob, being careful not to get it on anything you don't want insulated. I found it easiest to apply the foam to the wall, but then applied it to the panel for the ceiling sections so it wouldn't drip on my head. In actuality, there will always be some modest air bubbles remaining when all is said and done. This is not a problem as these small sealed air pockets aide the insulation process. In fact, the urethane foam essentially forms a semi-rigid plastic sponge trapping billions of tiny insulating air bubbles.

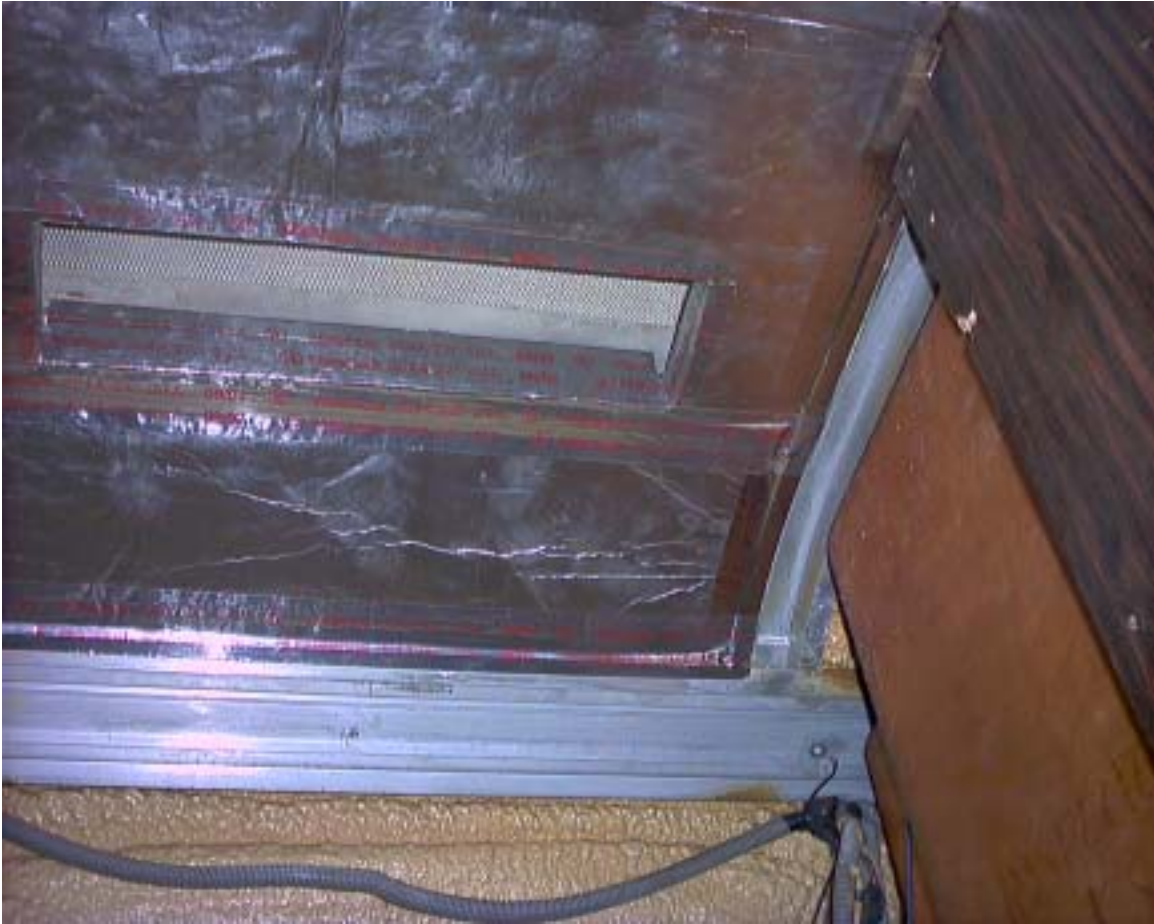
Another modification I made, with regard to the headliner segments over the refrigerator and bath modules, is that I extended them to the full width of the ceiling just like all other headliner panels. I did this in order to maintain uniformity over the entire roof area and not to have any hot spots on the roof at these points. This also extends the surface of the moisture barrier, so any potential leak would migrate to the edge of the roof-wall seam and not flow directly into the bath or refrigerator areas. Again, it was a little more work, but I felt it would be worth the extra effort in the long run.

The roof vent will eventually incorporate 12VDC exhaust fans to vent the furnace exhaust (which will be relocated beneath the refrigerator compartment and the heat from the refrigerator coils and compressor. They will be coupled to the power circuits of these appliances so that they cycle in unison with them.

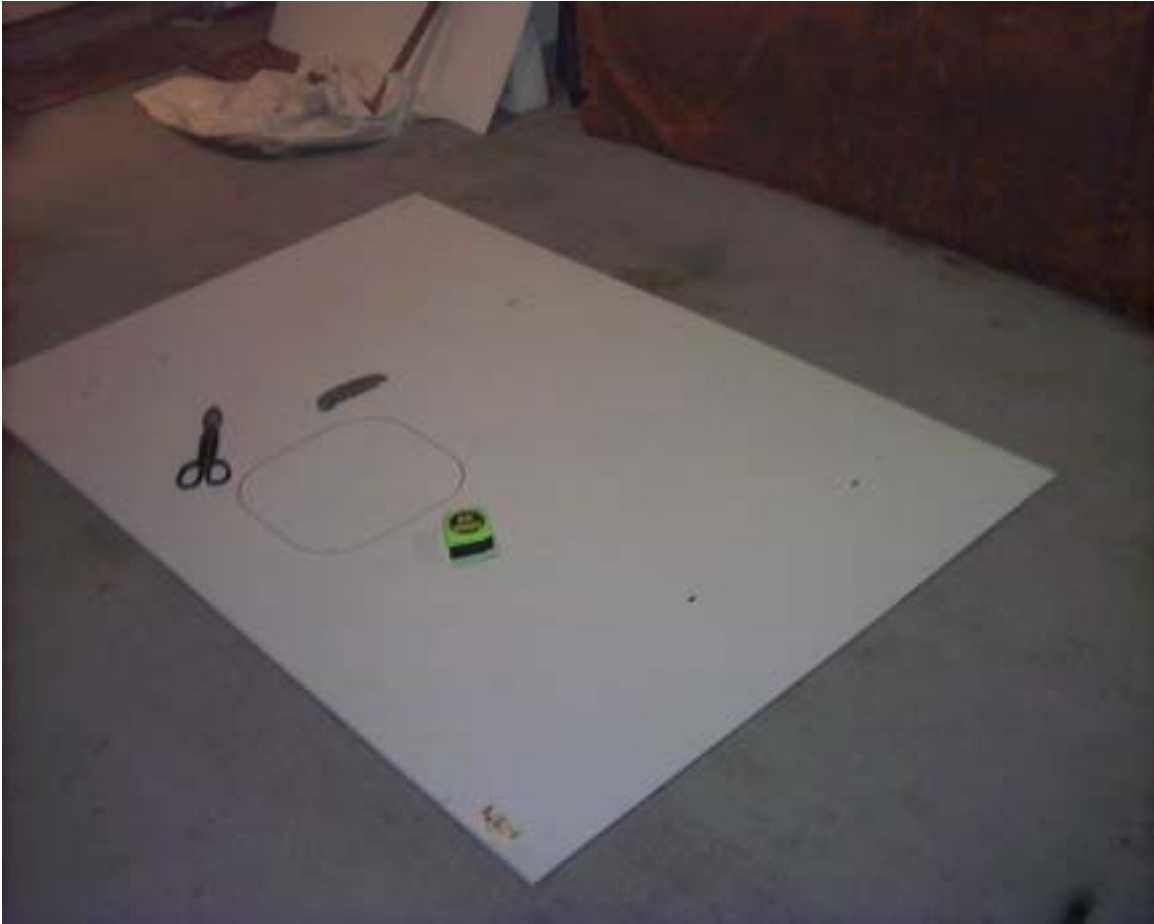
snips, a hand drill and my trusty Dremel Tool Saw for the curves, I managed to create a rather tidy set of replacement headliner panels. I opted for the textured gloss white variety FRP (found once again at Home Depot, @ \$26.50 per 4'x 8' x 1/16" sheet) to do the job. They are aesthetic, easy to clean, highly reflective of light, which makes the interior seem much brighter and best of all, water rolls right off the stuff. Any future roof leaks will not damage this new headliner. Isn't that clever? The original GM dimensional specs for the first headliner panel, which has the forward ceiling vent hole, are 72.75"w x 50.90"d. It turned out that upon measuring of the original panel, I found it had shrunk longitudinally by about a half inch. Therefore, the new panel was cut to the original specification. The old ceiling panel was then centered over the new one and used as a template to determine the cutouts for the holes.

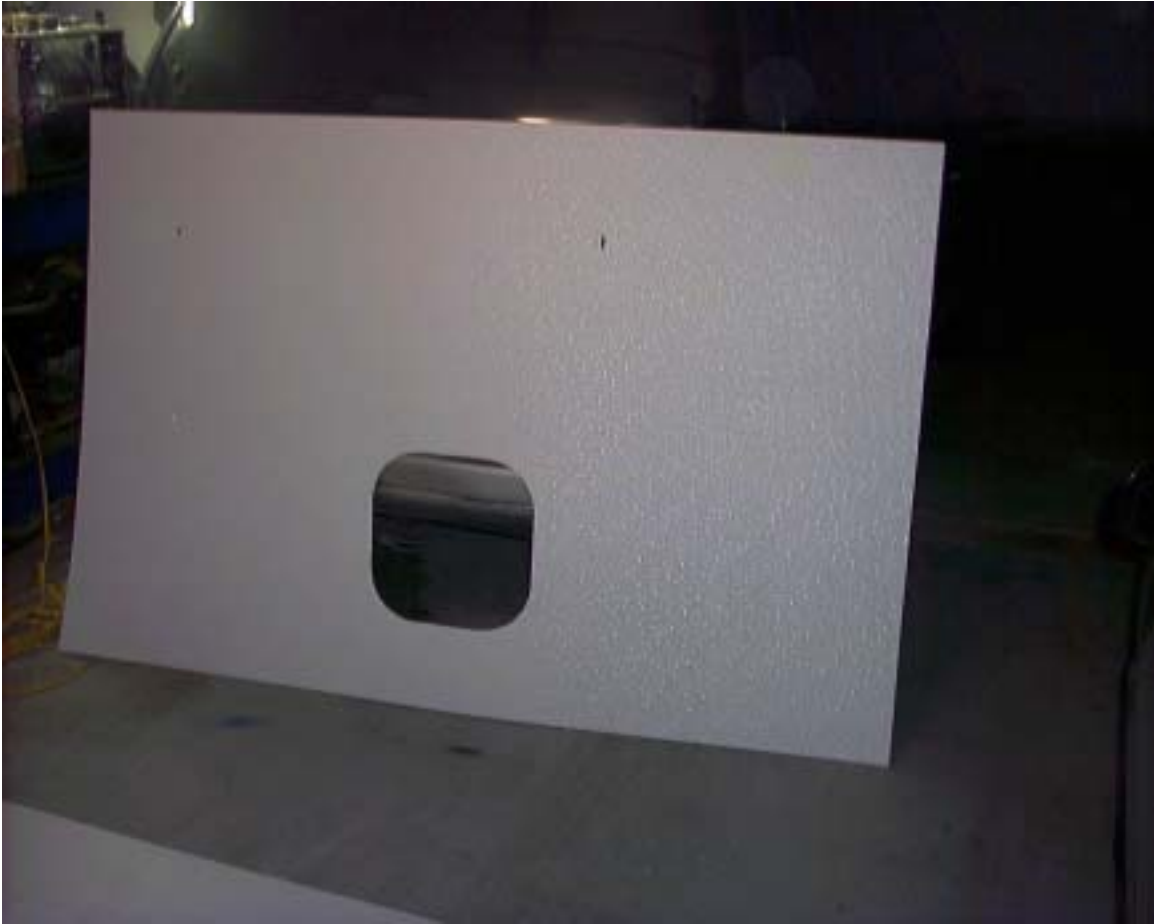
All measurements worked out to within 1/8 inch of center upon installation and only required relatively minor shaving of the holes in order to true the edges. Use of the original dimensions did not result in a tight fit side to side. There appeared to be adequate room for an additional 1/4" insulating pad or blanket between the panel and the ceiling without any sign of binding. Initially, I decided to mount the new headliner panels directly against the re-insulated ceiling without additional insulating material at the present time. I wish to experiment with the "Microfoil" insulation first and do some

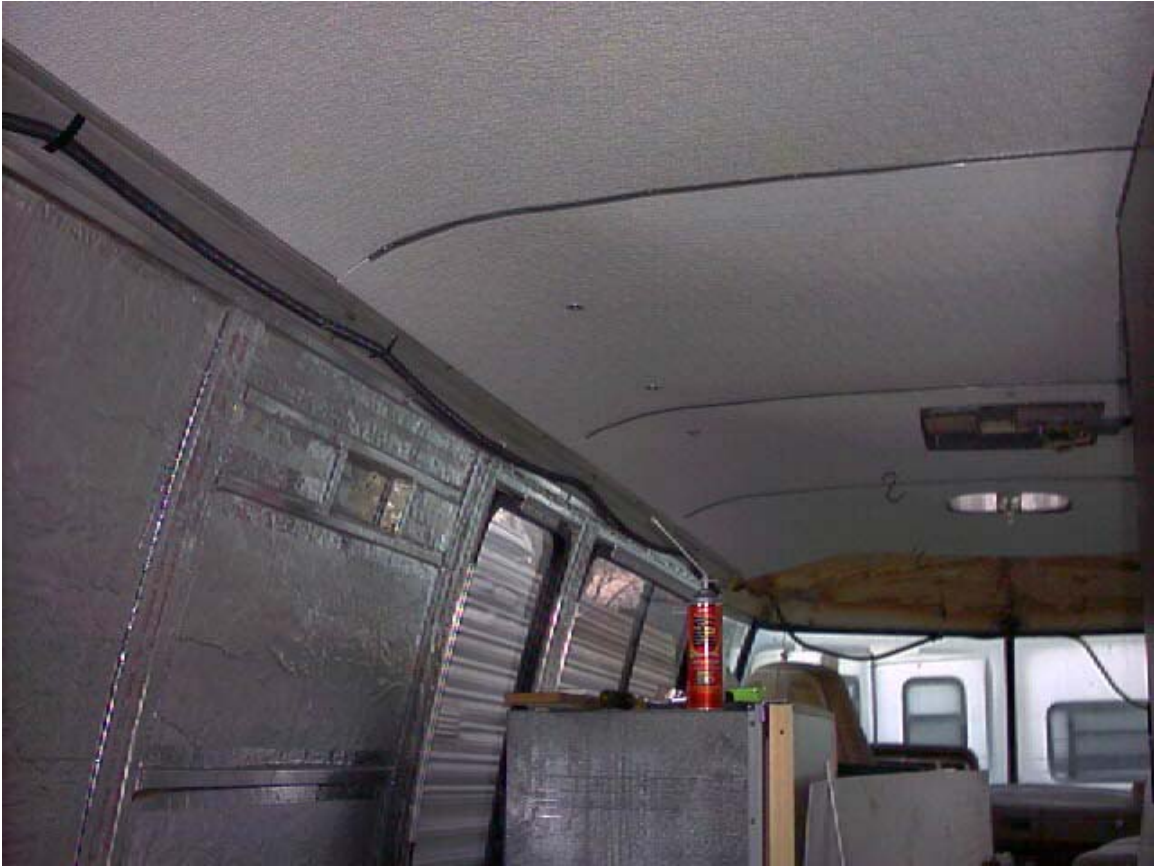
Something that has always bothered me about the automotive industry has been their prolific use of sheet metal screws to attach any and everything. I am personally very fond of machine screws and bolts, stainless steel fasteners in particular. So as I happen to own a self-retaining nut insertion tool, a complete number drill set, a tap & die set and a desire to prevent this ugly duckling from rattling apart from vibration as I go down the road, I intend to replace much of the existing hardware with the right stuff. "Death to sheet metal screws and particleboard!" For example, each of the screws used to attach the headliner retaining strips have been replaced by self-retaining nuts and 8-32 x 3/4" flat head S.S. screws. The various wall panel seams, which meet at structural members, are covered with 3/4" x 1/8" aluminum flat metal strips, which are also installed with self-retaining nuts and 8-32 x 3/4" flat head S.S. screws. These will eventually be painted with white enamel paint to blend in with the wall panels and permit easy removal for repair or

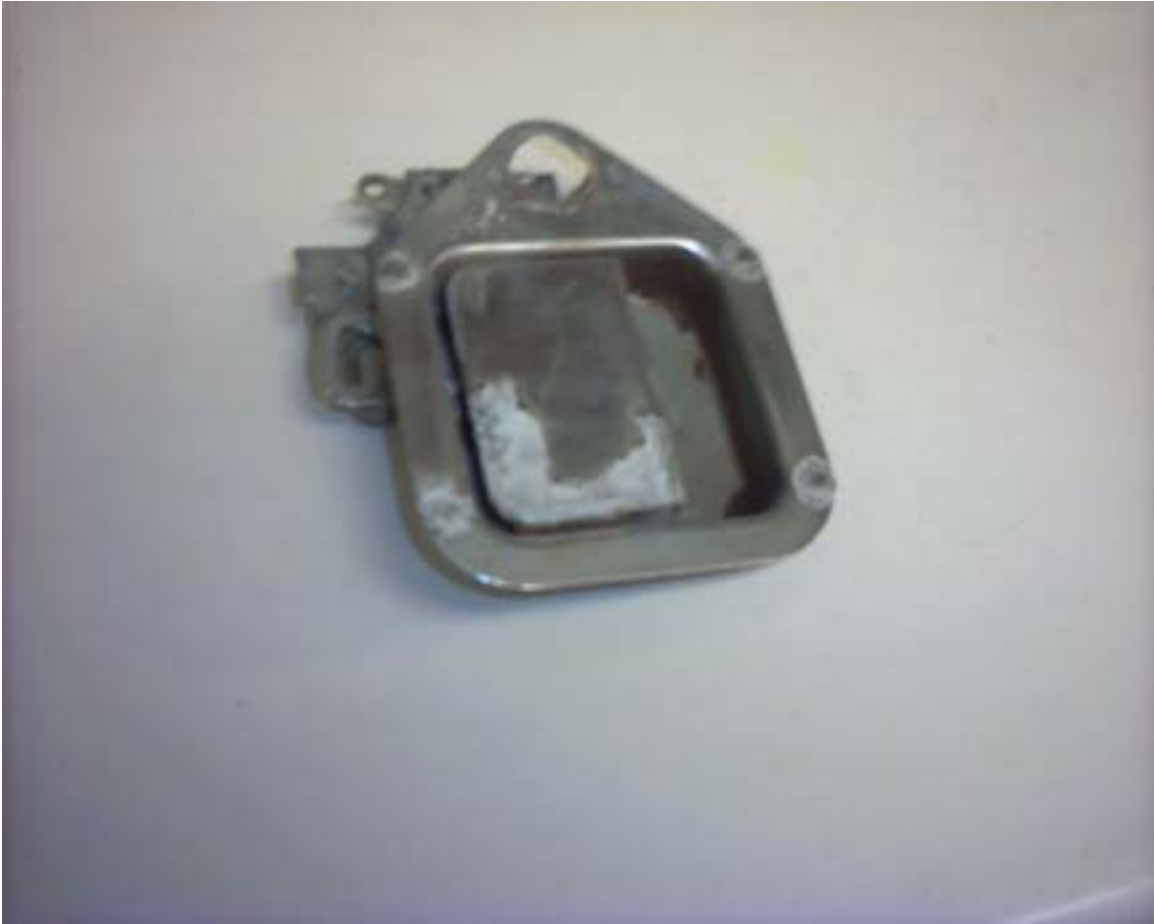
Removing the old door latch was relatively uneventful. After detaching the two panels in the lower half of the door, the handle mechanism came out without much difficulty. I could easily see the differences between the two parts. The keyway for the lock cylinder would require filing a bit to accept the original cylinder. In addition, the primary lever arm was T-shaped to allow attachment to the inner handle. The replacement had an L-shaped lever attached. Four flush rivets attach the mechanism to the chrome faceplate. These must be drilled or ground off to separate the two and allow access to the large pivot pin upon which the lever is mounted. The pivot pin is also riveted from behind onto this plate and must be drilled out. In this manner, the original T-shaped lever is removed from the original handle and will be re-installed on the new one. A through hole large enough to accommodate a 10-24 hex head screw was drilled through the pin. A thin square nut, which fit the recess on the back of the plate, was used to secure the screw and epoxy was used to hold it in place. This method of attachment would permit greater ease of repair, should it become necessary in the future. Both the plate and the exposed portion of the handle were once again pop-riveted together, making it ready for installation. The original paper gasket under the latch crumbled upon removal. So, to make a watertight seal, a small amount of DOW 791 was applied to the under surface before final attachment.

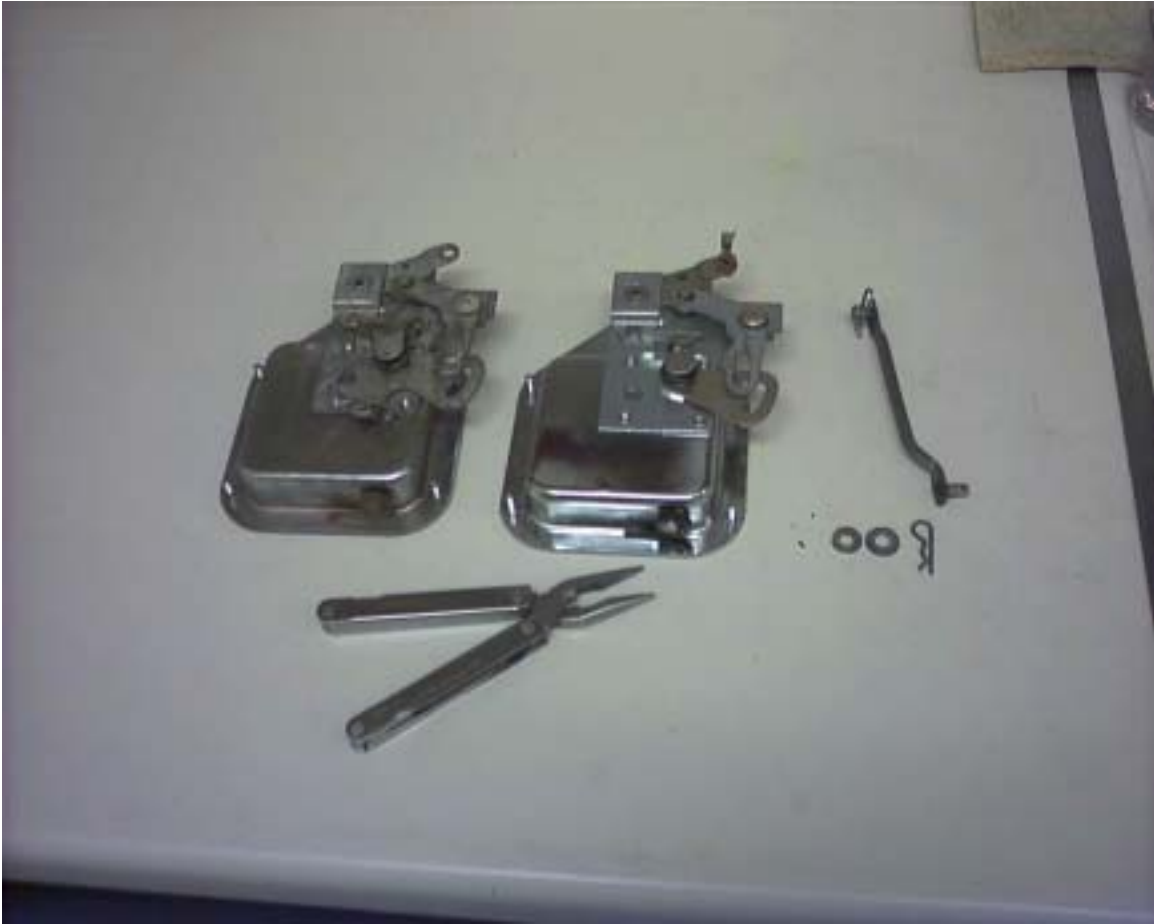
The modification and installation itself was not difficult. However, as I was doing an overhaul of the door, the addition of new insulation, a new door seal, a new lower interior panel, refinishing of the interior latch panel and the attachment of my new Ragusa interior aluminum pull handle required about two days to complete. I have yet to repaint the original window frame. That will have to wait until I decide to tackle the windows.

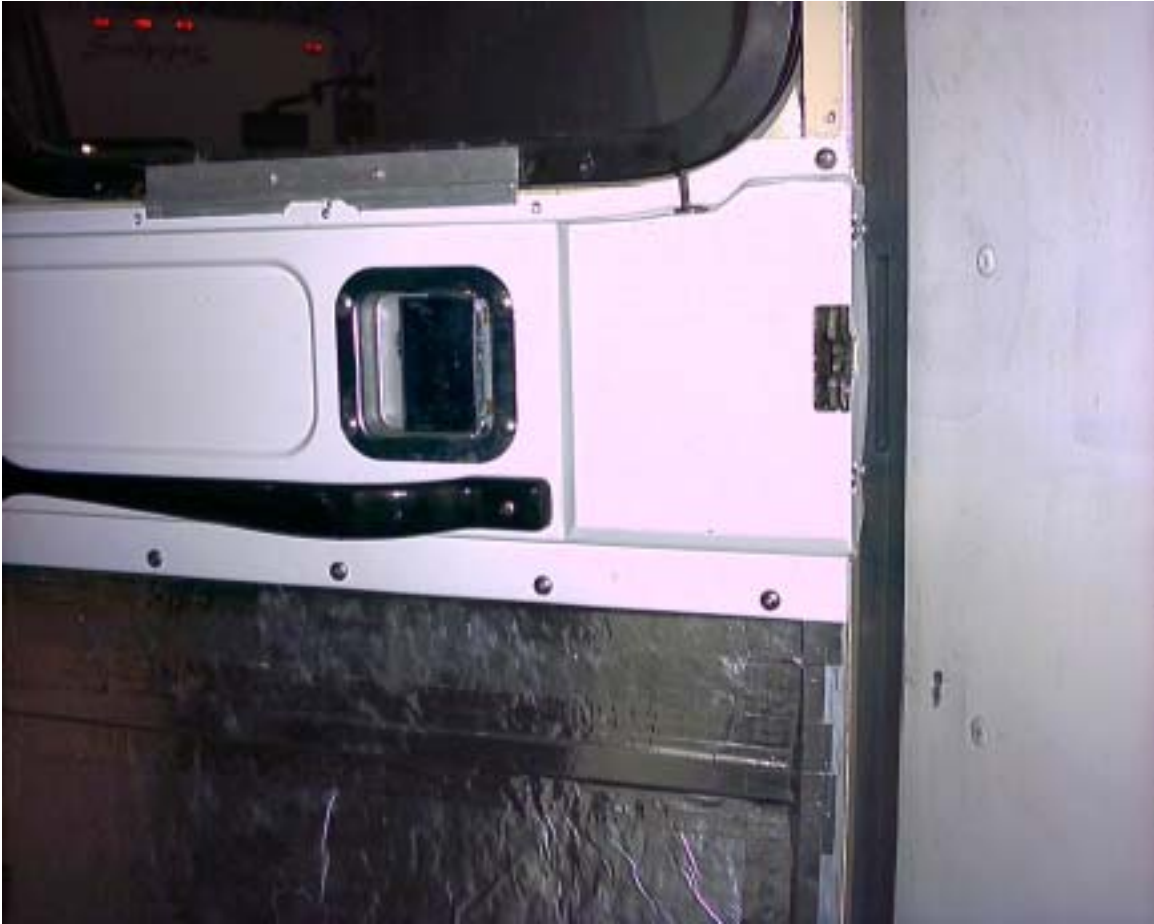
The interior door handle panel was originally covered with a cracked vinyl covering which had begun to peel and allowed the steel panel to begin to rust around the edges. With a little help from a heat gun, the vinyl covering was removed and the panel was sanded and painted with a gray primer coat. After it dried, a coat of white enamel paint was applied before the hardware was installed. I decided to put a coat of black enamel on the new aluminum door pull handle for a little contrast. As with most of the items one gets from Ragusa, they come naked, so you have the choice to make them whatever color you choose. The original pull handle was in very poor condition so it was a cinch it had to be replaced.

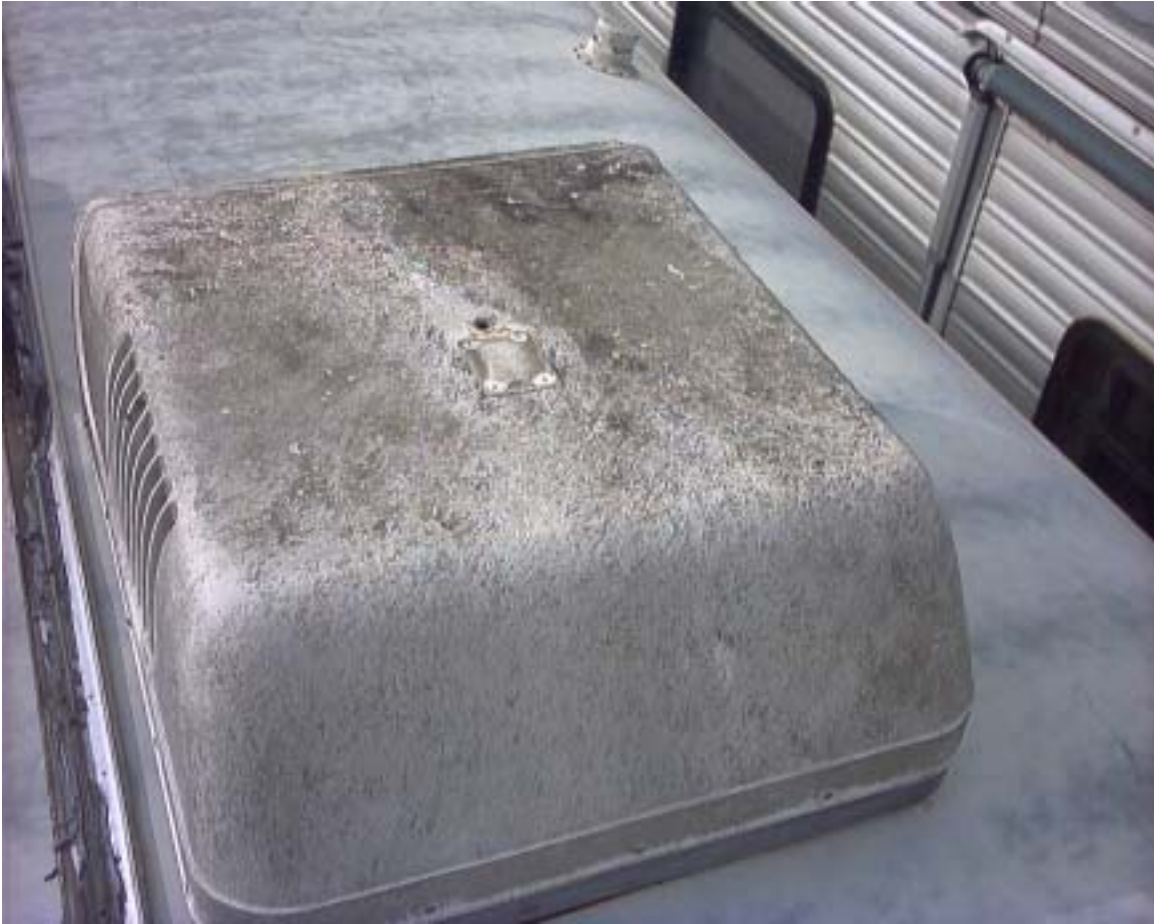
While I was on the roof I decided to check out the temporary sealing job that I had hurriedly done a few weeks before. I had run out of the DOW 791 sealer in the middle of things and had completed the job with another brand that the parts house guy assured me was of comparable quality. I wish I could have handed that gentleman a few of those red wasps in gratitude for his honesty. The sealant he sold me had cracked and shrunk as the

weather cooled into the 30's and the roof was leaking as bad or worse than when I started. When Jim Bounds tells you something, you can take it to the bank... Needless to say, I will had to scrape that crap off and do it right a second time 8-(. FYI, I found a Houston supplier for the DOW 791 Sealant, Silicone Specialties, Inc., 2211 Sabine, 77007, (713) 862-3900 if you should happen to need some of the stuff while you are in town. As an emergency leak repair measure, I had applied a strip of the 2-inch aluminum foil tape, the same stuff I had been using with my insulation, over the outside of several leaking seams. **DO NOT DO THIS IF YOU VALUE YOUR PAINT JOB!** Mine was shot anyway, so I was more concerned with temporarily stopping the leaks and water damage until I had time to effect proper repairs, than I was with the remains of my existing finish. This was purely an emergency and temporary stop-gap measure.

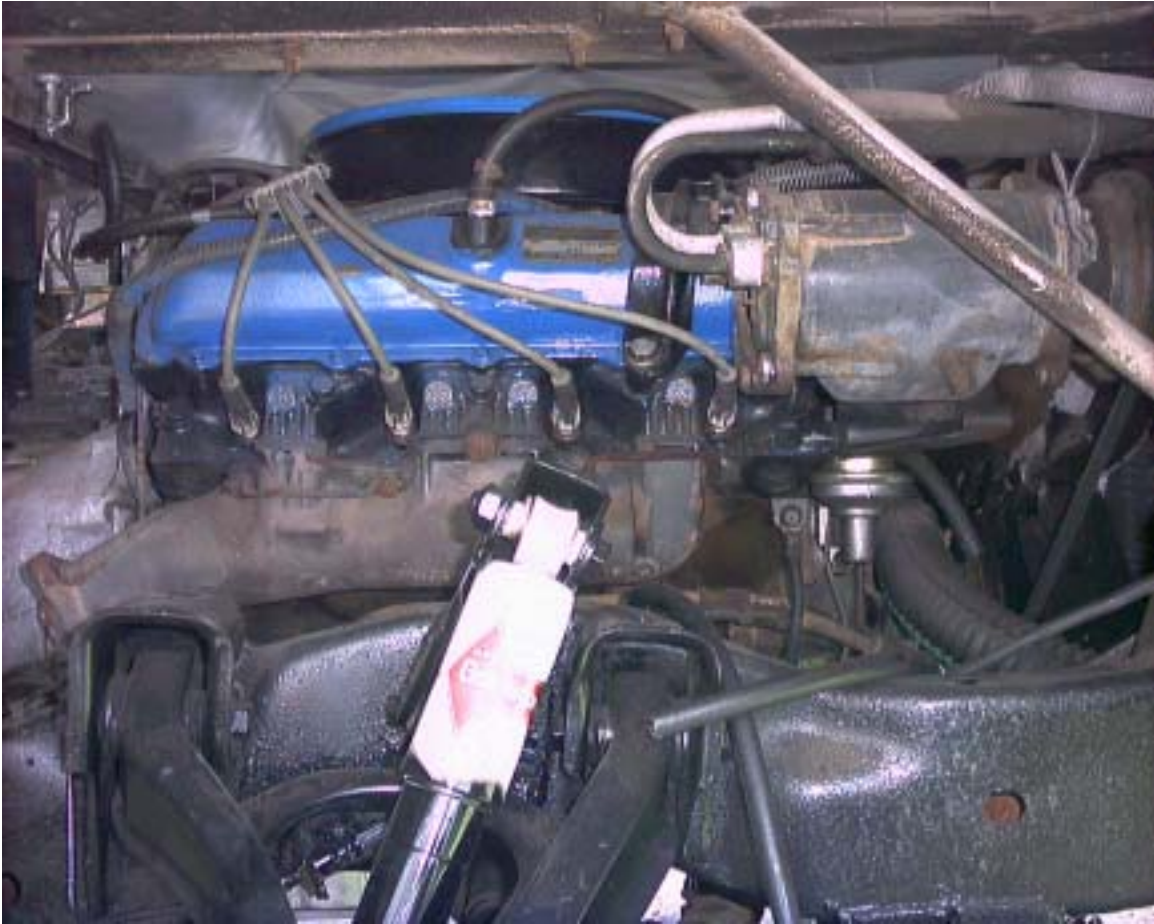
Today is the big day to awaken the sleeping giant. My mechanic friend who rebuilt my Rochester Quadra-jet carburetor came over to re-install it. I picked up a new battery and a 5-gallon gas can to feed the old 455. I cut a length of fuel line hose and ran it from the gas can to the fuel pump. We then found we had a problem with the ignition switch and decided to hot-wire the beast instead. Holding a fire extinguisher in one hand and a large screwdriver in the other, I shorted the contacts on the starter solenoid and said a quick prayer as the starter began to awaken the long dormant engine. At first, there was a long low growl as the innards of the beast began to churn. Then a sporadic series of individual cylinder firings caused a series of shudders and small clouds of dense white smoke

erupted from the tailpipe as the oil I had injected into the cylinders began to burn off. My friend rotated the distributor a bit and yelled, "Hit it again". Once more, a hail of sparks jumped from the starter solenoid and a series of explosions blasted a hole in the rusty exhaust pipe donut behind the right exhaust manifold. This allowed several long yellow fingers of flame to escape through the opening. My grip tightened on the fire extinguisher as a lump began to form in my throat. The smoke from the exhaust drifted across the parking lot and the rumbling misfire of the engine filled the air, then silence... "Hit it again", my friend yelled once more, as he continued to tweak the carburetor and twist on the distributor. Another flurry of sparks and the beast came alive! I yelled to my friend, but he could not hear me above the roar. A cloud of rust and mud dauber nests rained down upon the ground below. Then, to my amazement, the smoke began to clear and the roar diminished to a smooth and steady idle. "It's alive! It's alive!" I exclaimed. What a Christmas present, I was happy 8-).

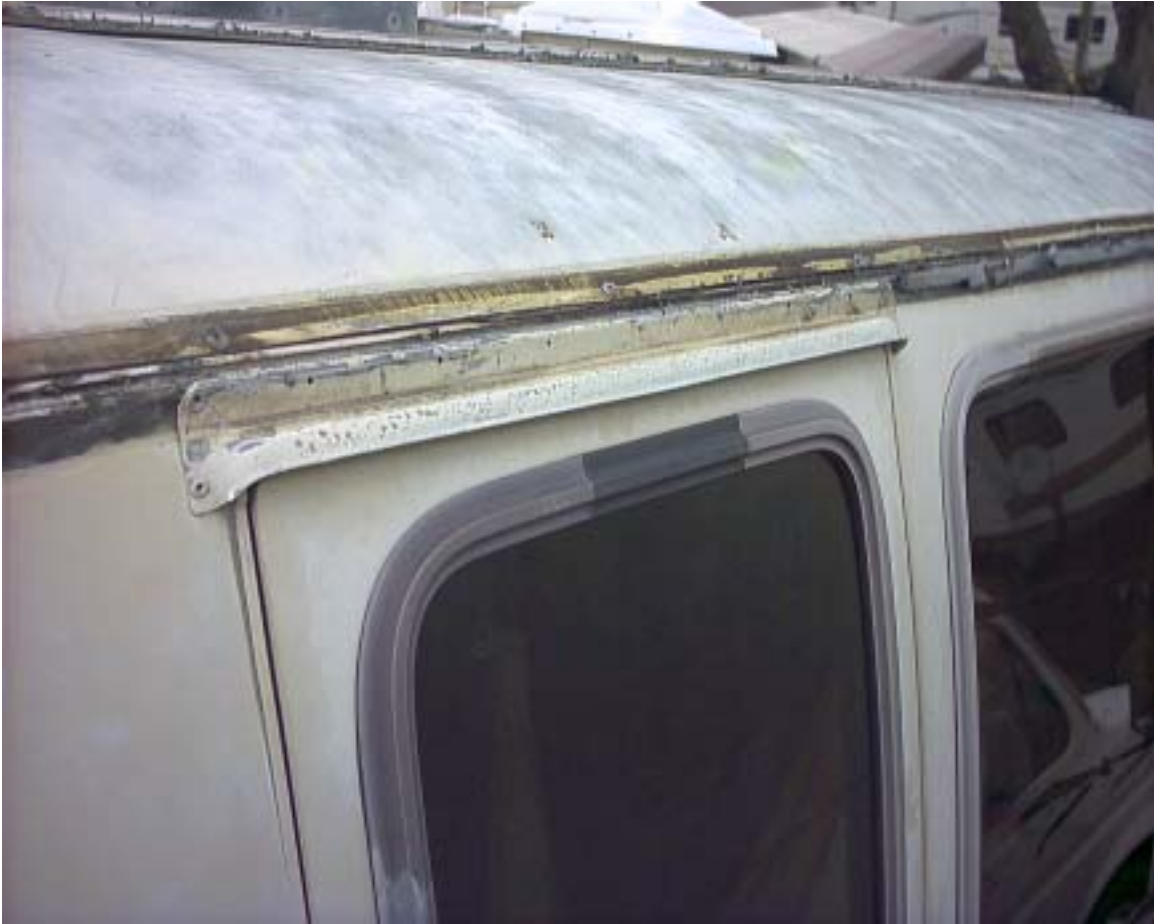
When I discussed the particulars of resolving my many roof leaks with Jim bounds, he advised me that I would have to actually remove the drip rails and reseal the roof and wall seams to get at the root of the problem. Application of sealant along the surface edges of the rail is of little value. I had no idea of the mess I'd find beneath them. The original sealant had dried in many areas and the screws attaching the rail were severely corroded. I had to use an impact driver to break most of them loose and managed to remove them all except for one, which sheared. It is extremely difficult to drill out a screw from a piece of aluminum. It is far better to grin off the broken screw flush with the plate, then move over slightly and plant another screw, if at all possible. It took several hours to scrape, wire brush and sand the surfaces with a green scrubby pad. Nine pop-rivets on the passenger side had completely corroded to the point that the heads fell off and required drilling before being replaced. It took between four and five tubes of Dow 791 sealant, for each side, to repair the multitude of leaks. 10-24 Philips flat-head S.S. screws were then used to re-attach the cap-rail to the body once again. Rusted steel screws are a bummer to remove from aluminum. The sooner they are replaced, the better. The longer the original screws remain in place, the more likely they are to break off when attempting extraction and require major surgery.

The original sealant resembled something akin to plumbers putty and was hard in some areas but rather goeey in others. There were occasional small voids where water and debris collected, allowing the forces of nature to eat away at the pop-rivet fasteners which attached the roof panel to the under-rail. A stiff putty knife, wire brush and more green scrubby pads served to remove the old sealant. Solvents should be used sparingly to avoid damage to the surrounding finish. Masking the area with masking tape would be a very good idea if you value the existing finish. A good clean surface is necessary to obtain a quality seal.
