“The rebuilding of Norman’s 75 Eleganza II-X, 01-09-75”, Rev.2

Norman Wheatley, Houston, TX 77054-4160 metrolog@hal-pc.org

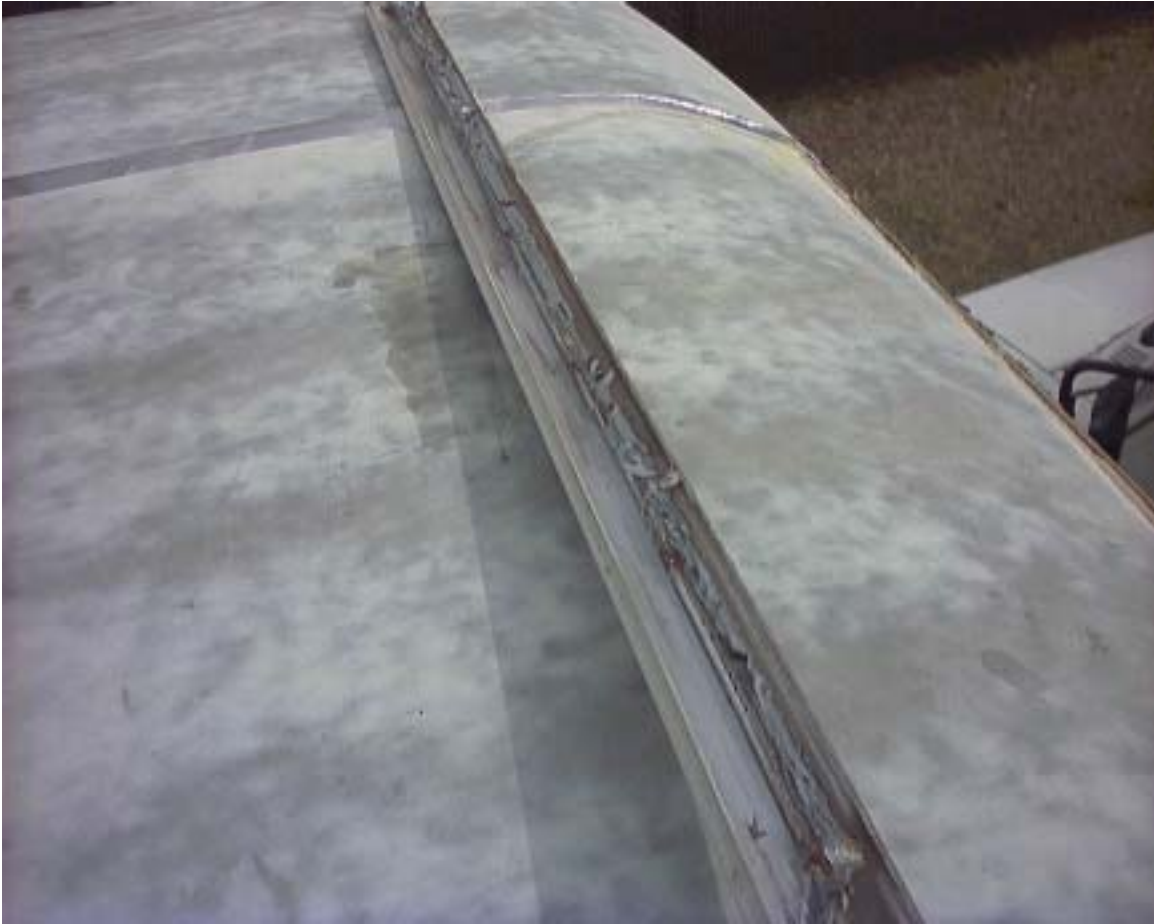
Extreme care should be taken when removing the drip rail such that it is not bent or twisted as it is removed. It is comprised of fairly heavy gauge aluminum, but the 18-foot length of this piece makes it somewhat unwieldy and difficult to handle by oneself. Get some help if you need it. I don't believe they make these things any more, so if you bend

one up, you could have a major problem. All screws should be removed before attempting to lift it away from the frame. A light pressure applied with a screwdriver or putty knife should lift it out away from the frame. Work slowly. If it doesn't want to let go, do not force it to the point of bending the rail. There is a small chance that some P.O. may have foolishly (out of ignorance) applied an adhesive (like liquid nails) rather than a sealant (like DOW 791) to the piece during a previous repair. If this is the case, you have a minor problem! A wire saw may be fashioned from a couple of dowels and some piano wire, which may then be slipped under the edge of the rail and used to carefully slice through the sealant joint. This tool will cut through a layer of DOW 791 Sealant like butter, but will require a bit more elbow grease to get through a layer of adhesive. If one should find oneself in this situation, I would suggest you call for reinforcements.

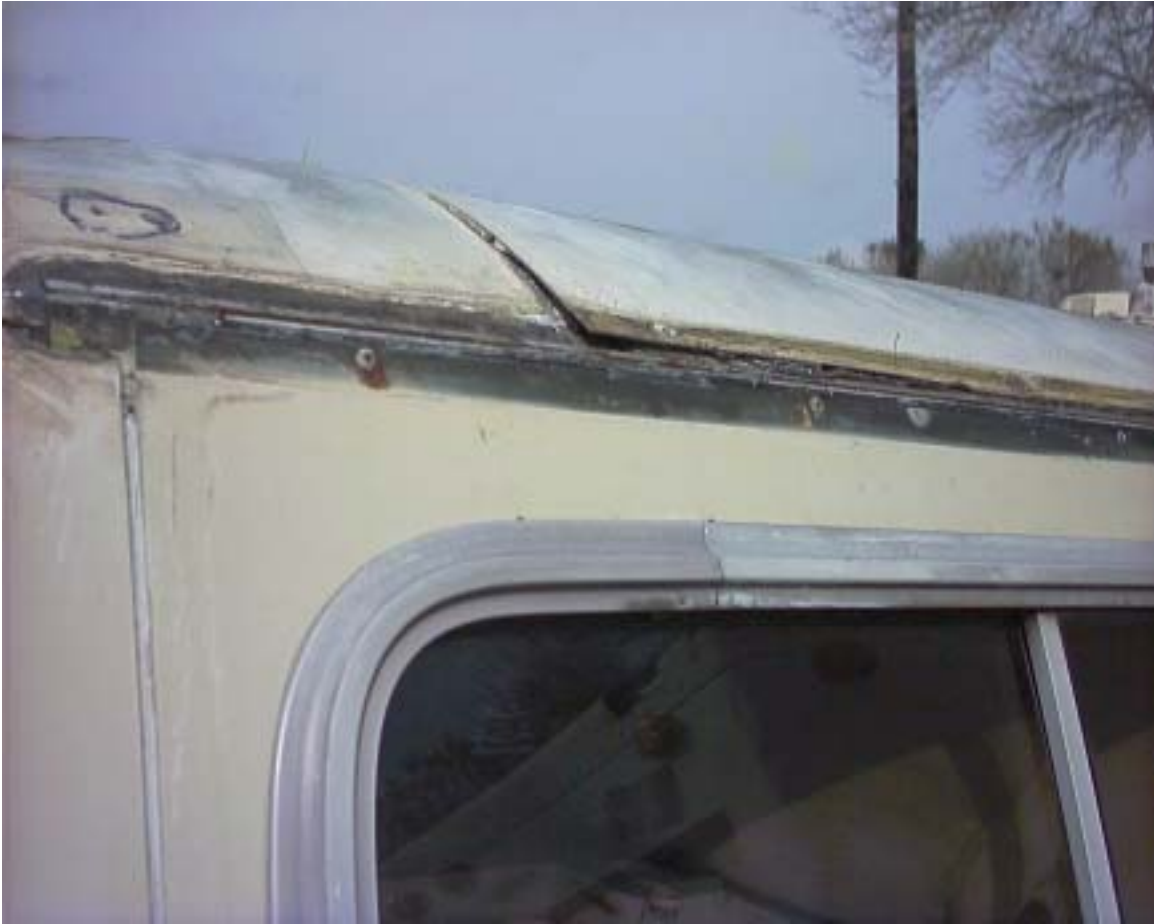
There are six critical sealing points along the drip rails. These are where the various panels come together and form a corner of sorts. The first two are located almost directly below the outer most rear clearance lamps at the rear end of the rails. This is where the fiberglass cap joins with the aluminum wall panel above the rear side windows. The next pair are at the junction of the rear cap and the aluminum roof panel, where they meet that same wall panel several inches forward of the first two trouble spots. The last critical location is at the forward end of the rails, where the fiberglass cap joins with the

aluminum roof panel and meets the wall above the corners of the cockpit side windows. Each of these locations has a substantial opening or clearance gap, which must be filled with sealant prior to re-installing the rail, in order to assure proper repair of the leaks. That is not to say that sealing the rest of the rail is any less important, but that these points should receive extra care, as the gaps at these points are much larger by comparison. With the old sealant removed, one can literally see through the joints inside the living compartment at these points.

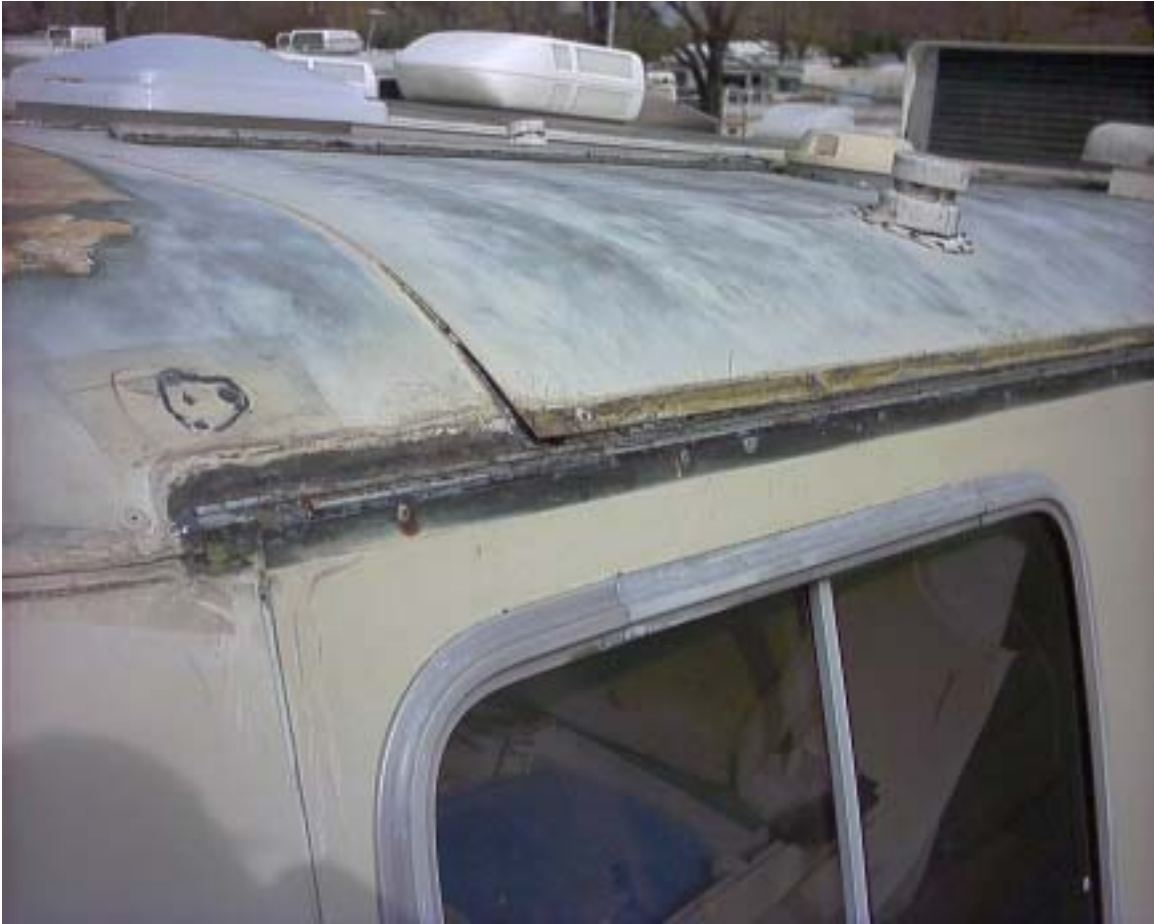
When everything has been cleaned up and it is time to reassemble, position the tubes of sealant along the roof at intervals so you can complete the application in a single operation. The sealant will “skin over” and begin to cure after only a few minutes, so it is

best applied in a continuous manner from one end to the other forming a single patch. This is why it's good to have help when performing this type of repair. As I was working alone, I did things a little differently than I might, had some help been available to me. First of all, I was concerned about getting sealant down inside the threaded holes where the screws attached the rail. In hindsight, I don't think it really matters all that much. But, to avoid this, I inserted inverted pop-rivets into the holes before I began to apply sealant to these areas. Because I wanted to be certain that the heads of the pop-rivets securing the roof and wall panels were protected, I applied a coating of the sealant over them as it was being applied along the length of the roof and wall edges meeting the lower rail. Trying to apply four or five tubes of sealant quickly, while keeping it where it belongs, can be taxing on the hand muscles. Having a rag and a putty knife handy will save having to make extra trips down and back up the ladder. Moving the ladder is enough of a challenge. Although I'm sure there are other techniques for applying the sealant, the best approach for me ultimately came to making several individual passes. By that I mean, I applied a bead along the length of the roof seam first and then went back and applied another bead along the length of the wall seam. Apply a third segmented bead down the length of the recess in the lower rail, leaving small gaps, perhaps a half inch wide at the location where each mounting screw hole resides. Lastly, with the rail positioned upside down on the roof, I placed two heavy beads down the

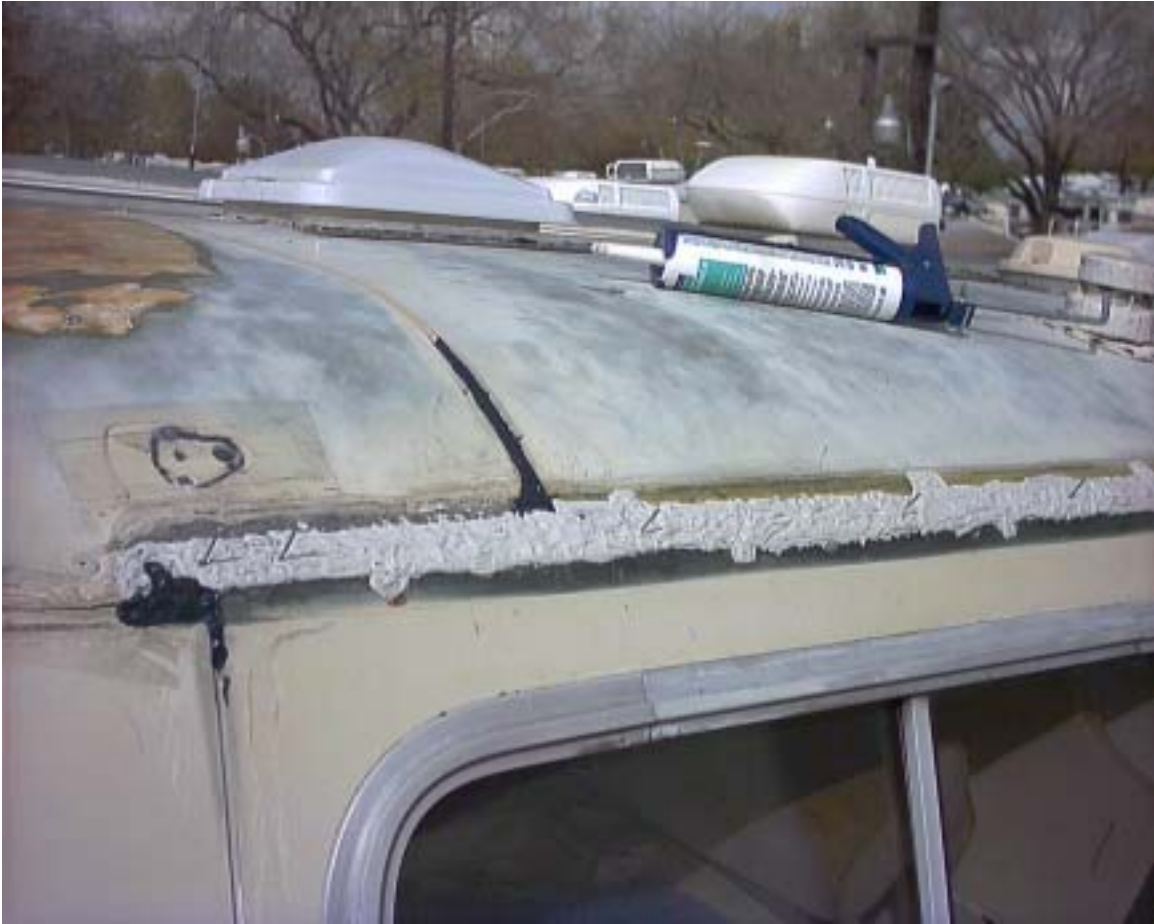
length of it, on either side of the raised structural rib running down the middle. This rib engages into the recess in the lower rail and locks it into position. At this point we are ready to re-attach the rail. Starting from the center, lift the rail from the roof, inverting it, and carefully positioned it such that the mounting holes align. Then inserted the first 10-24 Philips, flat-head S.S. screw, into position and began to tighten it. As this is done, the sealant will be compressed between the two surfaces and began to ooze slightly along the edge. I then proceeded to the next screw position, installing a screw and continuing all the way down to one end of the rail. Prior to securing the last screw on the rail, the end cap must be installed. The lip of which, fits under the edge of the rail, so it must be installed just prior to the last rail screw being secured. I then returned, once again, to the middle of the rail where I repeated the process in the opposite direction, finally installing the end-cap at the other end of the rail completing the operation. It turned out that my use of the inverted pop-rivets in the holes was unnecessary. I had initially been concerned about alignment and positioning of the rail as it was being reseated. But as it turned out the use of the pop-rivets only served to slow the operation down. Another discovery I made was with regard to cleanup when all was said and done. If the sealant is still fresh and fluid, it can be cleanly wiped from a surface with a little acetone on an old cloth. If it has set a bit, it is just as well to let it cure completely and then trim it with a single edged razor blade or a sharp putty knife.

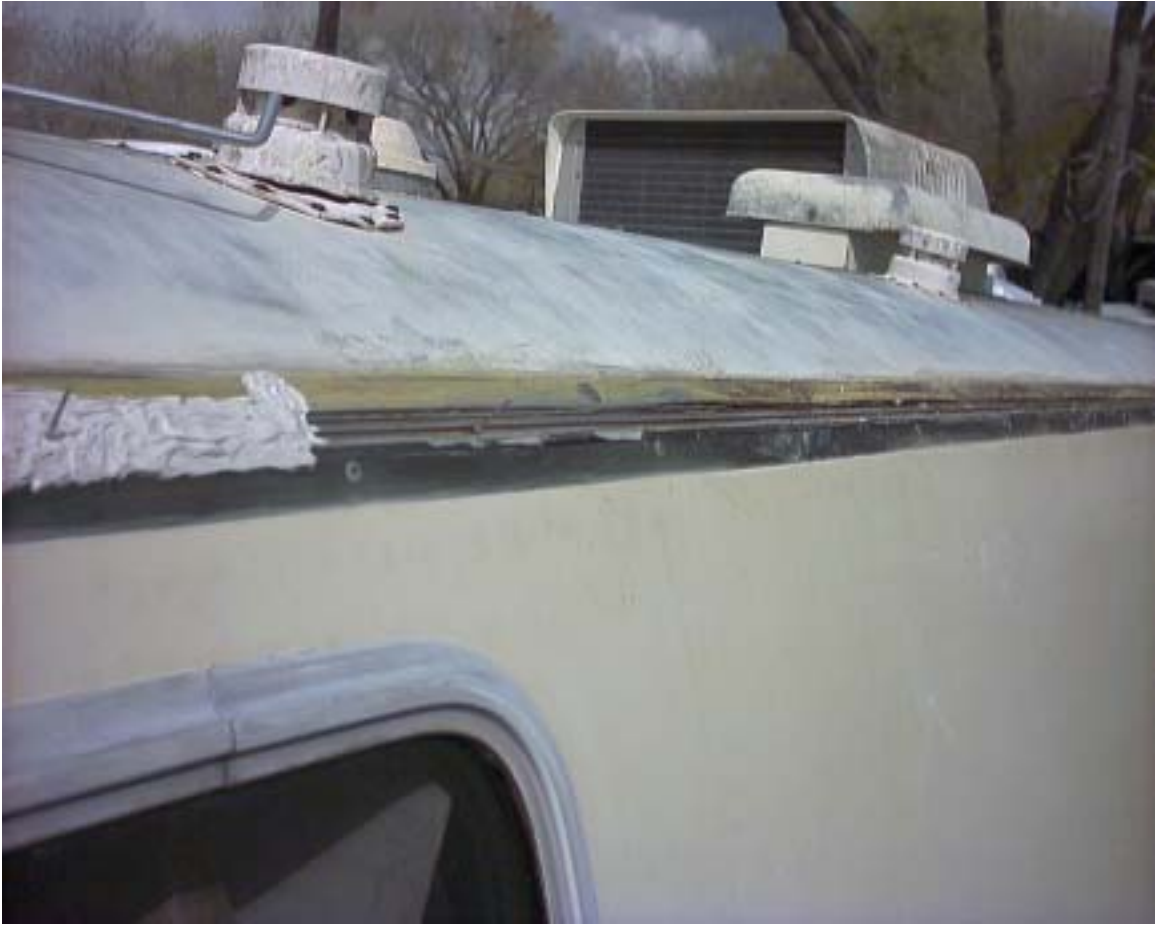
Be sure the surfaces are thoroughly clean before beginning application of the sealant.

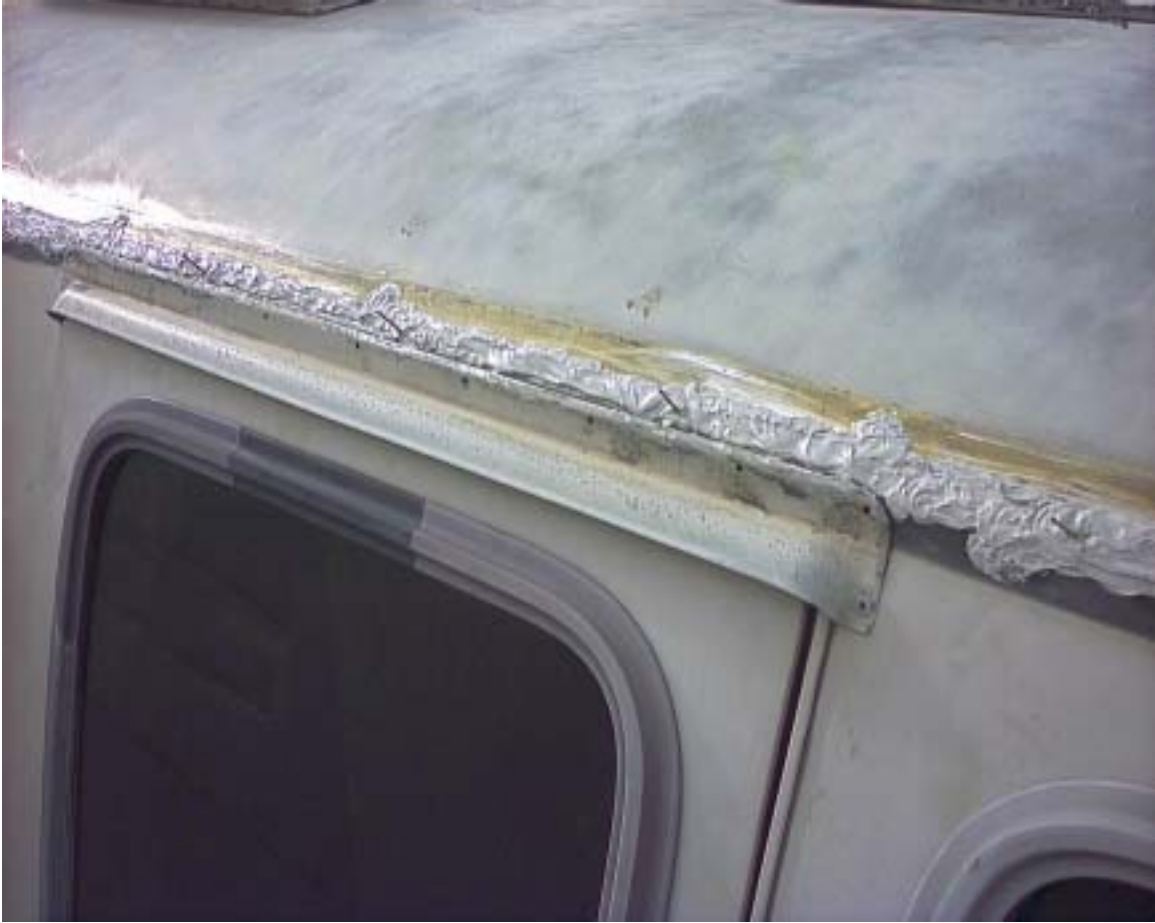
Two pop-rivets and the force of the drip rail clamping the top edge, attach the door gutter strip to the body. It would, in all likelihood, be necessary to remove or at least break the seal along the drip rail, in order to effect repairs to a damaged door gutter. It is comprised of a fairly light gauge piece of aluminum and could be easily damaged by the force of a ladder or much of anything else resting against it.

Be careful not to rest a ladder against the thin metal of the door cutter.

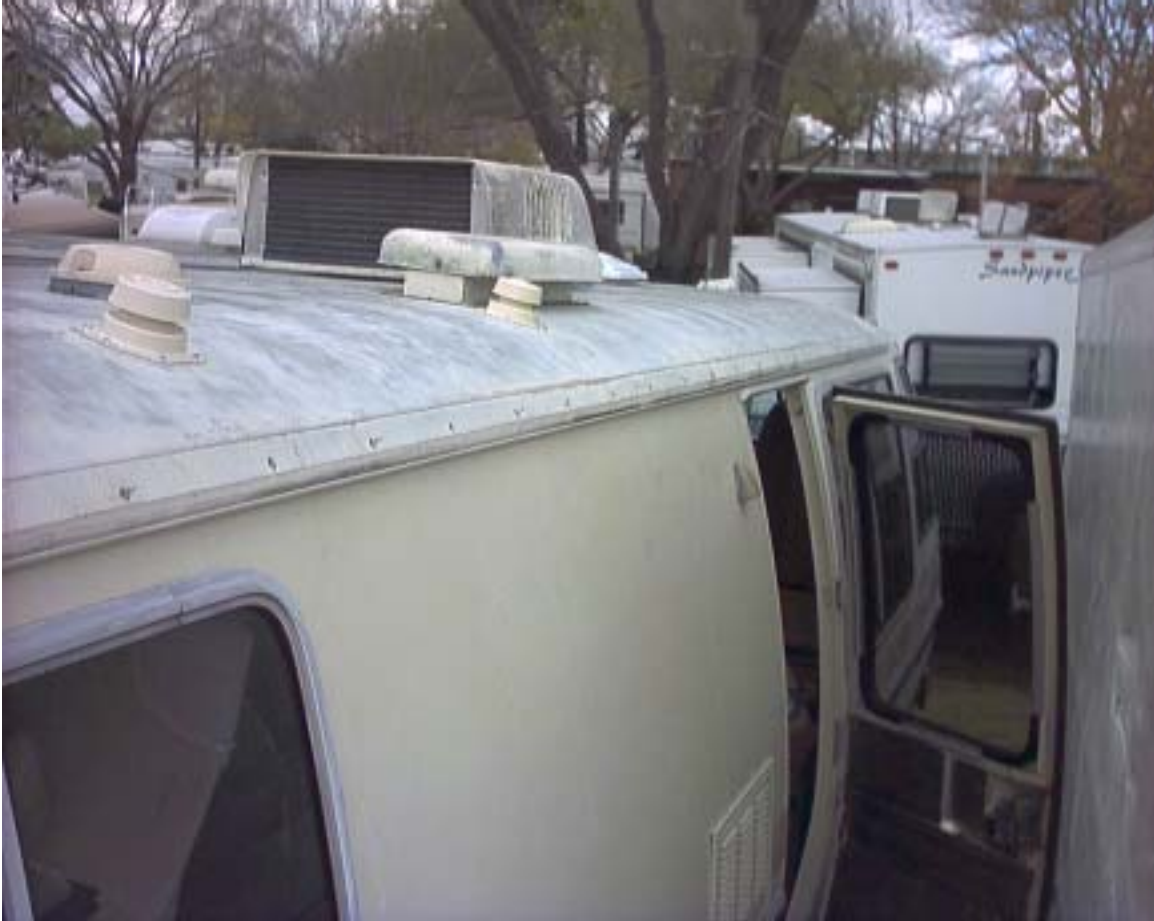
The 18' aluminum rail cap can be awkward to handle without assistance.

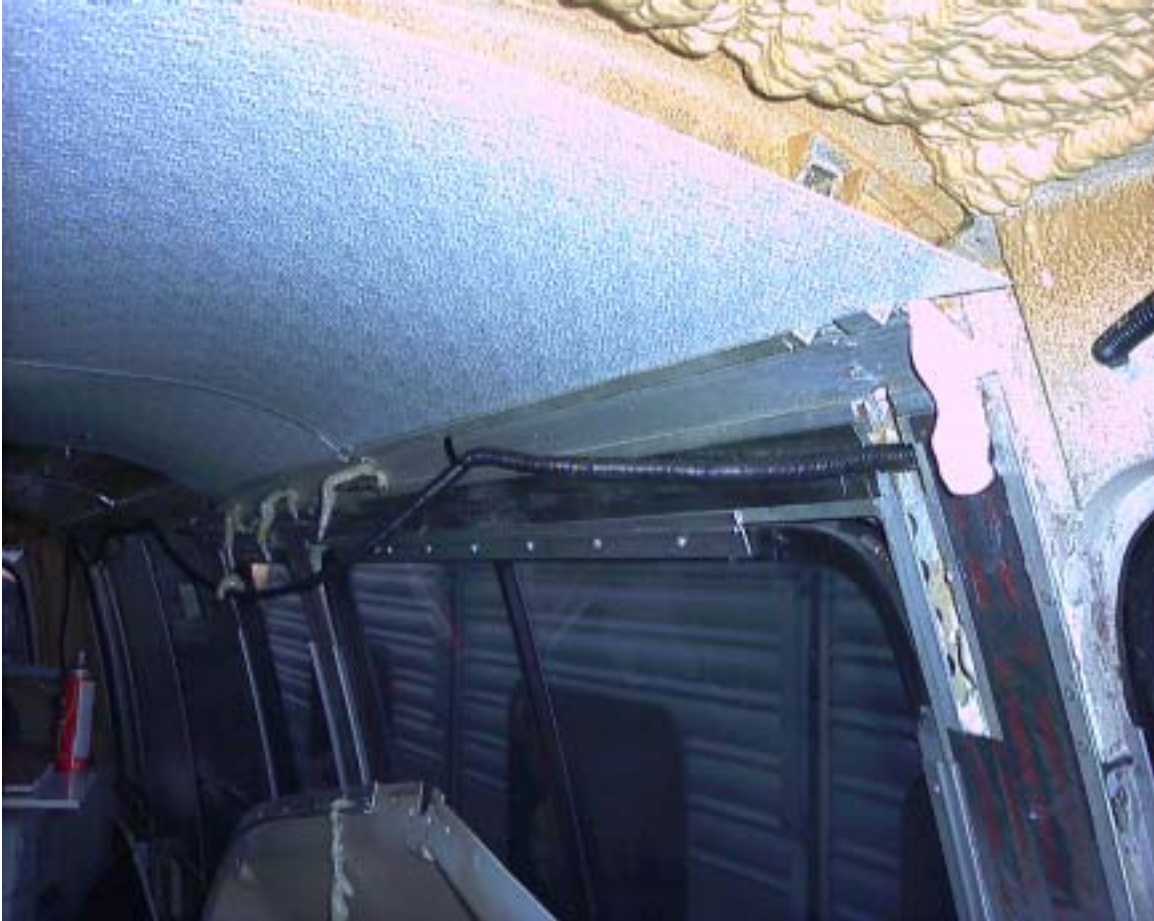
As the cable anchors attached to the cable chase below the rail on the inside of the coach had previously been removed, I decided to go one step further. Using the vacant screw holes as injection ports, I proceeded to fill the underside of the drip rail channel with expanding urethane foam. I felt that this would serve to act as a double seal along the drip rail seams from the underside, on the off chance that I might have missed a spot on top (which was not likely, as I really loaded it, to the point an excess of the 791 oozed when rail was screwed down tightly). I used a bit more sealant than might have ordinarily been needed to fill the channel void completely. My concern was that even though the exterior leak had been repaired, I didn't want any voids on the underside, which might catch and hold moisture should the upper seal fail at some point in the future. My concern was that, should moisture accumulate in a void under the drip rail, and should it ever freeze, the expanding ice could further compromise the seal once again and put me right back to square one. I suspected that the extent of the damage I found might have been the result of such an ice formations over the years. By the way, this is really a cool sunny day, two-man project. I managed to do it alone, but it was a lot of work. In hindsight, if I had to do this repair all over again, I would give serious consideration to having it done by a professional shop like the GMC COOP. P.S. Subsequently, several days of steady rain have shown absolutely no sign of a leak along either of the drip rail seams 8-).

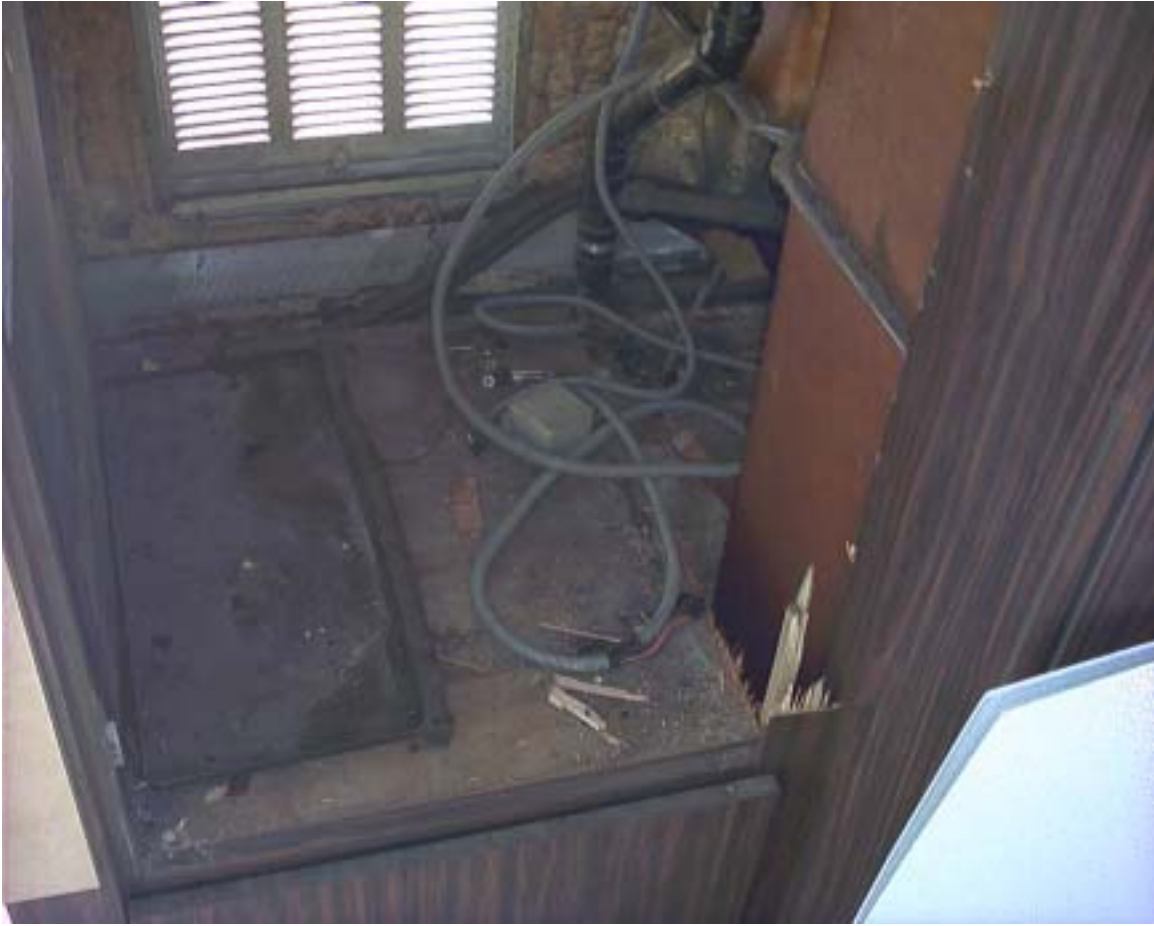
It was time to tackle the insulation on the ceiling and rear wall of the refrigerator enclosure. Upon inspection, I determined that there were four screws holding the original Norcold refrigerator in position and set about removing it from its' lair. After about thirty minutes of pulling, pushing, prying, pounding, a few expletives and some consternation, I made the command decision to get the hammer out. My efforts so far, had yielded a displacement of only about three inches, and it appeared it wasn't going to get any easier. I therefore shattered the top and right side facing boards, whereupon the box all but fell out in my lap. I was surprised to find that my refrigerator had developed middle age spread over the past 28 years. Measuring the cabinet, I discovered that the sidewalls had swelled by a full half-inch or more on each side and across the back of the refrigerator. This meant that it was at least, a full inch wider than the hole from which I had been trying to remove it 8-(. By the way, lifting this item is another two-man job. It can hurt you. If you have to take one out or install one, get some help. For the moment, it too will have to rest in the corner. Much of the interior plastic is cracked and discolored. My first impression is that it will have to be replaced, but I will eventually

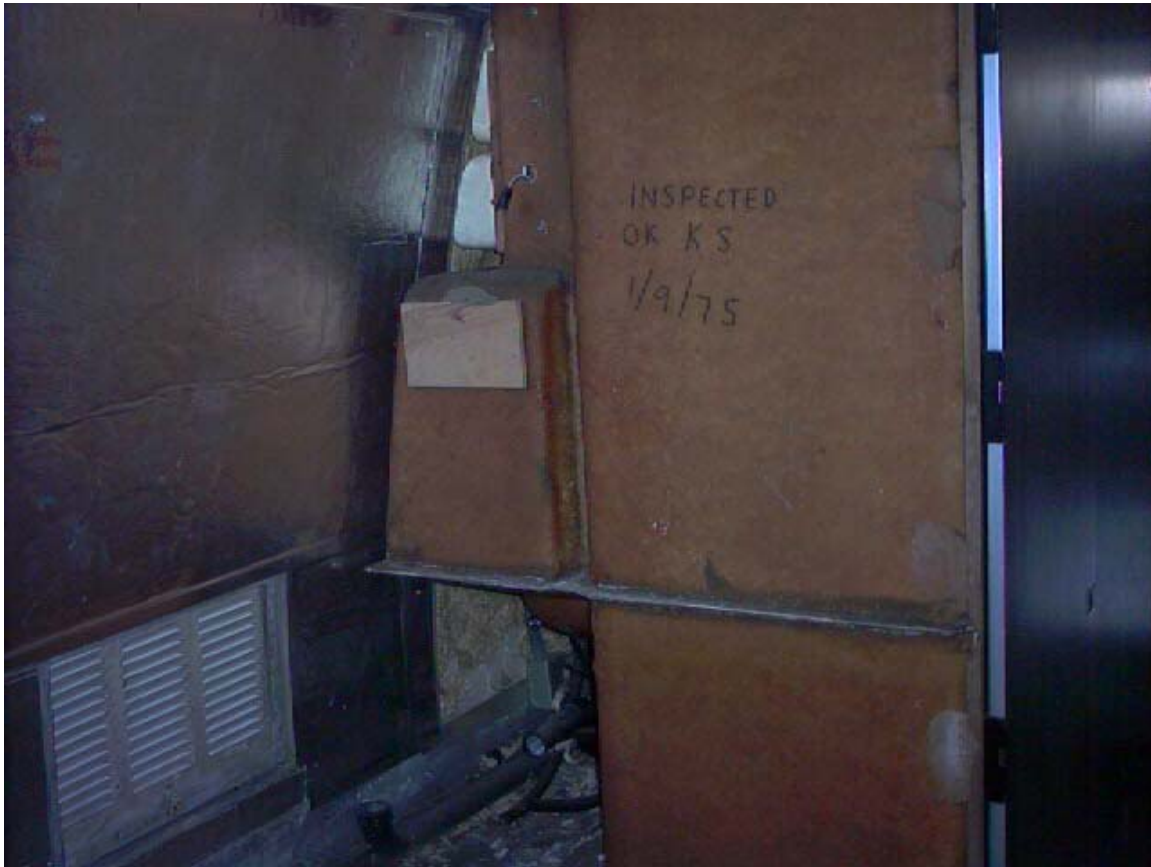
I'm sure that many owners would either skip the task of insulating above or behind the shower module, simply because of the working clearance, which is less than an inch in most places. Option "B" would of course be, to remove the shower and continue with the insulation. It has been decided that "B" was not really an option, as I am a one-man operation, recovering from my adventures with the refrigerator. In order to access the right rear portion of the shower module, the right side panel was removed. It was held in place by several screws and a large quantity of RTV sealant along the front or leading edge, which had to be cut with a knife. Using the trim tool fashioned from a 48" length of 3/4" wide aluminum flat bar stock, with a hacksaw blade taped to one end, I trimmed the original urethane to permit installation of a layer of 1/2" urethane board. Once the original insulation had been properly trimmed, the new sheet could be maneuvered into place and sealed with foil tape. As in other areas, a quantity of expanding urethane foam was applied as needed to fill the remaining voids and to act as an adhesive to help secure the panels in place. My intension has been to eventually insulate all of the interior surfaces of the MH. Without question, it is a great deal of work, however the benefits should be well worth the effort in the end, regardless of climate. The wall area behind and the ceiling above the shower have proven to be the most difficult to address so far.

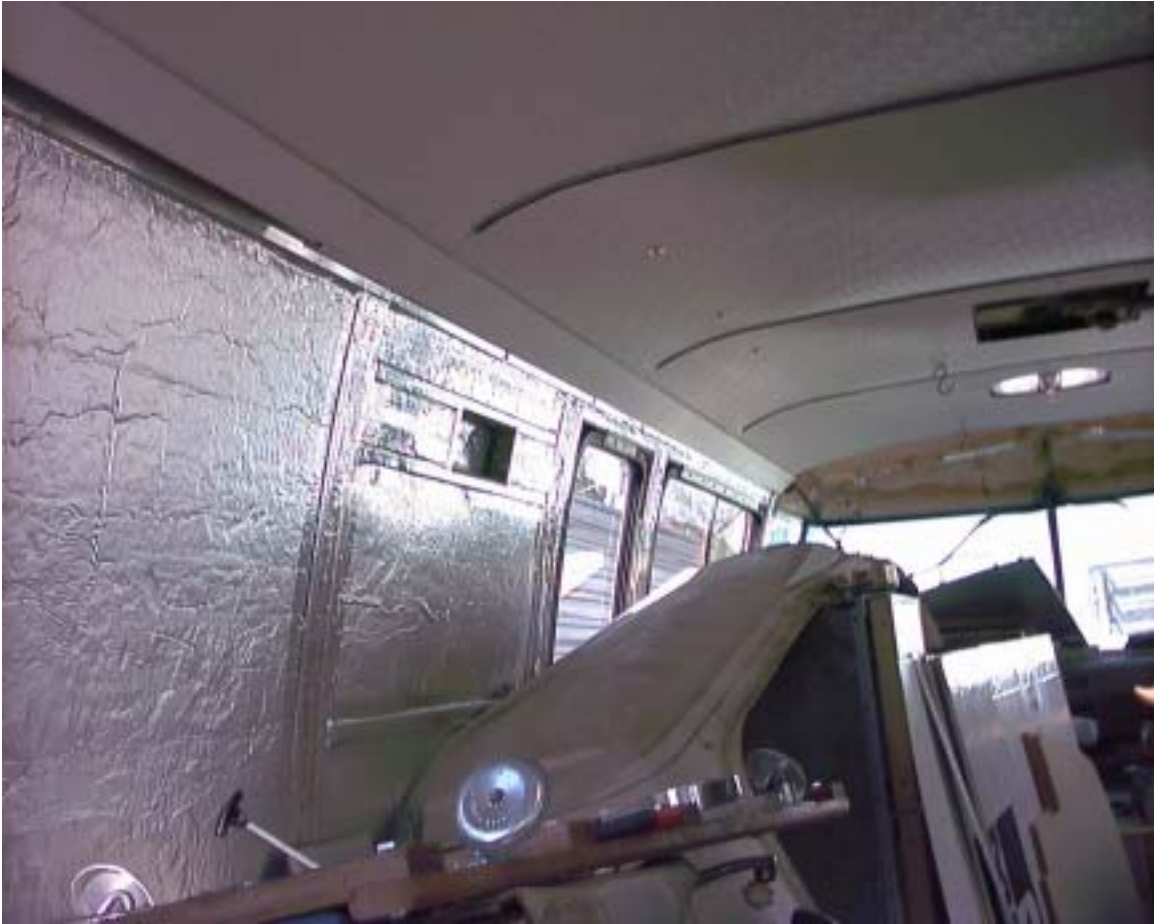
Like many other GMC owners, I have been pondering a replacement for the molding strip or covering for the cable tray at the roof wall seam. In measuring the width of the aluminum tray I found it was exactly 3 inches wide from the top to the bottom edge. The overall length of the tray measured exactly 18 feet. I then happened to notice a scrap piece of "Panduit" wiring tray stuffed up on a shelf in my garage. The cover supplied with this tray has a toothed lip, which locked nicely over the edge of the aluminum rails on the GMC cable tray. The cover is made from flat white PVC (although it comes in other colors, could be readily painted or covered with ones choice of fabric). The Part No. C3WH6 Panduit Tray Cover is also exactly 3 inches wide 8-). It comes in 6-foot lengths, packed 6 lengths to the box. The spec's may be found on the Panduit web site at: <http://www.panduit.com/>. Do a parts search for Part No. "C3WH6" and you should find a picture and specification sheet for the product. The two tray rails measure 18 feet each, so the box of 6 covers completely covers both trays (36 feet total) front to back. I obtained the covers from a local commercial electrical supply house. The price, for the C3EH6 covers was \$1.74 per foot or \$67.82 with local taxes. If one decides to replace a

portion of the tray cover, such as the section over the door, then the cost would be lower accordingly. As I am reconstructing the entire interior of my GMC, and it is all but naked inside, I chose to replace the entire length on both sides. When in place, the covers fit tightly over the tray rail lips and form a slightly concaved curve, rather than being flat. I had to use a bit of force (small rubber hammer) to work it over the rail lips, but once in place, it locked down firmly. If one should want to finish the cover in some color other than the original flat white (standard automotive paint should work nicely) or a fabric. Refinishing should be done before final attachment. I was able to remove the cover, without damage, with the aid of a large screwdriver, twisting under the lower edge/corner and slowly prying, while working it back over the bottom rail lip. But, a secondary finish, could easily be marred if one were not very careful. The PVC material may be readily drilled, sawed, cut with a carpet knife or box cutter when required for wire clearance. It only took about 15 minutes to install all six sections, however, as I said, the inside of my 75 E II is essentially naked at the moment 8-).

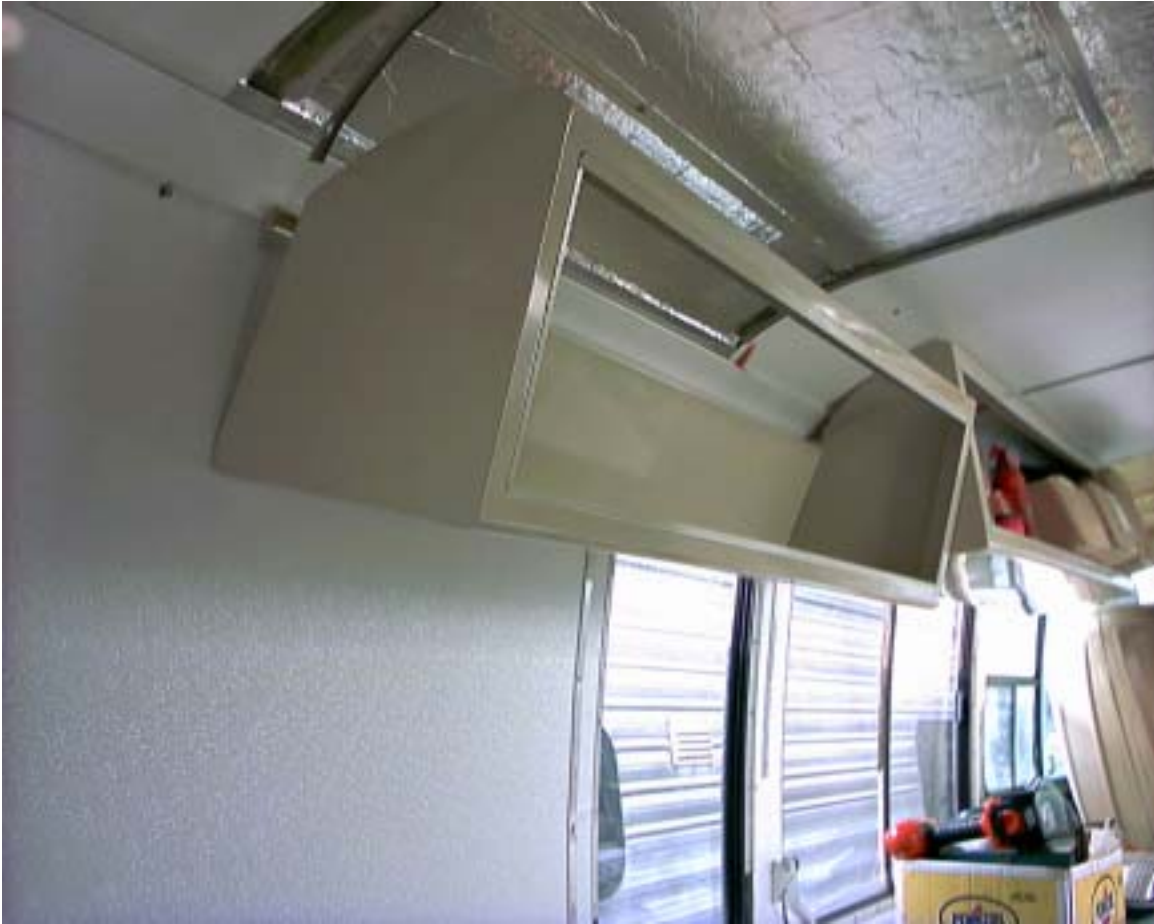
The next panel I chose to install was a 4’x 8’ segment, reaching from just left of the galley window to the right side of the rear window above the Generator compartment. In measuring the locations of the structural members in this area, it was determined that the height of the wall segment to be covered measured 48 and $\frac{9}{16}$ inches from the underside of the cable tray, to the top edge of the aluminum structural beam traversing the midline

of the body. This posed a bit of a problem, as the FRP panel was only 48" wide. Unless the additional 9/16" could be accounted for, the panel would not exhibit the proper curve and fit the contour of the body. I chose to address this by cutting a strip of FRP, 9/16" wide from a piece of scrap material and attaching it with several lengths of 3/4" aluminum flat metal along the upper edge of the midline beam. Holes were drilled near the base of the frame studs and self-retaining nuts were installed at six inch intervals to secure the flat metal strips and the 9/16" shim. This left a narrow lip, approximately 3/16" in depth, which would retain the lower edge of the new wall panel. Another 3/4"x 48" section of flat was secured in a similar fashion to a stud which formed the right hand edge of the wall panel. In all cases, 8-32 self-retaining nuts, along with 8-32 x 3/4" flat head Philips Stainless screws were employed to attach these aluminum retaining strips.

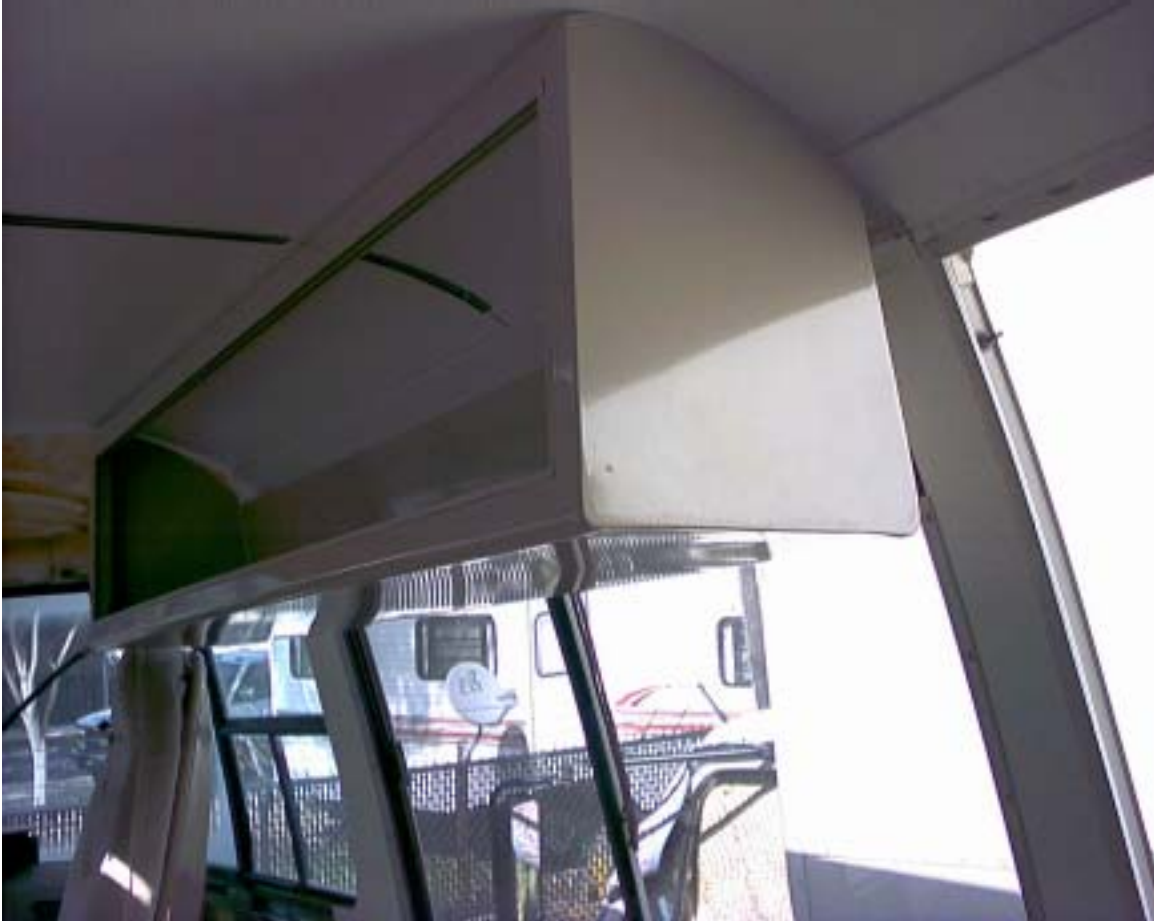
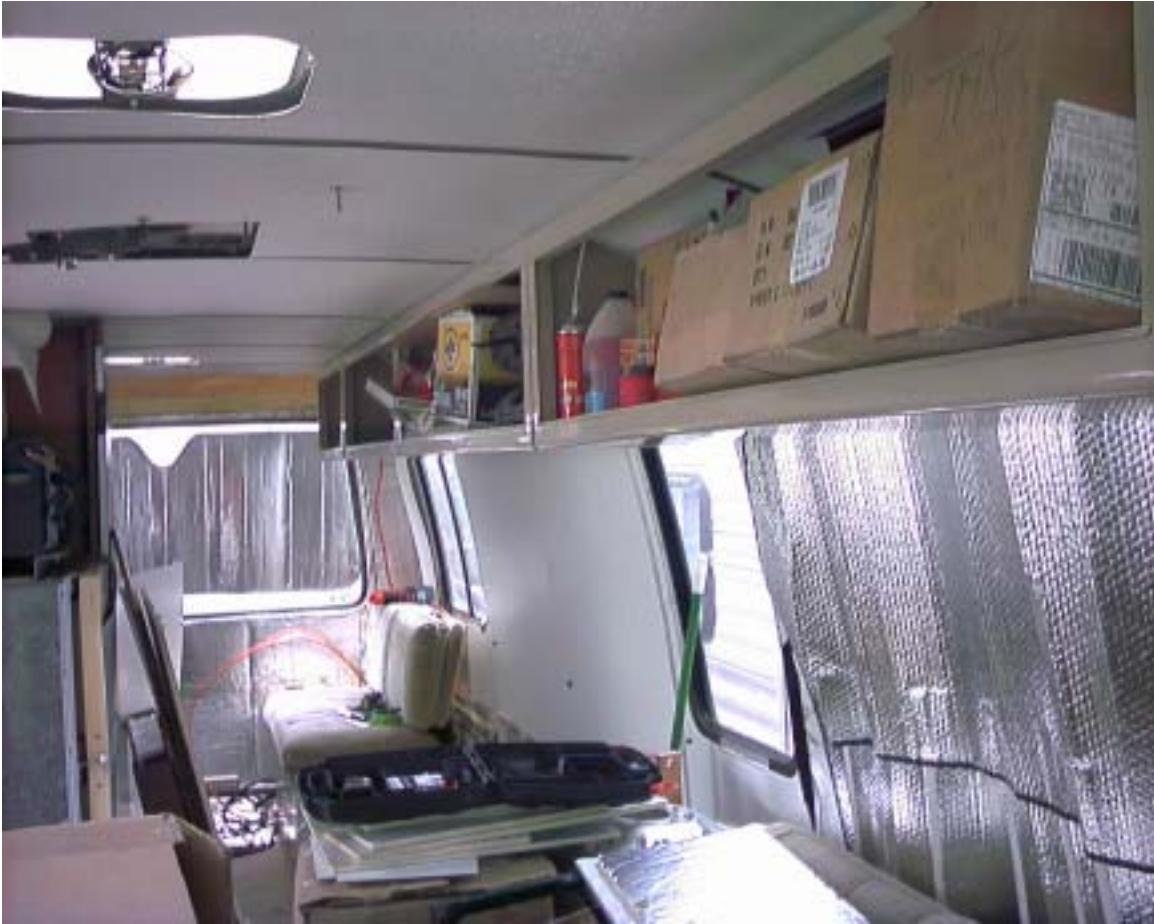
Today, my new TZEplus custom overhead cabinets, raised aluminum engine cover and Timkin wheel bearings arrived 8-). The engine cover and bearings will go on the shelf for the moment, but I was most anxious to see how the cabinets would look against the new headliner and wall panels. The coffee colored, powder coated finish of the new aluminum TZEplus cabinets, contrast well with the textured white FRP material. An opening along the length of the cabinets' backside will permit easy routing of the various electrical cables traversing the cable chase. As the cabinets arrived without pre-drilled mounting holes, some study was required to determine the best way to attach them.

Without the use of some sort of shim stock, as was present on the original cabinets, the mounting surfaces did not align with the original threaded fasteners. After carefully measuring the spacing and centers of the original mounting holes, I decided it was best to make a modification with respect to the factory mounting arrangement, by fabricating a new aluminum bracket to simplify the attachment at the rear tie points. Using lengths of one-inch aluminum angle, which corresponded to each individual cabinets overall length, I fashioned brackets by using a sheet metal brake (large bending tool) to form a single, $\frac{1}{2}$ inch, reverse 90 degree fold, along the length of each piece. Looking at the edge of the bracket, it resembles a "Z" with 90-degree bends, having a one-inch surface and two $\frac{1}{2}$ inch surfaces. I then positioned the wide (one-inch) surface of the bracket under the cable chase (with the PVC cover installed), marked and drilled four $\frac{1}{4}$ inch through holes and attached it to the wall with $\frac{1}{4}$ inch by $\frac{3}{4}$ inch Allen-head screws. This arrangement forms a $\frac{1}{2}$ inch lip, upon which the rear edge of the cabinet firmly rests. I then measured, marked and drilled $\frac{1}{4}$ inch through holes to correspond to the four original mounting holes along the top leading edge of the cabinet and fastened it with the same hardware, securing the new cabinet in place against the ceiling. It was thus unnecessary to drill any mounting holes in the rear of the cabinet yet it is supported along the entire length of the rear surface. For proper symmetry, the forward (left hand) edge of the cabinet was aligned with the leading edge of the cable chase.

These cabinets are considerably lighter than the originals and were not very difficult to mount. The bracket permits the cabinet to be hung against the wall without even having the top retaining screws in place. Although it might have been a bit easier to have some assistance in mounting the cabinets, it was not entirely necessary. It will also be easy to route the 12VDC and 120VAC wiring from the cable chase to the new florescent light fixtures and receptacles, which will be attached behind and to the underside of them. To keep stored items from vibrating and sliding around within the cabinets, a thin rubber matting material will be attached to the inside surfaces after all other installations are completed. The over all length of the new portside overhead cabinets is 18'.

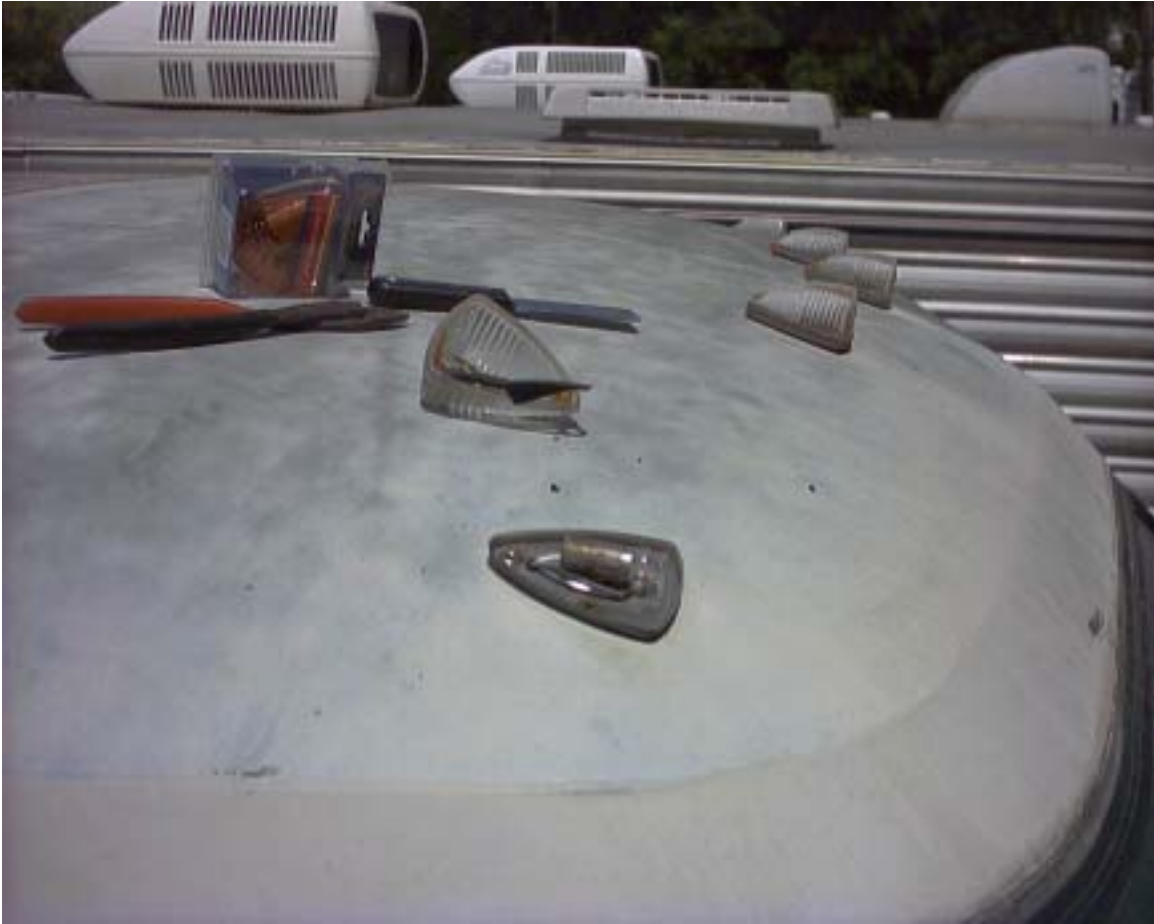
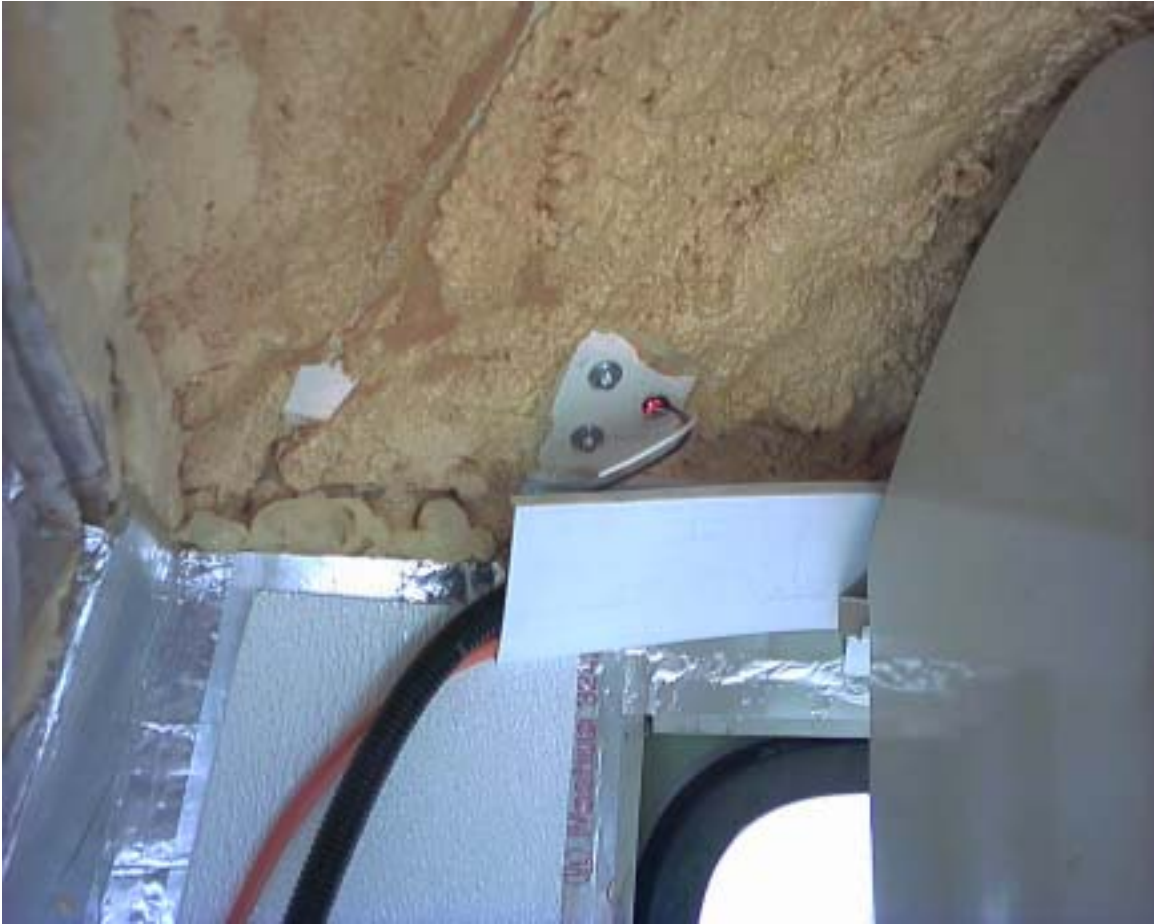
The original clearance lamps were in terrible shape. The lenses were faded, cracked and leaking badly. Virtually all of the mounting screws were corroded and many required drilling to effect removal. The thirty holes in the roof required for mounting of these fixtures were also a major source of interior leaks. So, the only practical solution to the problem was replacement. Optronics, Inc., at 401 South 41st Street East, Muskogee, OK

74403-6233, Telephone: (918) 683-9514, www.optronicsinc.com/trailer.htm was my choice of vendor in this instance. I opted to purchase a complete replacement set of (5) red fixtures (P/N: CB-21RS) for the rear and (5) amber fixtures (P/N: CB-21AS) for the front. In addition to these, I ordered (3) extra amber fixtures to replace the porch lamp, LP and Battery compartment lamps. Each fixture comes complete with new gaskets, mounting hardware and use a standard A-194 Lamp. They have the same basic footprint as the original GMC clearance lamps. Optronics does not offer a white or clear lens for this model, but then again, insects are not attracted toward the amber light at night as they are with white lighting fixtures. The total for all thirteen (13) fixtures came to \$44.52 + \$6.95 S&H and delivery was prompt. A NOTE OF CAUTION should be mentioned here. ANY lamp fixtures and/or switches employed in the LP or Battery compartments MUST BE EXPLOSION PROOF. That is, they must be sealed gas-tight, so that they cannot possibly produce a spark when actuated, which could act as an ignition source to flammable vapors, which might be present in these areas. Failure to properly install gas-tight fixtures or similar electrical devices in these areas could result in serious personal injury, death, and damage or total destruction of the MH. This is no place for "Rube Goldberg" type installations.
