“The rebuilding of Norman’s 75 Eleganza II-X, 01-09-75”, Rev.2

Norman Wheatley, Houston, TX 77054-4160 metrolog@hal-pc.org

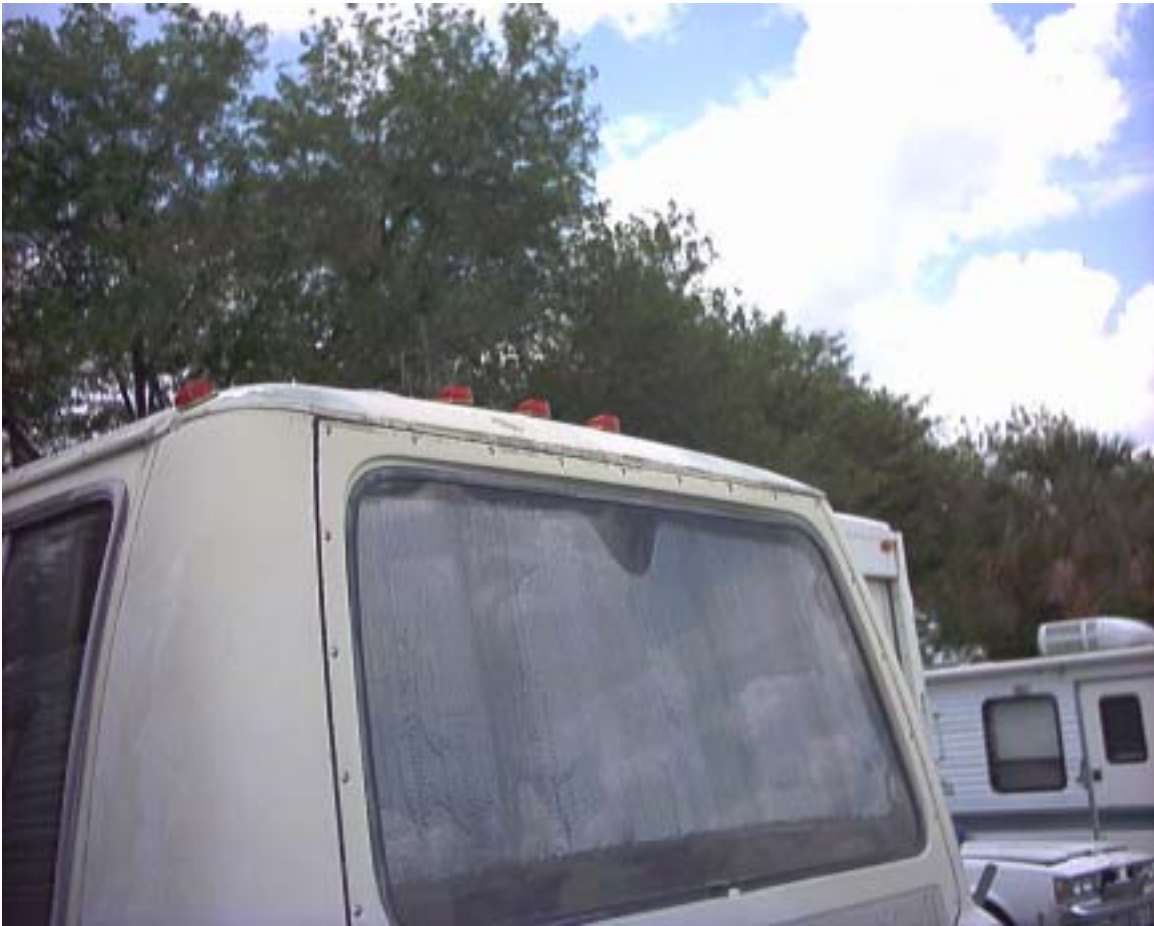
For those that are simply replacing their clearance lamps, without other interior modifications or repairs, requiring removal of the interior ceiling caps, the entire process can be accomplished from the outside. The only catch was the rusty screws in the toggle

bolts. Several of mine had corroded to the point of destruction. The fiberglass surrounding these fasteners is very brittle and can crack if any significant lateral force is applied while attempting their removal. But, that's why they make "J.B. Weld Epoxy".

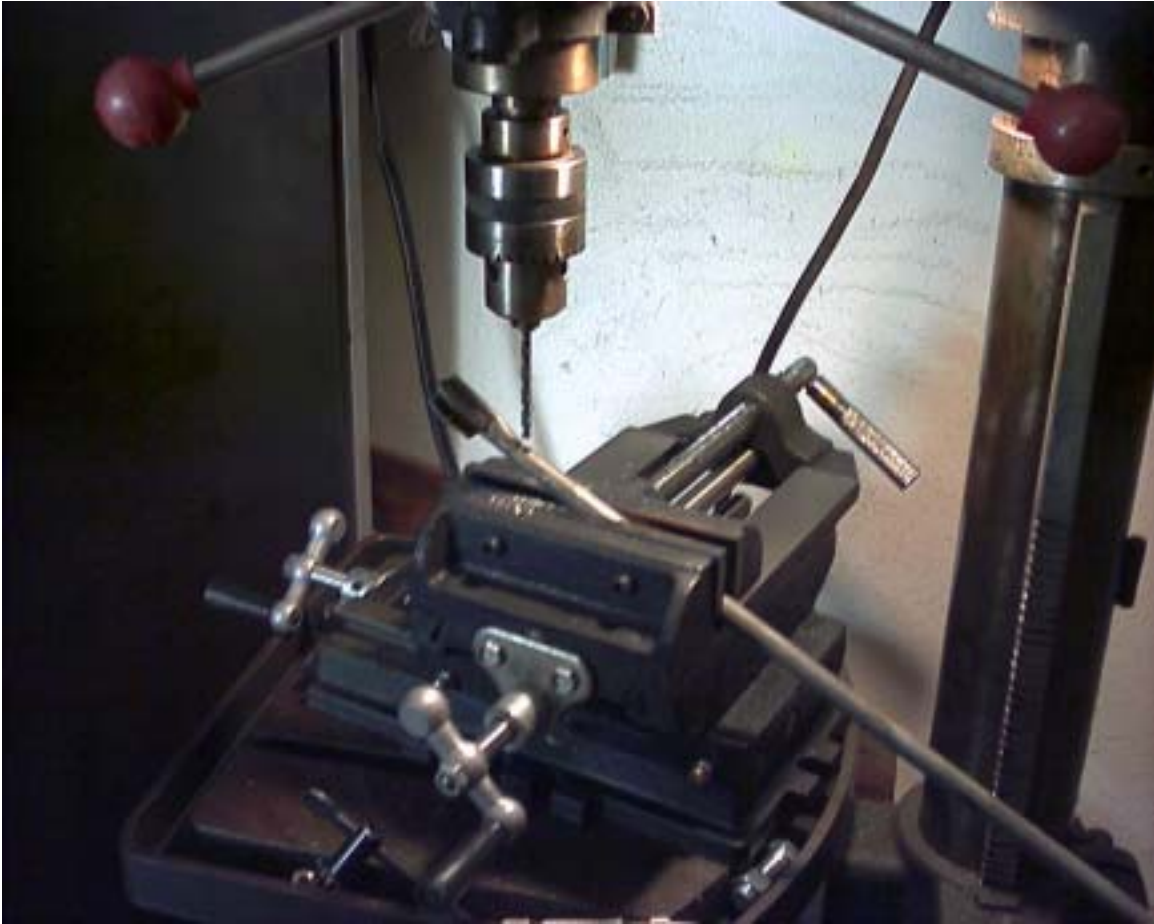
The original finish on the Trico wiper arms had gone away. The old chrome cap nuts had long lost their luster in a rusty mess. After removing what was left of them, a small wheel puller was used to extract the arms from the mounting posts. A search of the net yielded new part numbers for the washer nozzles and hoses, along with replacement blades. I also happened upon a commentary concerning a nifty little modification. The original washer hoses had been retained along the edge of the wiper arm by a series of little plastic clips. Fragments of these remained, but I wasn't sure if replacements for such items were still available. The modification I refer to does away with these pieces by routing the hose literally through the center of the arm. It simply involves drilling two small holes in the arm.

Using a drill press, an outboard hole is drilled in the underside of the arm just below the blade attachment bracket (saddle) at an angle to permit easy insertion and threading of the washer tube through the shaft. To start the bit at an angle and prevent it from walking or skipping away from the intended penetration point, a small file may be used to score a little groove at the location of the desired hole. The bit is fed with a very light pressure until it has begun to penetrate the surface enough to remain on center. If this light pressure is maintained, a neat clean hole will result. Rushing the activity could result in a broken bit and other headaches, so take it slowly. After the bit has broken through, a deburring tool or jeweler's rat-tail file is used to remove any sharp edges.

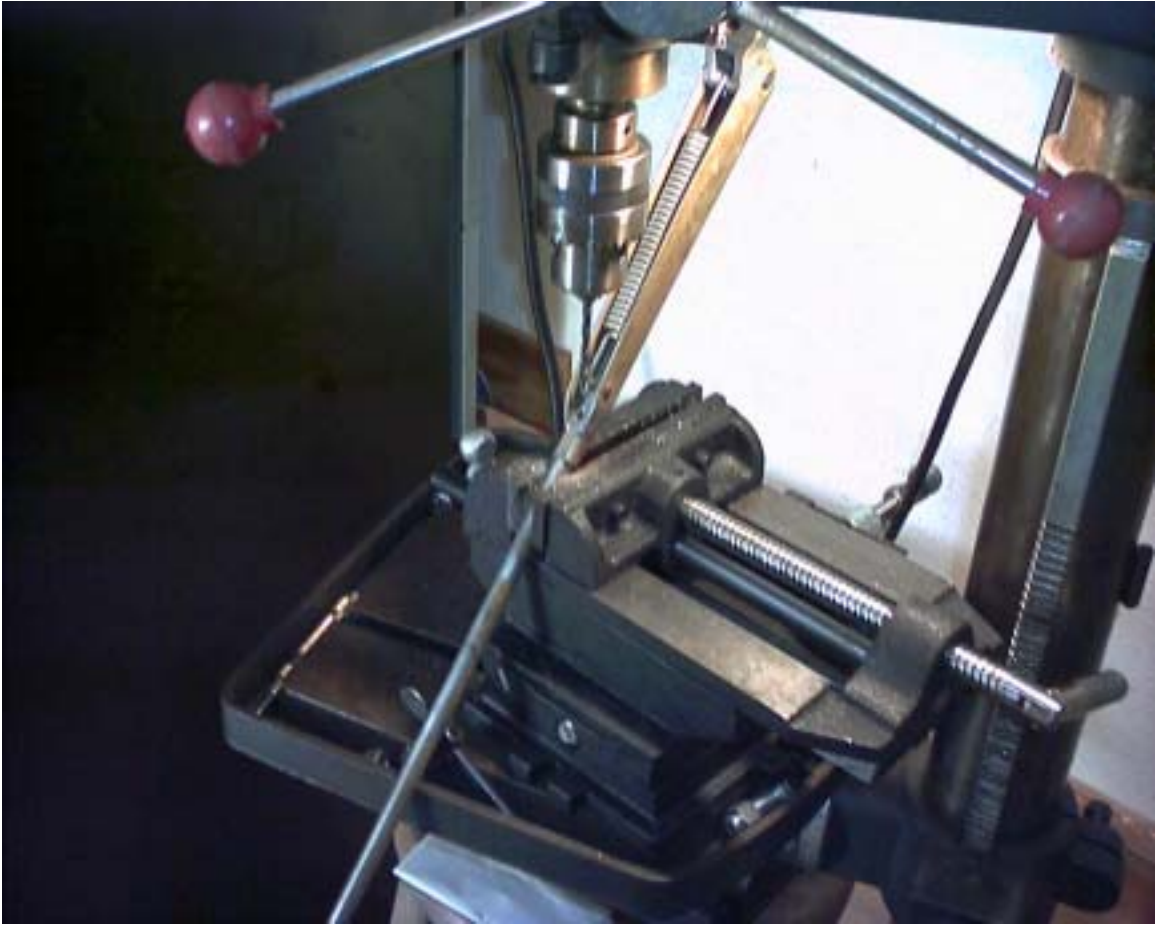
A second angled hole is drilled at the base of the arm where the washer tube will exit the shaft and thread through the length of the spring. The same drilling technique is employed with the second hole. Repeat the process with the second wiper arm. A wire wheel placed in the drill press can then be used to clean and prepare the entire surface of the arms prior to painting them. Just prior to painting, wipe the arms with a solvent such as acetone to remove any oil or fingerprints. I chose to paint them with SEM 39134, "Trim Black" automotive paint, (along with a couple of window frame pieces) on the recommendation of Jim Bounds. This self-etching paint requires no primer coat and leaves a smooth satin finish that reduces reflected sunlight glare and contrasts well with

other finishes. It dries quickly and a second coat may be applied if desired. This is the same paint that will be used to refinish each of the aluminum window frames when it comes time to refurbish the windows.

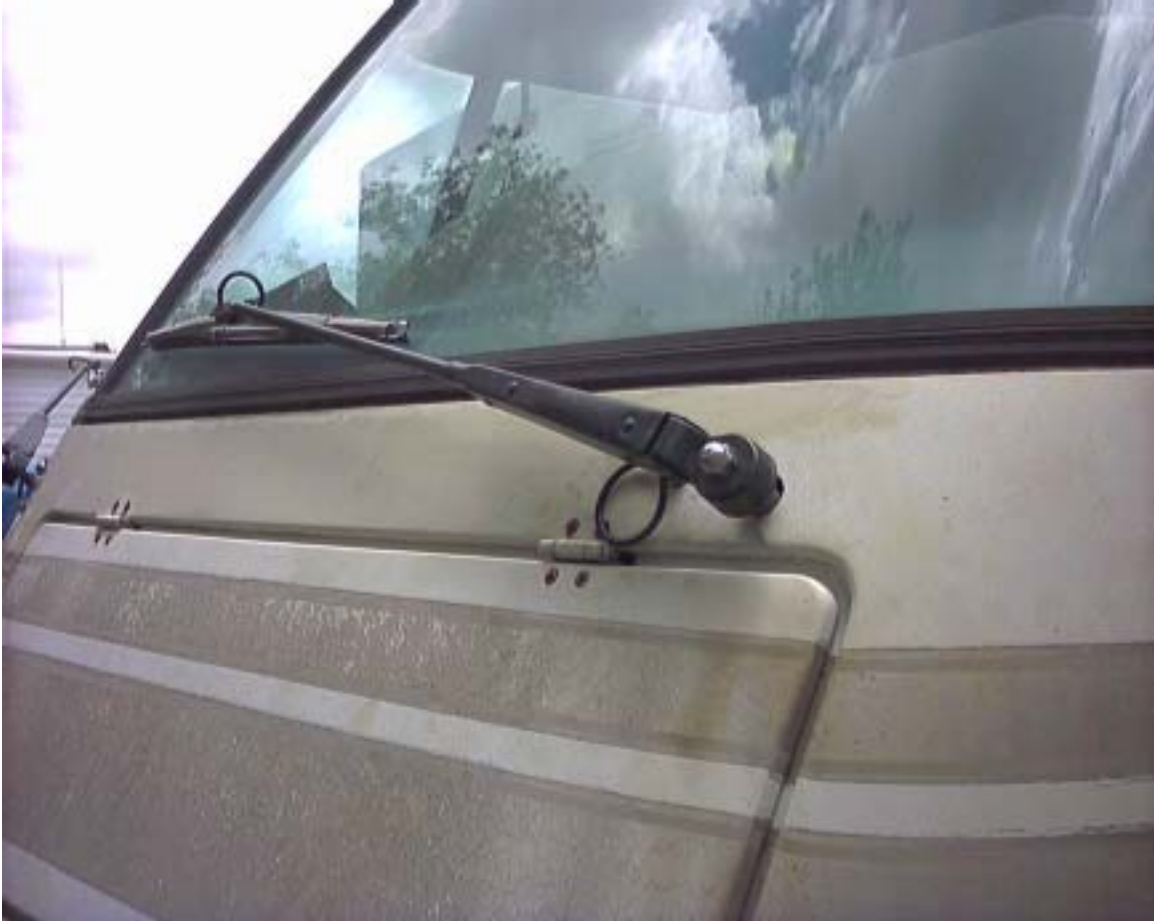
Coupled with a new set of ANCO Stk. No.52-20 heavy duty, 20" (508mm) wiper blades, ANCO Stk. No. 48-03 washer nozzles, washer tubing (which is supplied with the nozzles) and stainless steel cap nuts the wiper blades are ready to go back into service. The TRICO parts were a special order item at the parts store I was using, so I went with the ANCO items that were on the shelf. The alternative TRICO wiper blade assembly, Part No. 64-200 (silver finish) or Part No. 64-201 (black finish) should match the original OEM parts. The TRICO blade refill is part No. 72-200.

A small service loop is left in the ends of the washer tubing to prevent kinking of the line and to make them easier to attach. A dab of anti-seize goop was applied to the knurled spacer on the drive shaft to make it less difficult to remove later on.

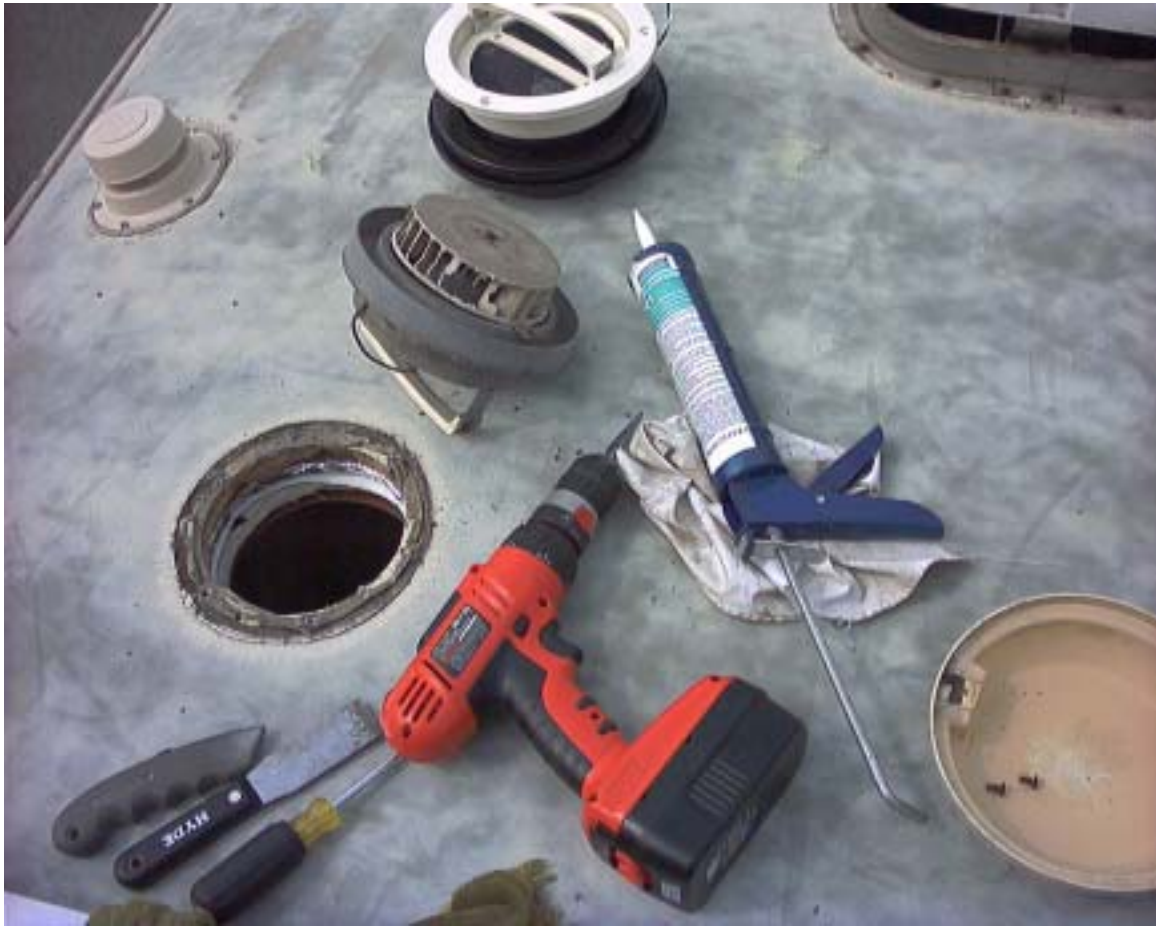
I discovered another large red wasp nest inside the bath exhaust vent/fan housing. While trying to remove the original vent, the blades began to crumble in my hand. It looked like I would have to add one more fixture to my shopping list. I managed to locate, what appears to be a direct replacement vent fan for the bath in the J.C.Witney catalog, Item # 13UC5736R, "Compact Exhaust Vent with 12V Fan, 6.25" OD, 1.5Amp" \$39.95. UV had eaten mine leaving the crumbs for the wasps. The new escutcheon (lower flange which attaches inside the bath) is substantially shorter than the original and doesn't sleeve the fan through to the fan body. So, I used the original component with the new fan element. Otherwise, there would be a gap exposing the underside of the roof to significant moisture from the shower. The J.C.W. replacement unit is of much lighter

construction, stamped metal, as apposed to an aluminum casting of the original fan. The fan motor is only about 20% of the physical size of the original and looks like it came out of a "Mattel" toy. It really looks cheap and if the old one weren't completely shot, I wouldn't even have considered installing it. As they say, you pay your money and you take your chance. It was easy enough to install though. It is essentially the same diameter, but slightly shorter, having lighter gauge plastic components as well. It took longer to drill out the pop-rivets from the original than it did to hang the new one. The original had six mounting holes. The J.C.W. model has eight. The roof surface was first cleaned with a putty knife and a thin seal of Dow 791 was applied. Eight self-tapping #8 sheet metal screws were used to anchor and seal it down. All in all, it should be serviceable for a few seasons, but it's not my idea of a long-term fix. The original vent was leaking so badly, it had to be replaced and I was trying to save a buck. Unless, at some point, I decide to go with another source, I will in all likelihood rebuild the old one and press it into service once again. A 5-6" DC axial muffin fan would fill the bill nicely and an 8" round aluminum cake pan, with a little paint, would make a fine top hat. Toss in a toggle switch and it should be as good as new.

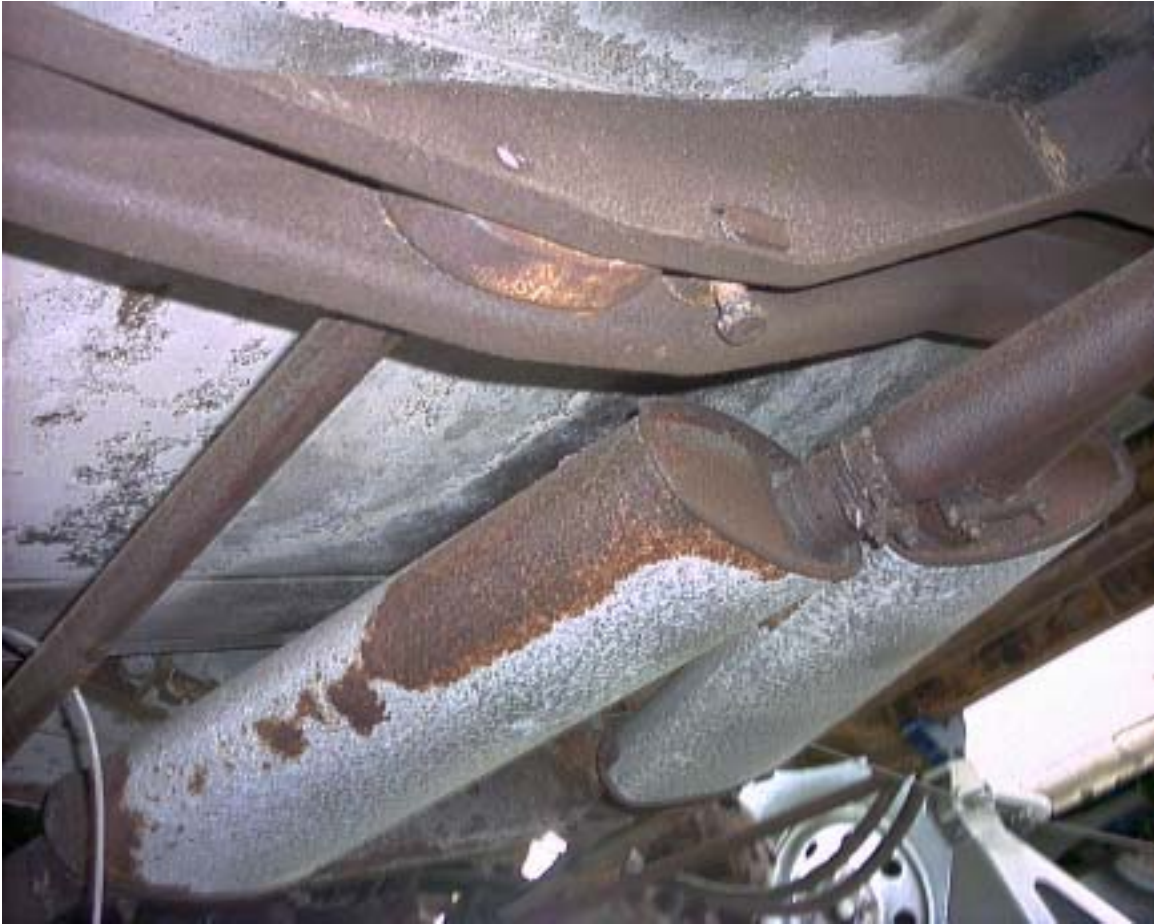
The exhaust system was a shambles. Where it wasn't missing, it was full of holes. Aside from a couple for brackets, none of it would be salvageable. I went back to the web once again, in search of a solution to this mess. Fortunately, I was not the first to run up against this situation and I had several excellent options to choose from. I could always rebuild the existing system in its' original configuration. That option didn't last long. Many owners had decided to increase the diameter from the original 2 1/2" exhaust to 3", thus reducing backpressure on the engine and increasing horsepower. That sounded reasonable. Then there was a group who favored replacing the dual mufflers with a single muffler located at the rear instead of in the middle under the forward section of the living compartment. This cut the expense by 1/2 for mufflers. But then I happened upon some photos on a website by Mr. Lawrence Gaskins of West Union, WV, <http://www.PictureTrail.com/GMCLawrence> which showed, what I thought was a rather clever exhaust system design. The system modifications he had made to his 1973 Painted Desert struck me as ideal. He has installed the Thorely headers, maintaining his 2 1/2 " diameter pipes and routing his tailpipes out under the drivers side of the living compartment ahead of the rear wheels. Some had expressed concern about the heat from

the exhaust system adjacent to the fuel lines and other equipment in this area. I had already made the decision to relocate my fuel circuits behind this location, so that would not be a problem for me. In addition, I had decided to install additional heat shields on both mufflers and an auxiliary heat shield between the exhaust pipes and body to further cut the heat radiating to and through the floor. The shortened 2 ½" circuits would be less expensive than going to a longer 3" circuit. The individual exhaust legs of the dual design, in conjunction with the substantially shorter tailpipes, would reduce the backpressure to a minimum while affording the lowest sound level.

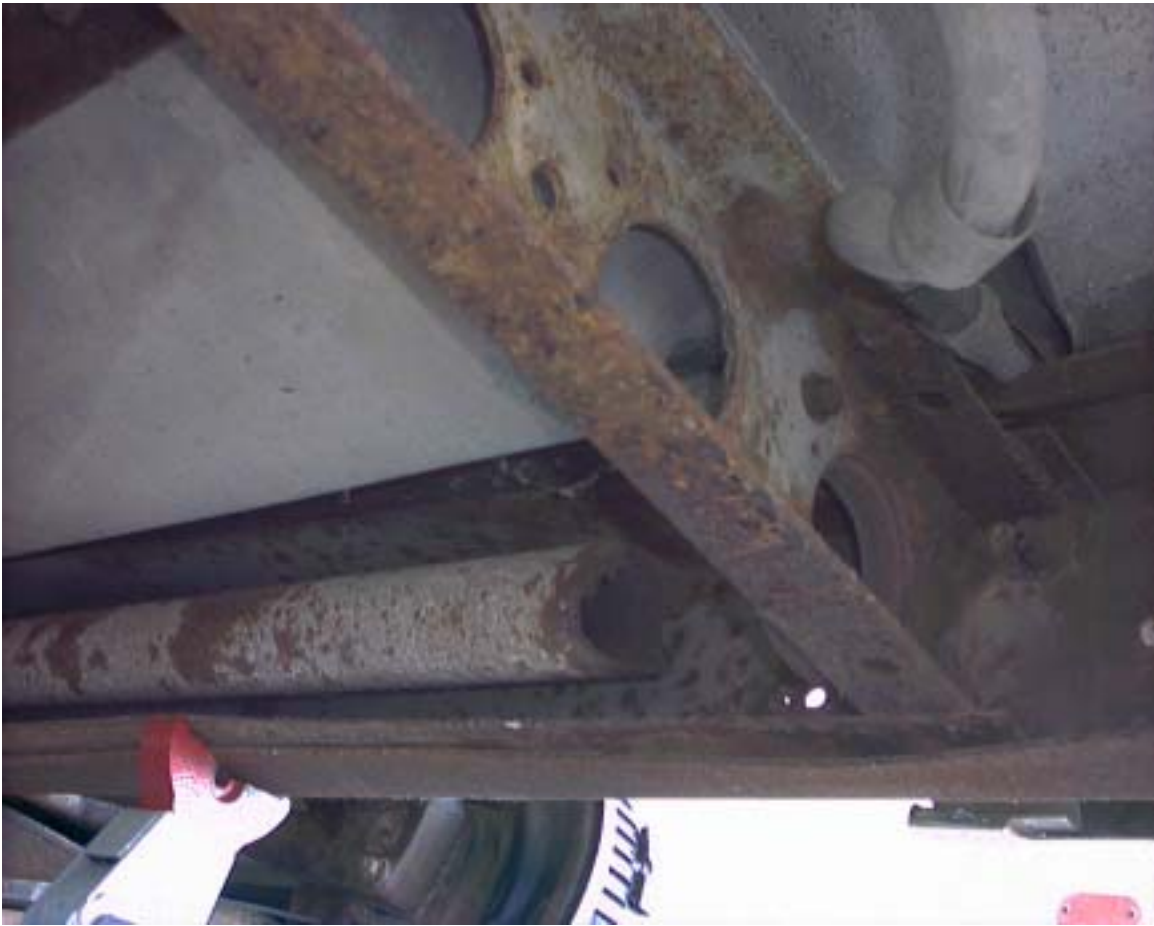
About half of the original tailpipe was gone. It also looked like a P.O. didn't know how to properly place the hydraulic jack, judging from the bend in the lower frame rail near the cross member under the LP compartment. Fortunately, it wasn't serious. The LP plumbing will be replaced and re-routed to the starboard side where the furnace will be

relocated under the refrigerator.

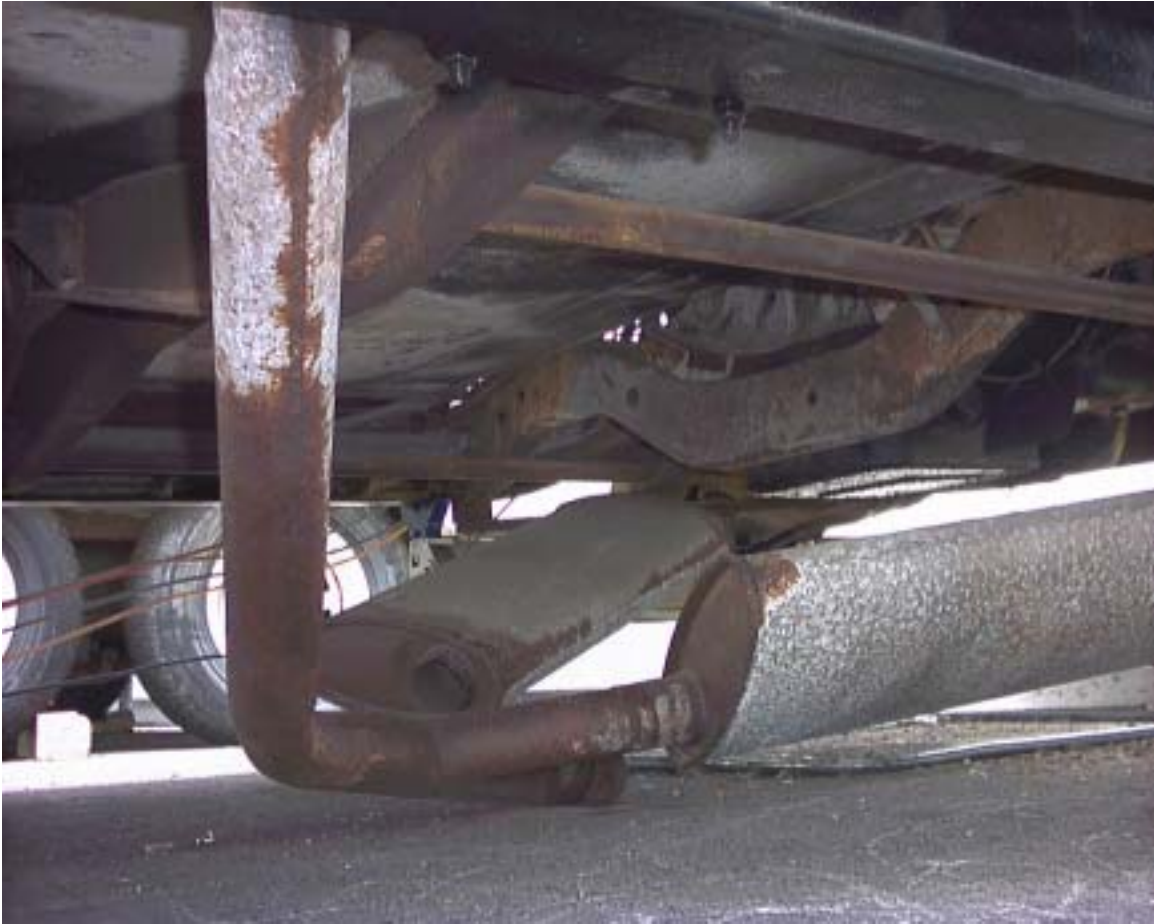
The remains of the parking brake cabling and associated hardware were removed, along with the rusty brackets, which held the pneumatic lines and fuel circuits. The parking brake elements would be discarded. The remainder of these items would be replaced and rerouted, along with the LP plumbing. The fuel tanks would have to be dropped and overhauled. A large crack was discovered in the sanitary tank, so it would have to be replaced. The retaining brackets, which held the sanitary tank, were severely corroded as a result of the leak from the tank and would also require replacement. New muffler and exhaust pipe brackets would have to be fabricated to support the new exhaust system. All of these chores would be done with an assortment of hand tools and a rechargeable hand drill, while lying on the creeper. Is this what they mean when they say I'm lying down on the job?

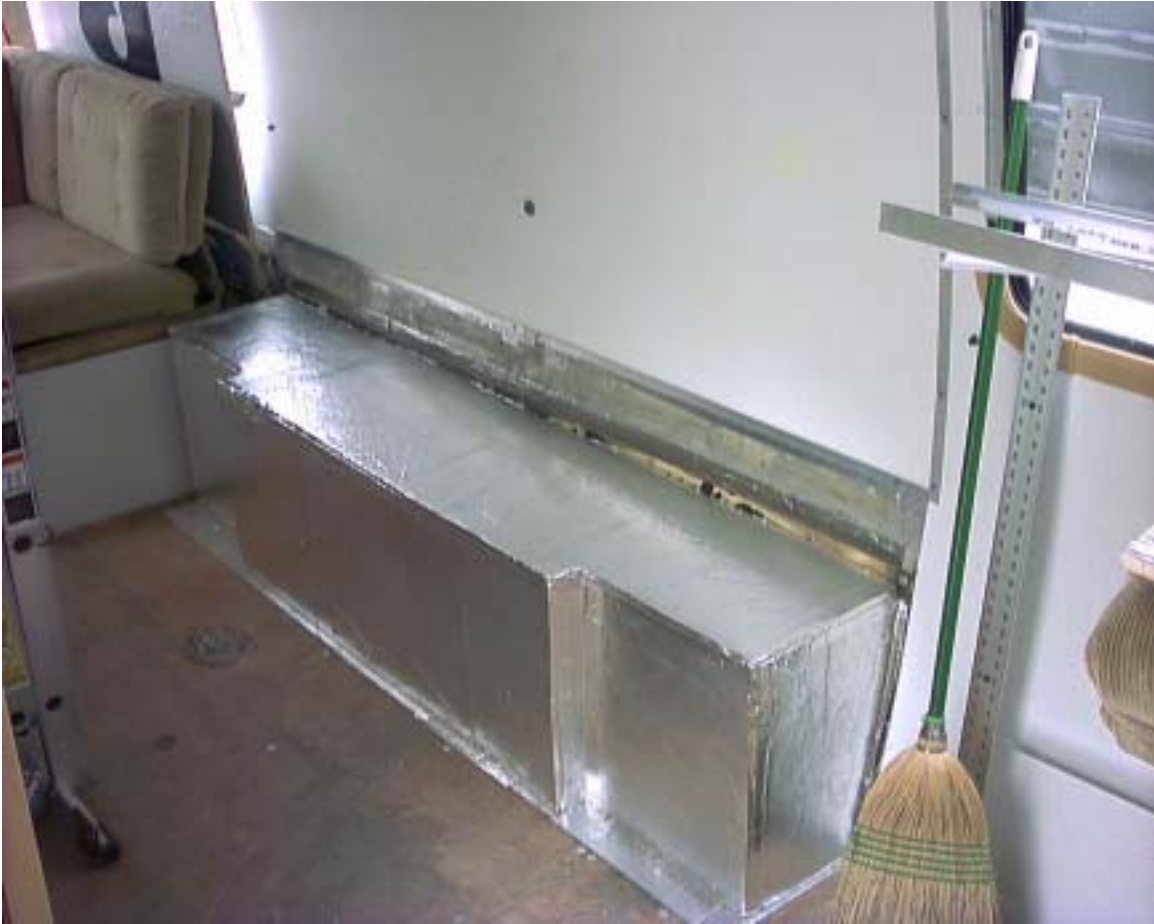
Wheel well insulation -

A rather ugly aspect of the interior that many GMC owners seldom see because they are generally hidden from view, are the wheel wells. With the new galley design, they will be much more visible, so they will need a serious facelift. The original thin layer of foam covering the wells were trimmed and sections of 1/2" aluminum foil backed urethane insulation material were cut to cover each surface. Each section was fitted together with 2" aluminum foil tape at the seams and then the remaining voids were filled with expanding urethane foam to bond the insulating panels in the same manner as had been done previously for the ceiling and walls. The location of the various mounting screws through the wheel well, which attach the liquid-vapor separation and leveling valves were marked for possible future access and service. The original fasteners for these items were replaced with new S.S. hardware. Large voids along the top of the well, where there are two surface elevations to clear the wheels, were filled with scrap segments of urethane board prior to applying the more expensive expanding urethane foam. Finally, a top piece was installed to cap the enclosure forming a solid shelf.

When the insulating foam had cured, forming a sealed rigid surface, sections of FRP panel were cut to cover the insulation and provide a bright clean finished exterior surface.

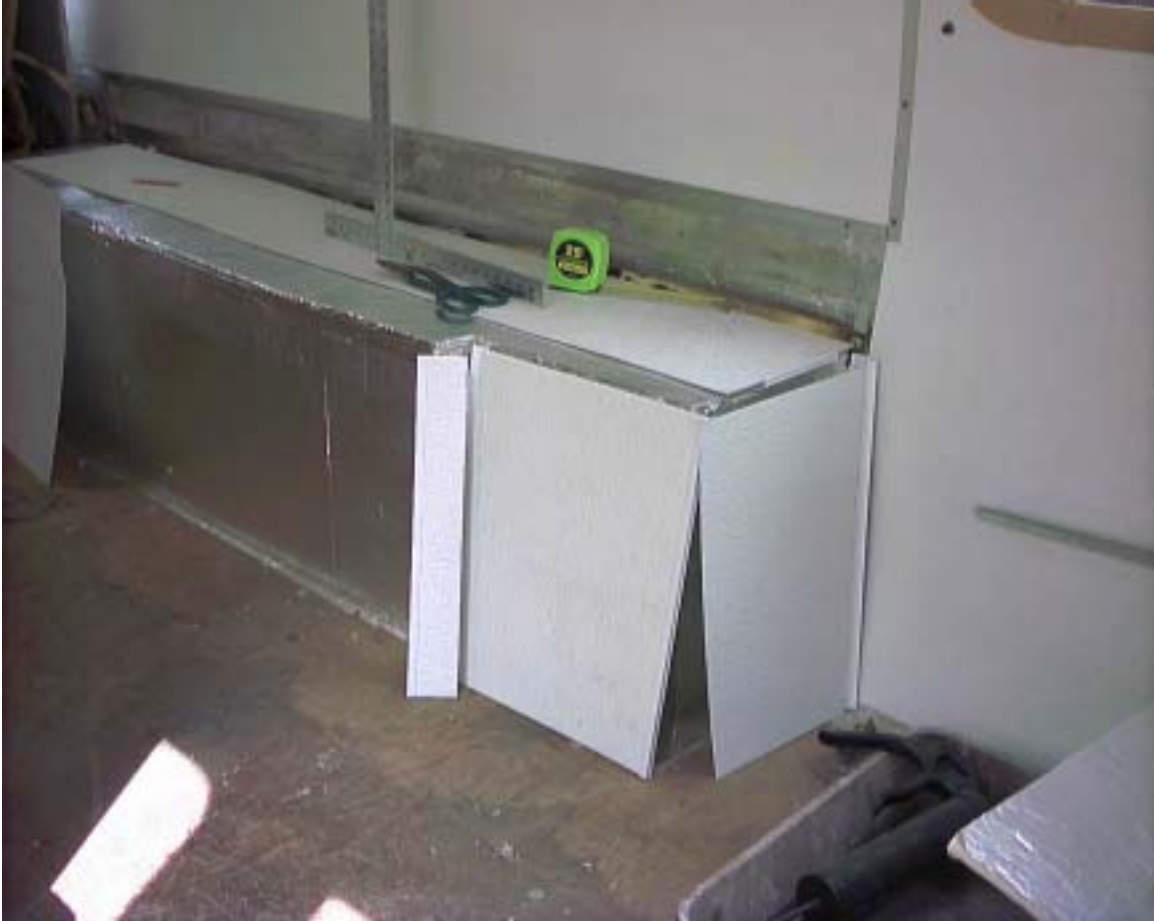
The FRP was bonded to the surface of the urethane with a bead of 791 Sealant around the edges. The corners were trimmed with appropriate internal or external vinyl corner molding.

The wheel wells will of course, eventually be entirely enclosed within the new galley cabinet and the new starboard utility area. This will serve to further slow the loss or gain of ambient heat within the GMC and afford a clean, waterproof surface lining the interior of these new storage compartments. It will also serve to act as a secondary structural barrier in the event of a catastrophic rear tire failure on the vehicle and further reduce the level of road noise.

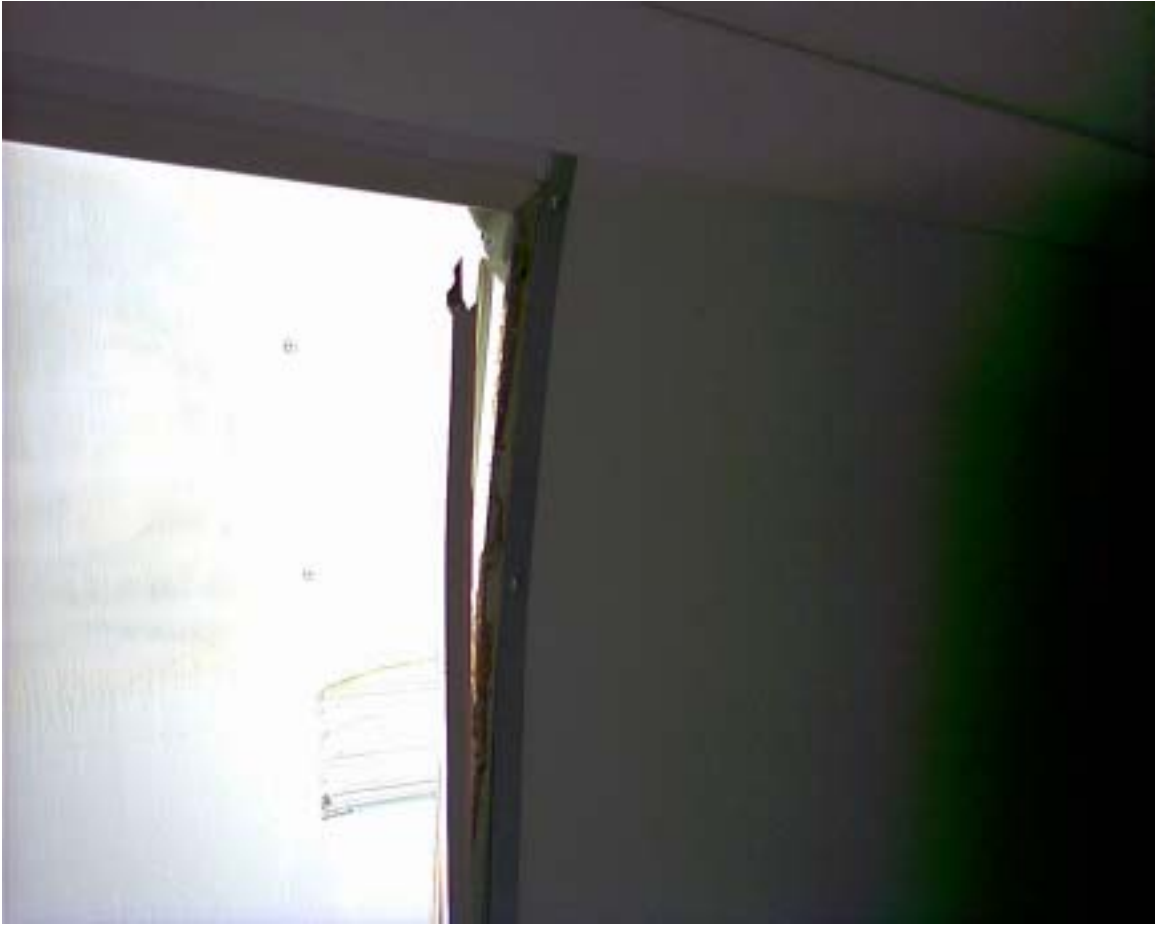
The original door molding had turned yellow, brittle and had fractured in several places.

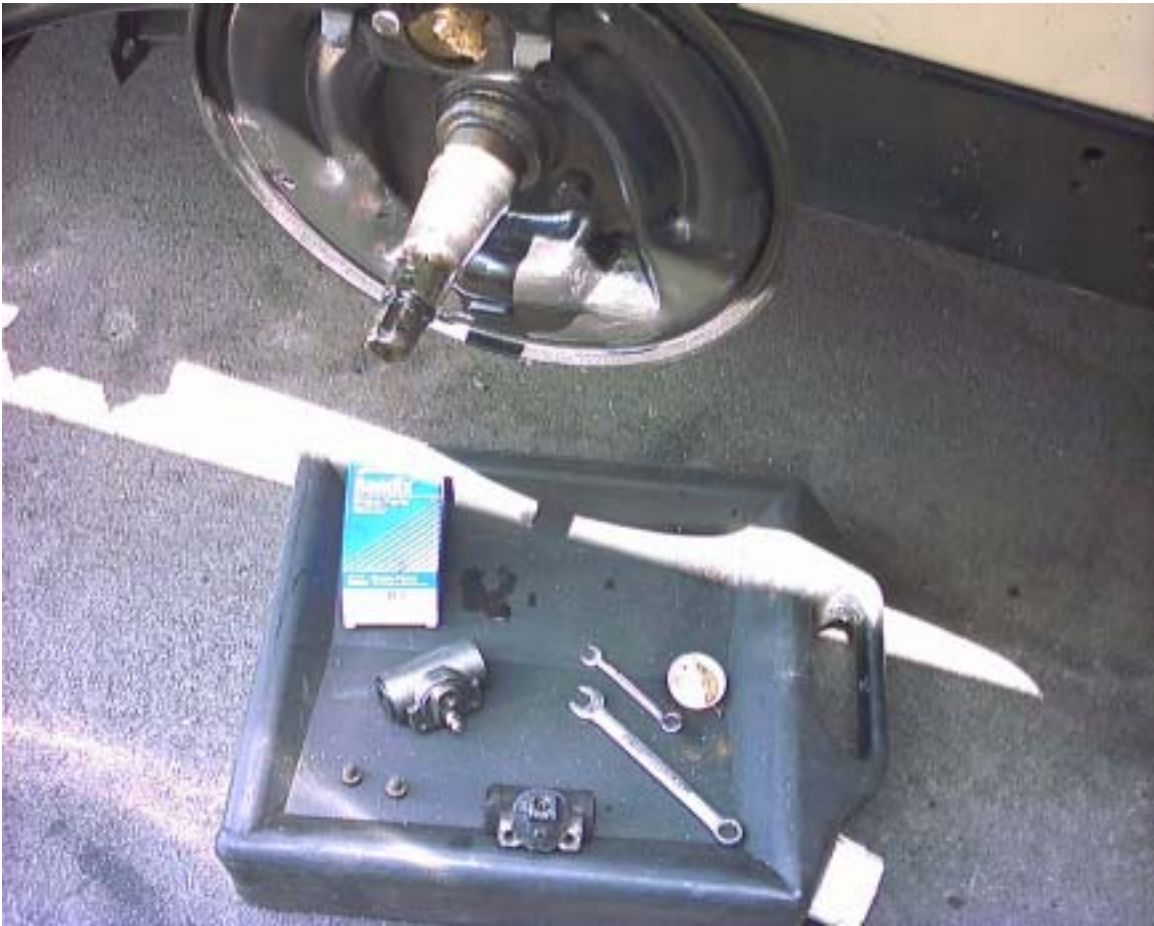
Standard Rear Brakes & Suspension

I had decided to take a few days off in June so that I could tackle several of the more involved refurbishing tasks. At the forefront of the list stood the rear brakes and suspension system. There is a great deal of information concerning the braking system available on the web. There are many variations and configurations to choose from and many opinions concerning the virtues and vices each exhibit. It had been a couple of decades since I last did any kind of brake job, so I wanted to review the available technical information pertaining to the GMC, discuss the subject with several of those who have gone before and assess my options. I felt that a disk brake conversion, although technically superior to shoe brakes, was a bit more than I wanted to tackle at this stage of the game, so I resolved to stay with the original basic design. The wheel cylinders would certainly require a rebuild kit at the least, after sitting so many years, but it seemed more practical to just change them out. A number of GMC owners I spoke with, had decided to change out their wheel cylinders to a larger diameter. The original cylinder measured 15/16". Some had decided to utilize 1 & 1/16" and others preferred to use 1 & 1/8" cylinders. There were numerous arguments expressed both for and against

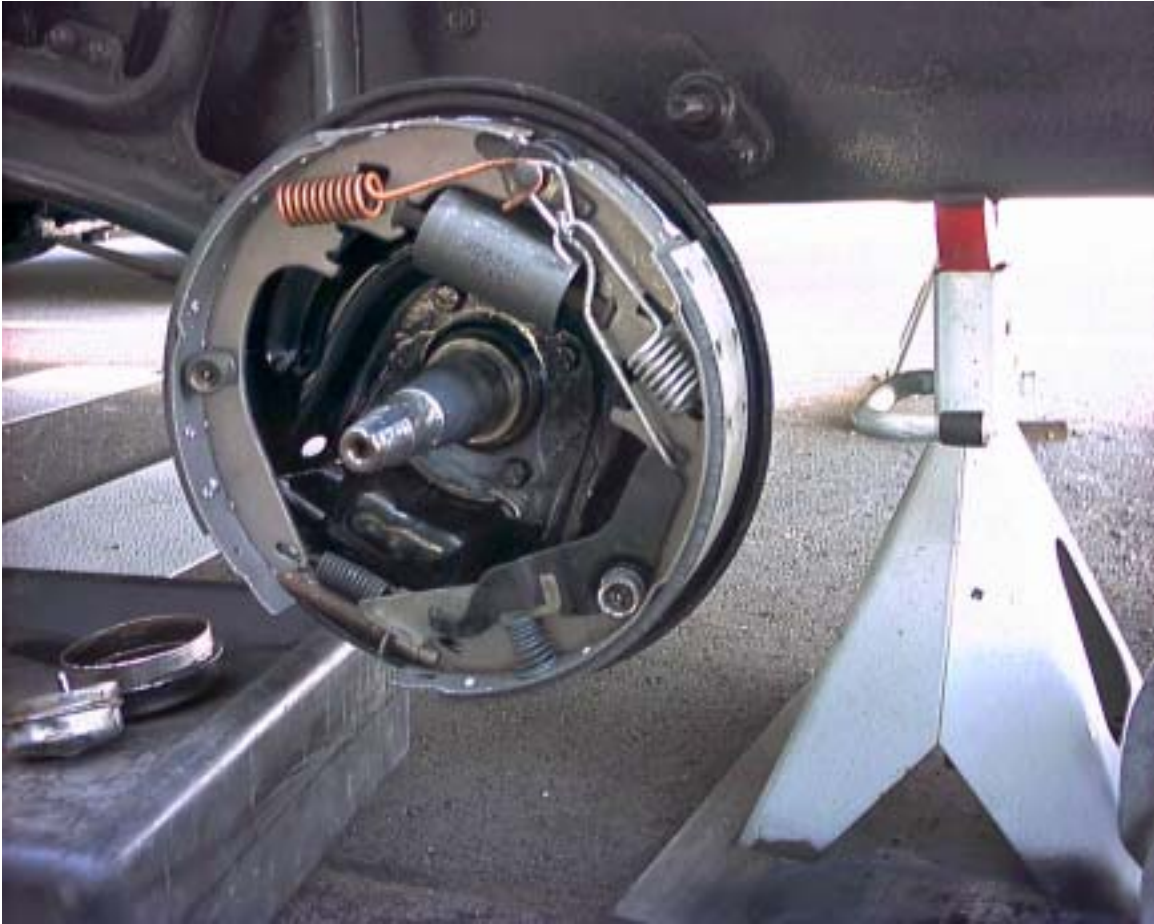
I also wanted to install the new "Check Valve" type bleeder valve stems. The two different numbered cylinders each have different sized bleeder valve threads requiring the use of different bleeders. The Bendix Part No.33710, 1 & 1/8" cylinders, which happened to be installed on the middle wheels, use Check Valve Bleeder Number 12701, which is 3/8"-24 thread, 1.19" OAL. Wagner Part No. WC86000, 1 & 1/8" cylinders, which happened to be installed on the rear-most wheels, use Number 12704. Both types sold for \$11.89 each. These devices allow one to bleed the brakes without assistance. The replacement brake shoes used were P/N 462 and sold for 16.99 each, for a set of four shoes. The small pads always face forward while the large pads always face the rear.

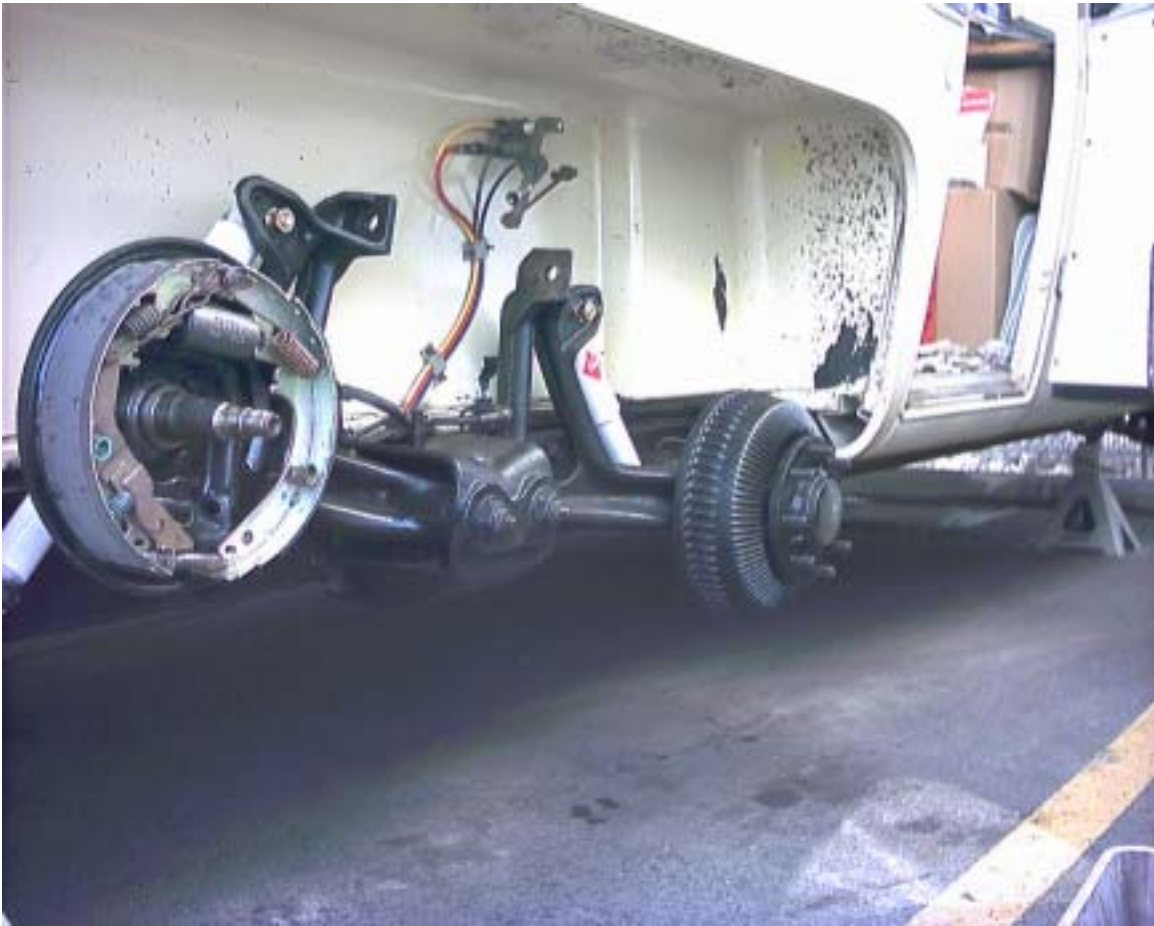
The various springs, retainers, self-adjuster and drums appeared to be in good condition. Masking was applied to the spindle, friction and bearing surfaces of the drum and all were then briskly wire brushed to remove the surface rust. They were then given a good

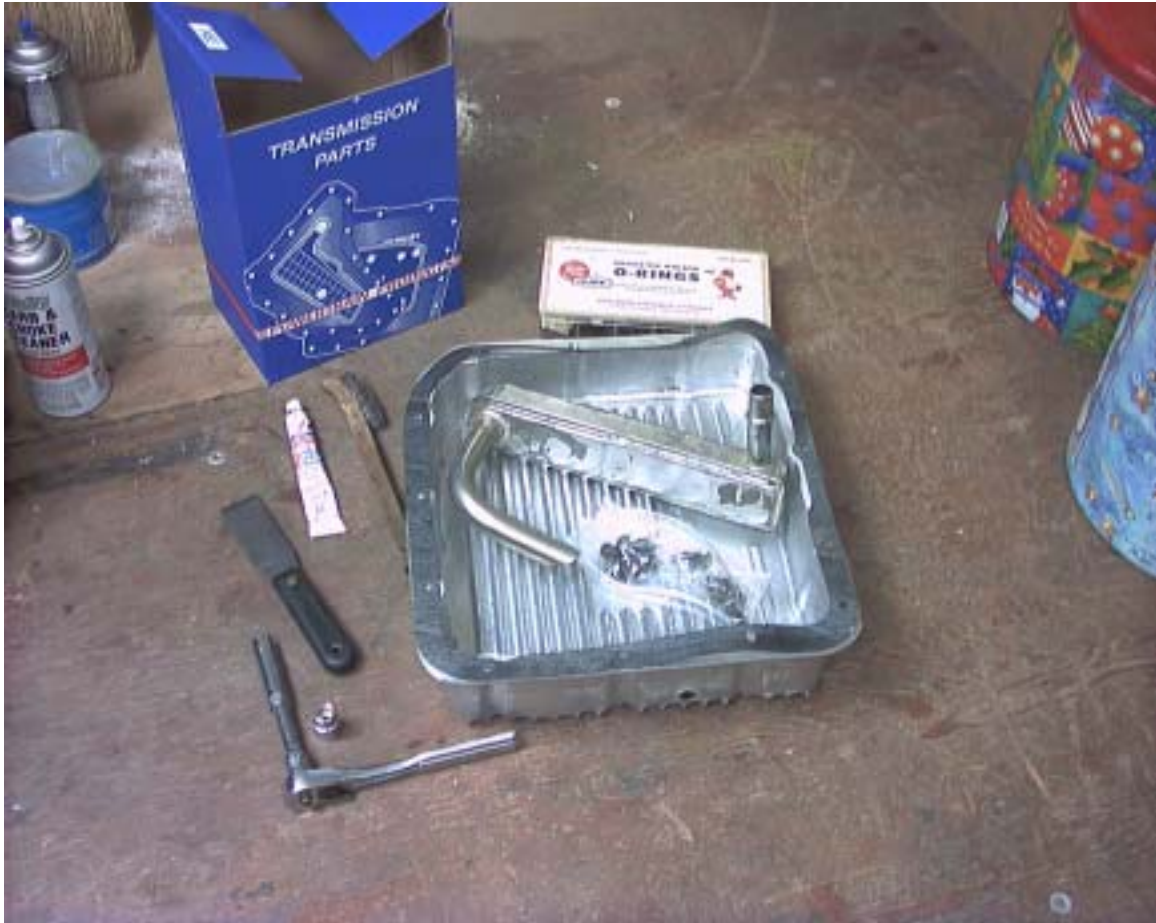
The O-ring rests against a lip on the upper filter tube.

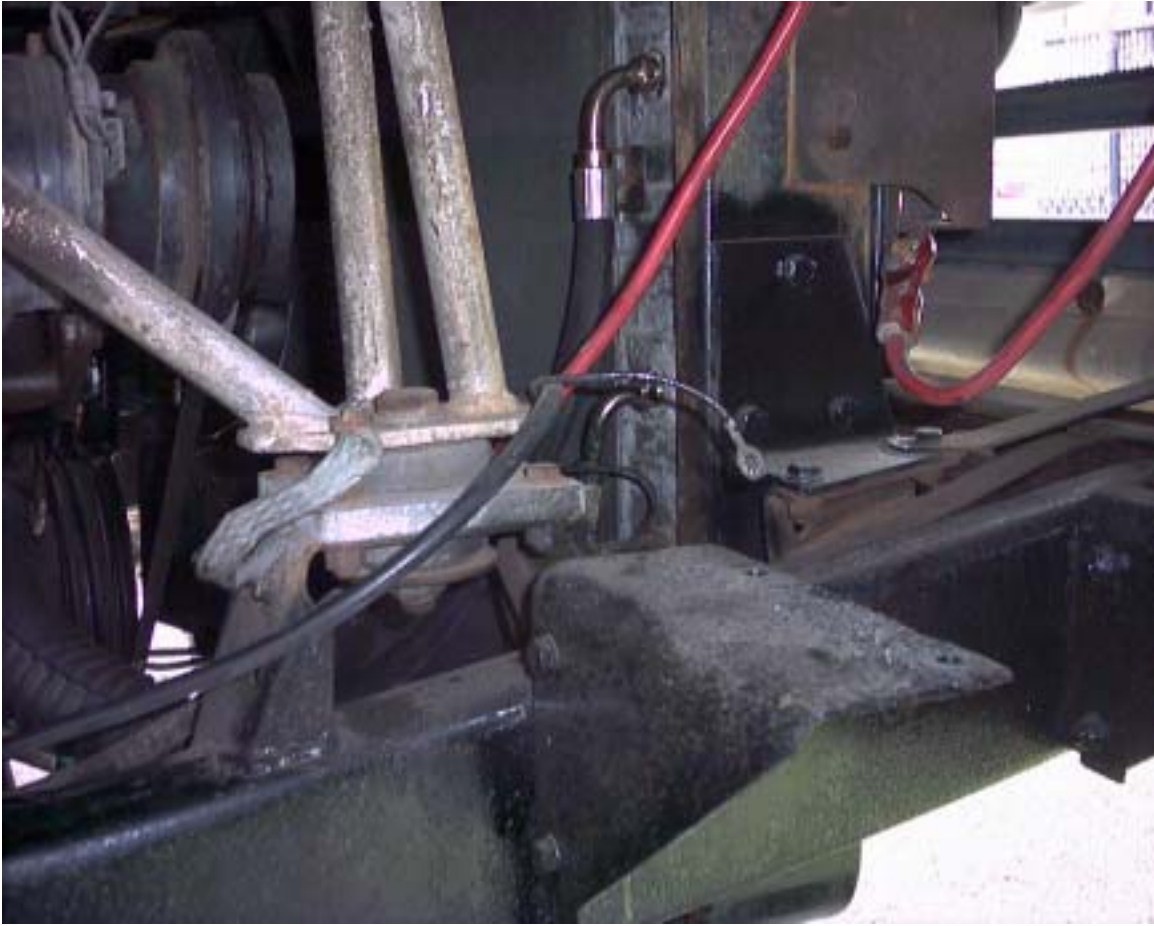
The next Christmas package contained the new TZEPlus elevated aluminum engine cover. It only took a few minutes to attach the twist latches and foam rubber lip seal.

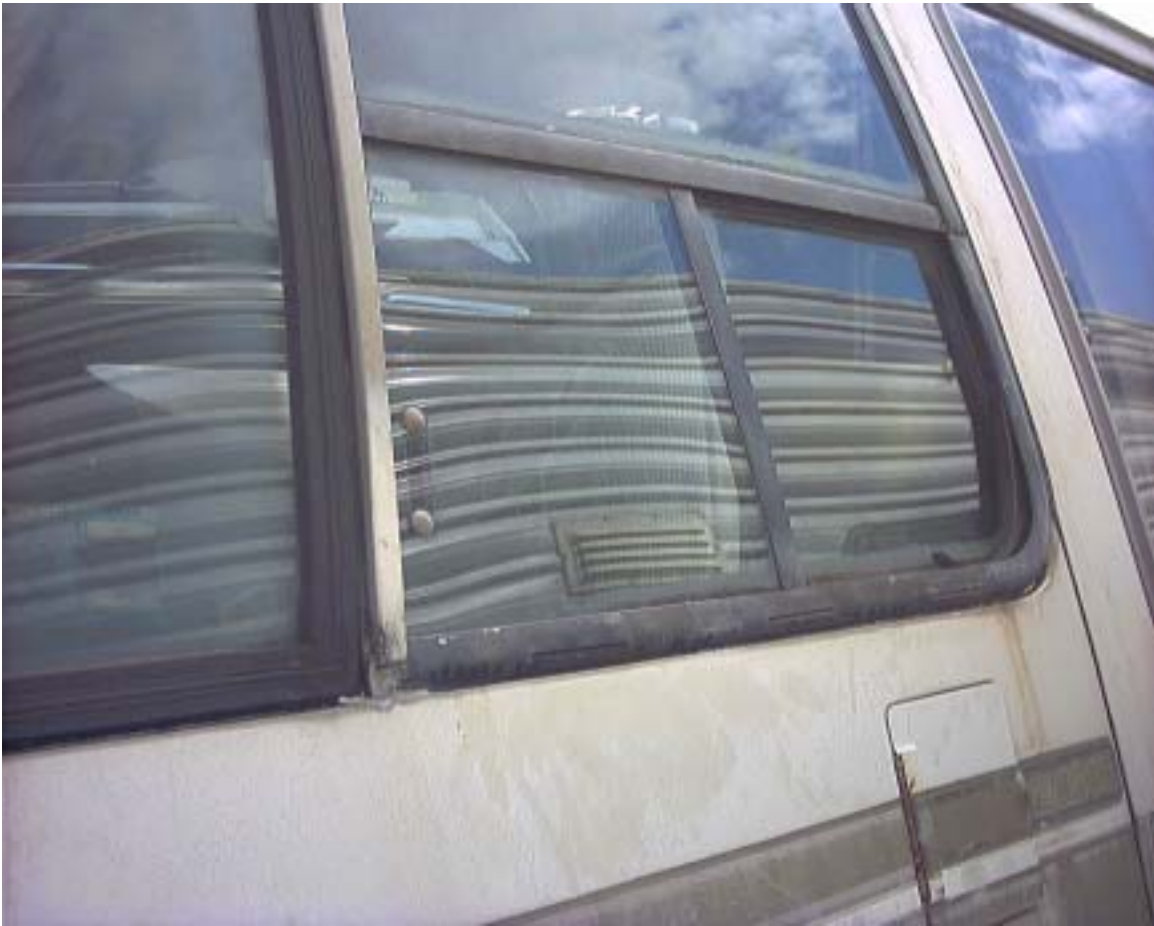
Having replaced the weather stripping around each of the sliding windows. All was going well, having replaced the stripping on all four main compartment windows, I was a bit nervous about the step in the instructions which says to utilize a block of 2" x 4" and a hammer to remove the vertical edge molding from the glass. But to my surprise, it worked rather well, at least until I got to the passengers cab window. I first started on the outside to remove the vertical molding from the movable pane. It took considerable force, much more than any of the previous pieces. I split the 2" x 4" block and had to get another to continue. It finally broke free, half way through the second block, from the adhesive (black, RTV?) and corrosion bonding the aluminum vertical to the glass. It took a razor blade and green scrubby pad to remove the stuff from the edge of the glass.
