“The rebuilding of Norman’s 75 Eleganza II-X, 01-09-75”, Rev.2

Norman Wheatley, Houston, TX 77054-4160 metrolog@hal-pc.org

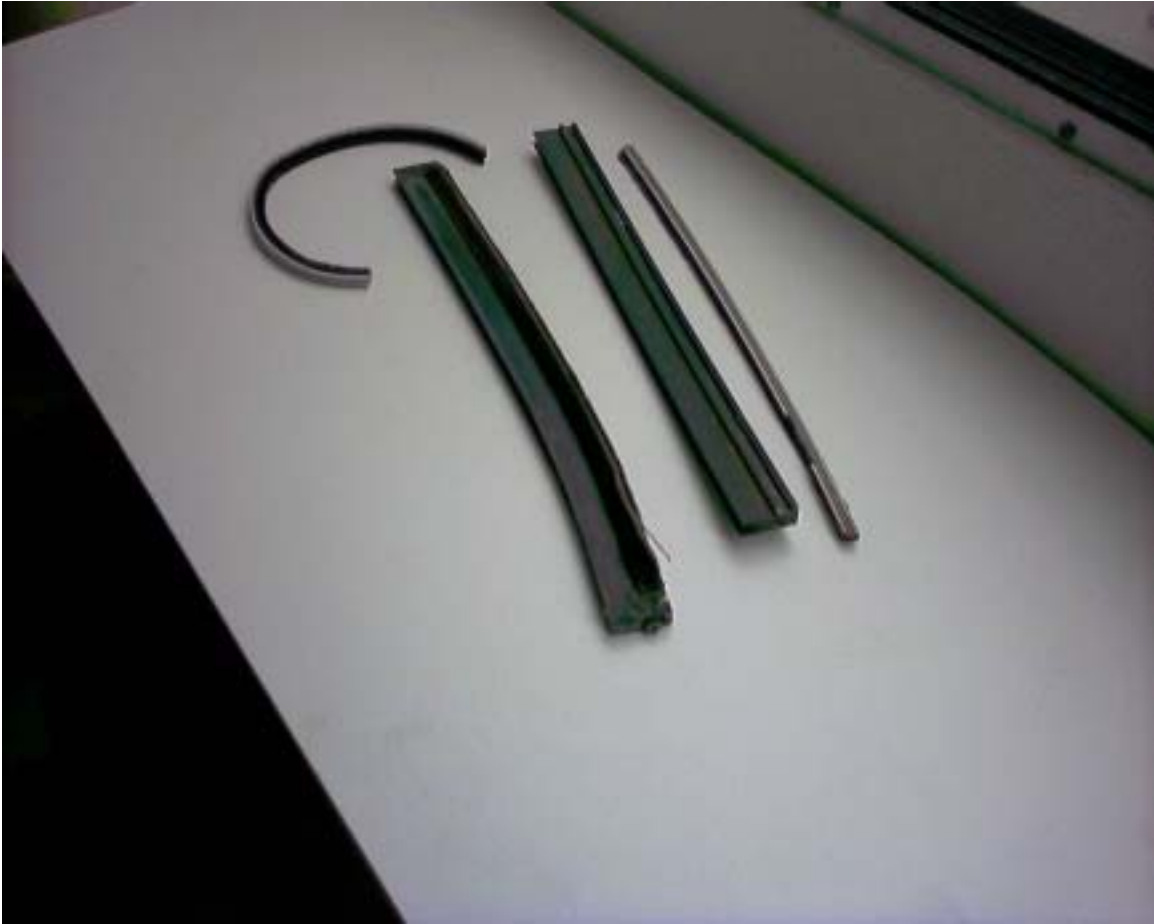
The headache came while attempting to remove the vertical from the fixed pane on the inside. Suspecting more adhesive/sealant on this pane, I proceeded to shatter the second 2" x 4" and was concerned that I might be approaching the shatter threshold of the glass itself. Finally the lower edge started to move as I worked upward with my strikes. I noticed that the aluminum vertical was beginning to bow in the middle. Stopping to examine the piece, I found that it contained two corroded 1" sheet metal screws attaching it to the frame at both the top and bottom. Neither screw was obvious on prior inspection, due to the level corrosion. I managed to remove the top screw without much difficulty. However, the bottom screw was situated within the frame channel and was virtually inaccessible without removing the entire window frame. With a prayer and a new block of 2" x 4", I decided to go for broke. Hammering the lower edge of the piece, in an effort to shear the screw, the head of the corroded screw pulled through the frame the hard way. The surgery was a success, but now there was one dandy curve in the vertical. This should test my metal working skills. There was a healthy application of the same adhesive/sealant holding this one in place as well. Unfortunately, there appears to be no easy way to determine before hand, that any type of adhesive or sealant might have been applied under this vertical member. Why it was done in the first place is beyond my comprehension. The screws are another matter. If you are attempting to

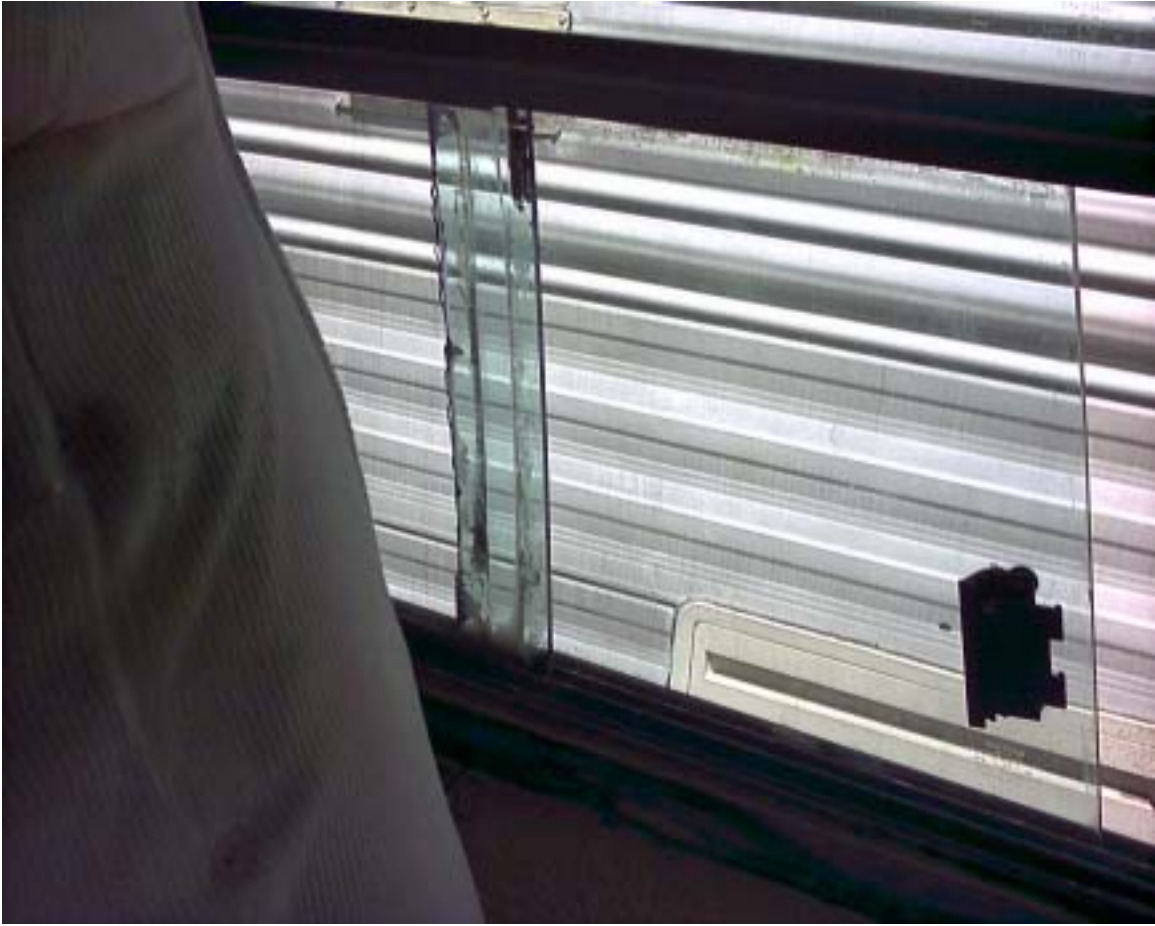
Adhesive had been used to retain the vertical bar in addition to the screws.

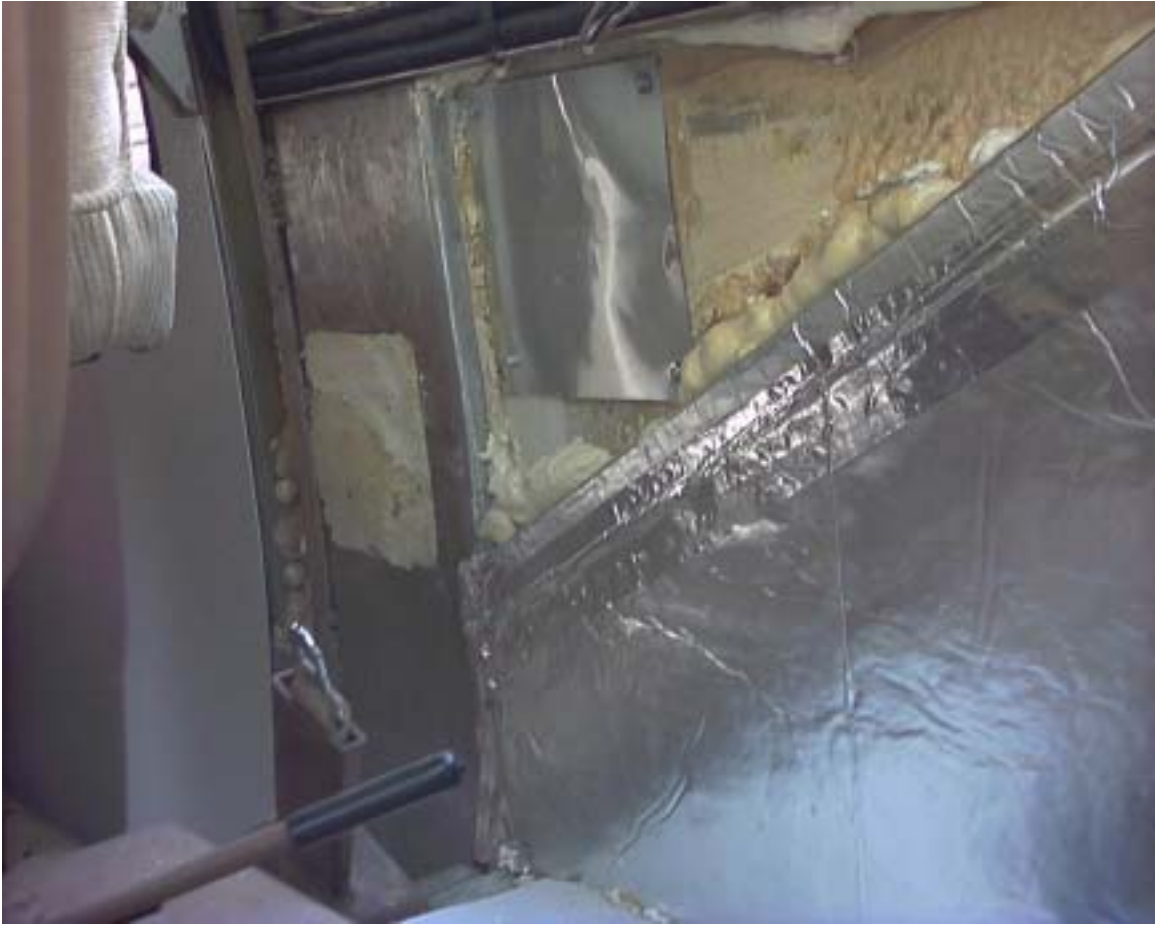
The flashing is secured with pop-rivets at the corners within the recesses of the panel.

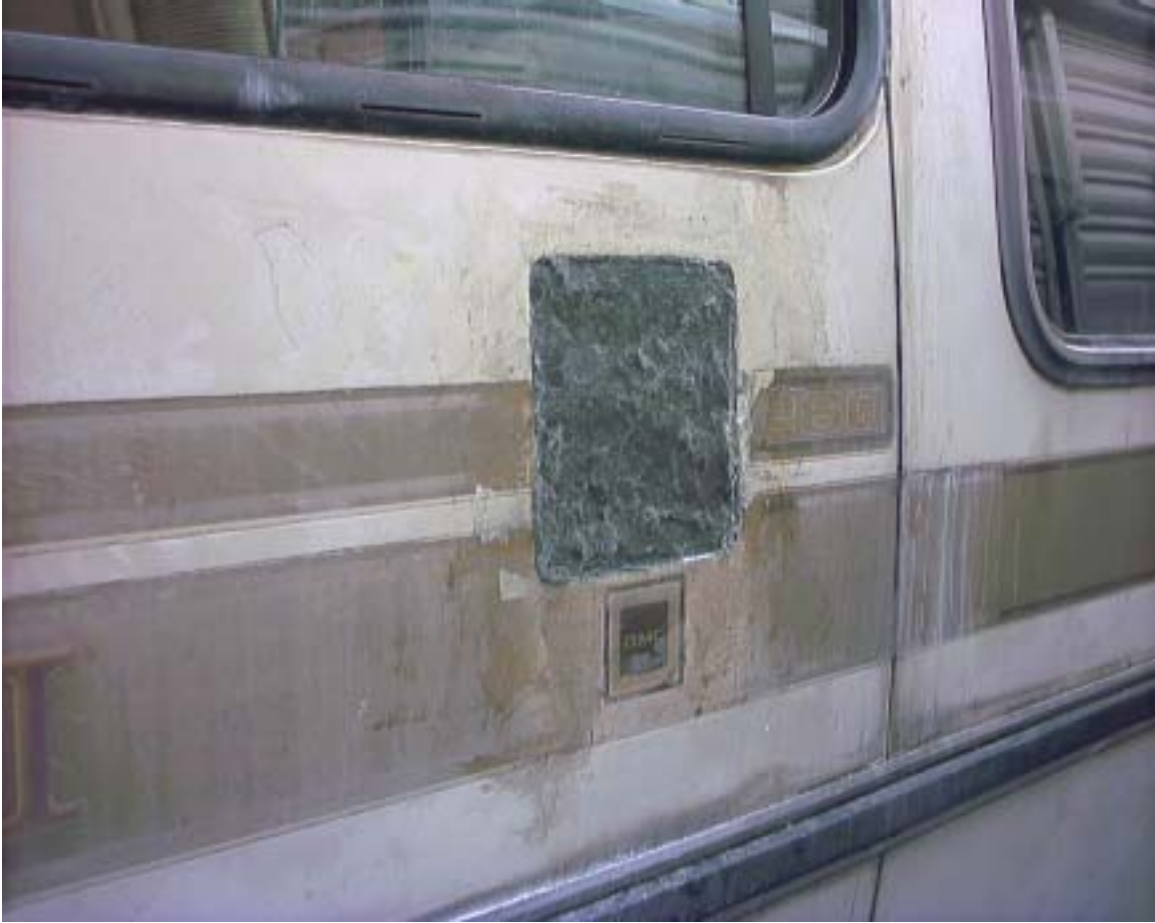
It's not necessary to use the full amount of hardener when mixing the resin.

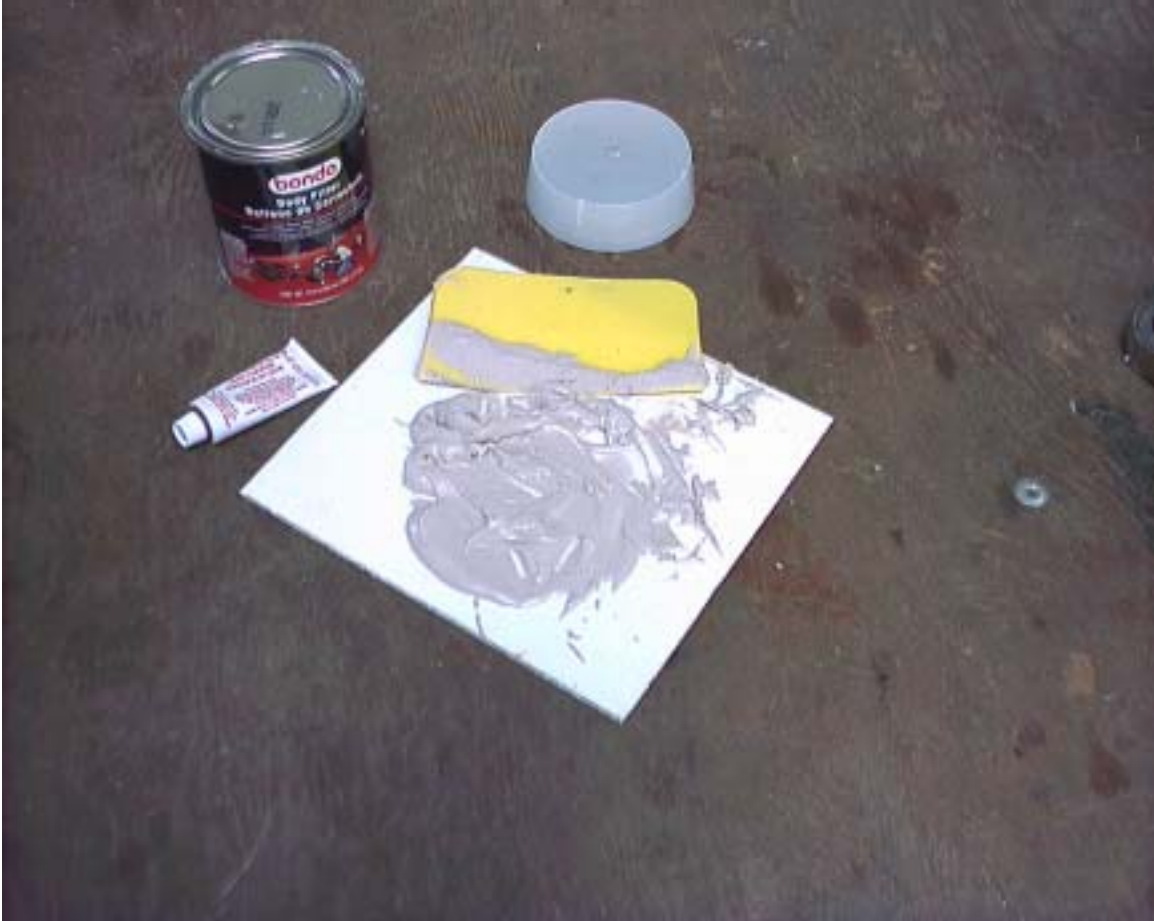
The “Dyna-Hair” forms a strong patch due to the fiberglass fibers suspended in the resin.

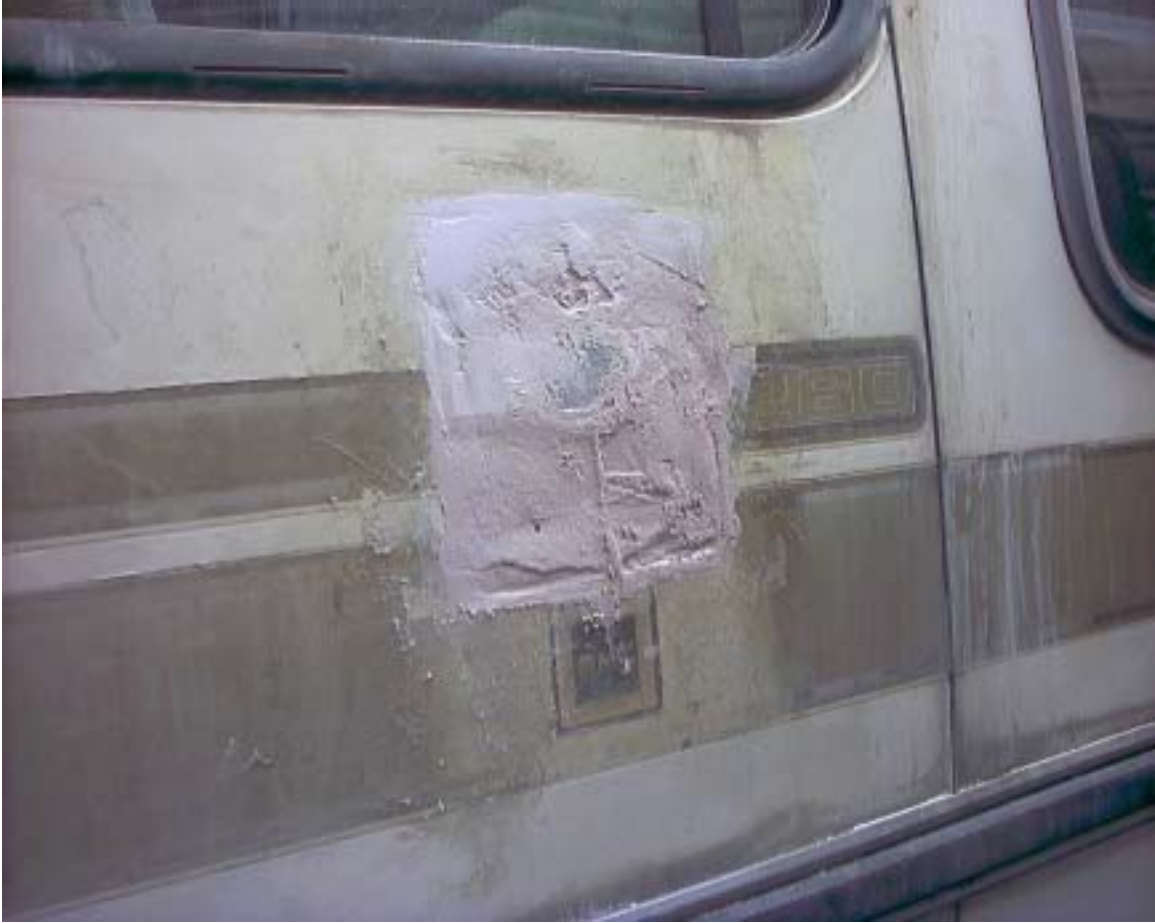
A wide spreader is used with the “Bondo” filler to get a smooth uniform surface.

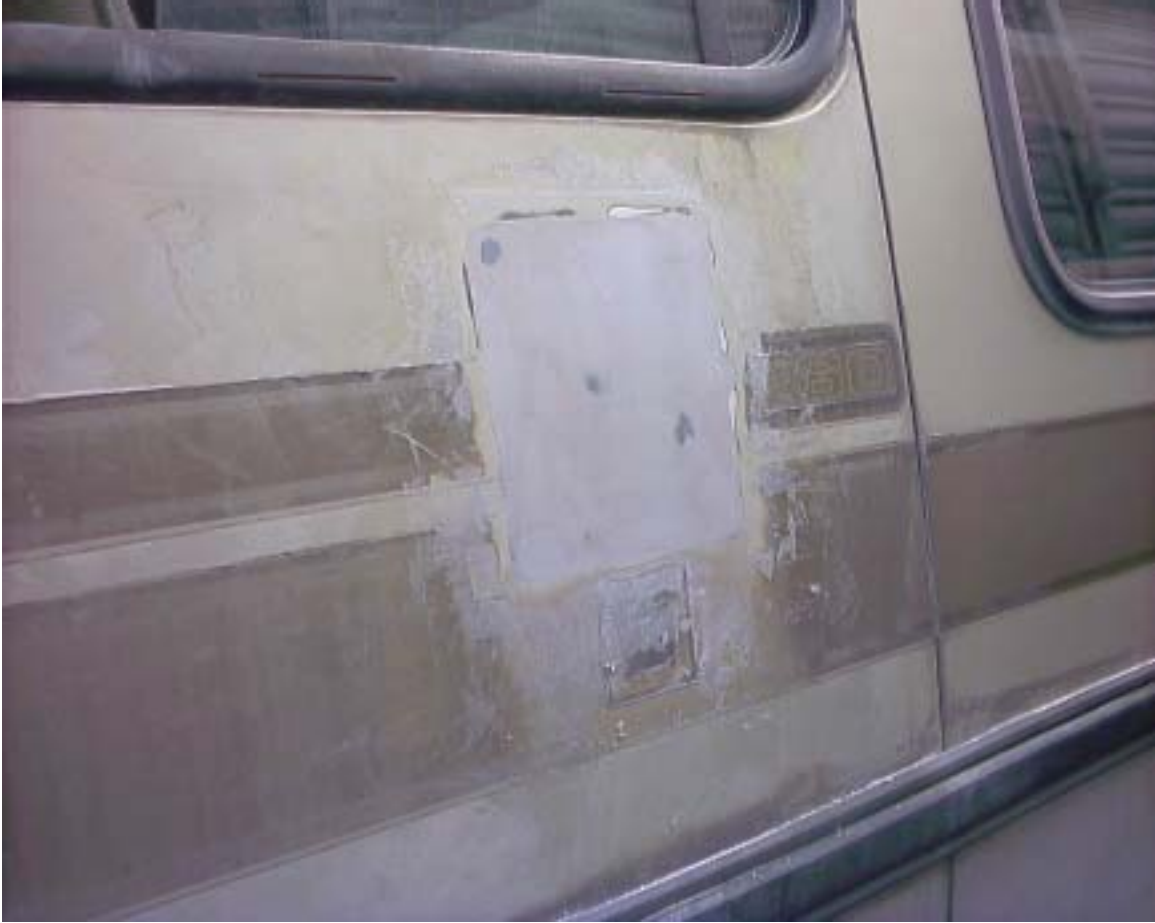
The “Bondo” is applied in several thin layers until a uniform surface is achieved.

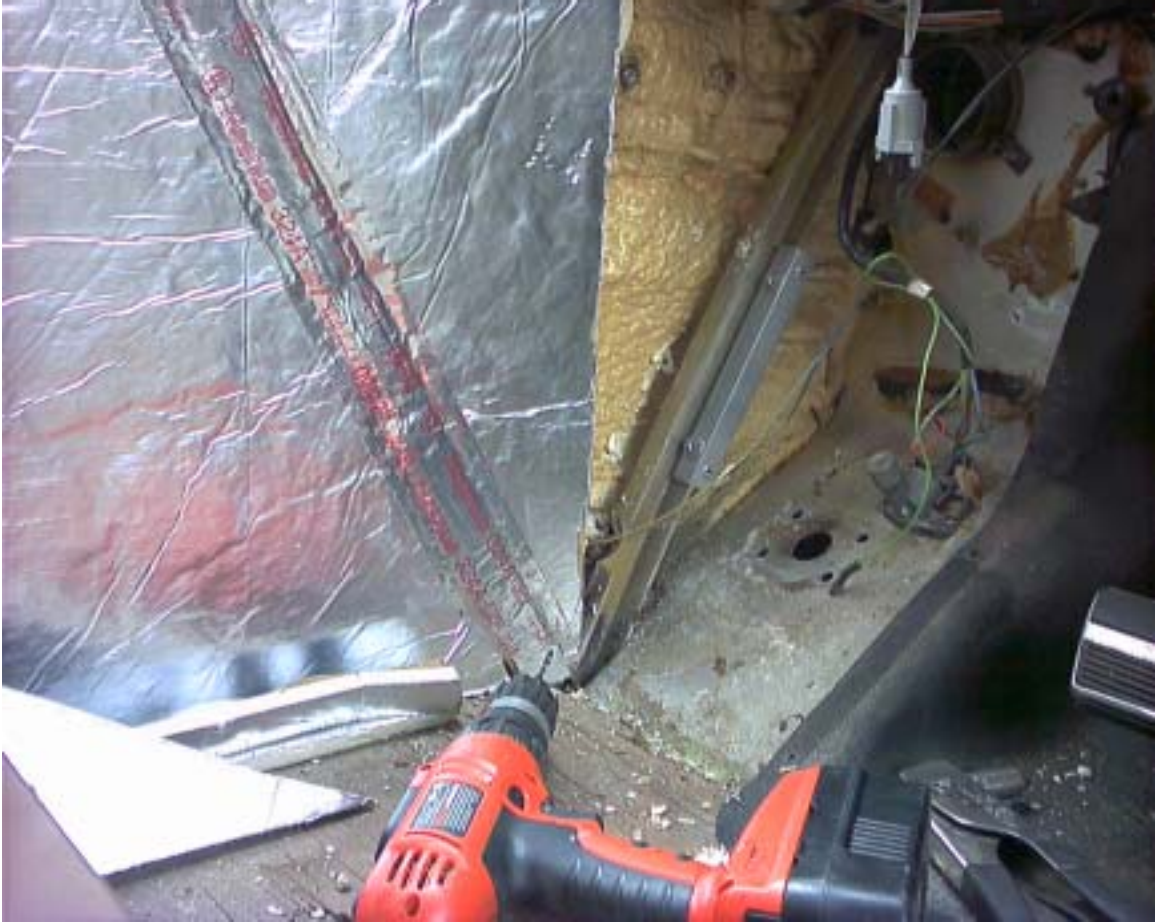
The Finished patch should be smooth and follow the contours of the surface.
